Thermal upgrading

Michael Dignan looks at how the non-standard construction characteristics of a Scottish housing association's properties pose challenges for refurbishment

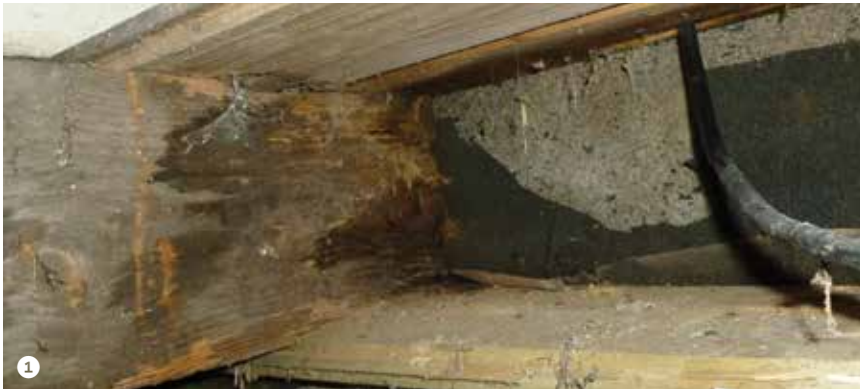
The floor joists were fixed to a wall plate on damp-proof course supported by a concrete ledge (see image 1) with a sub-floor void of around 300mm. The most surprising discovery was made on the inner face of the cladding panels: at the top edge, each was shaped to form a lap for a joggle joint and bent inwards to form a horizontal lip (see image 2). It is suspected that these were formed with the intention of giving rigidity to each panel.

- 1 Sub-floor showing tongue and groove flooring, floor joist, damp-proof course and wall plate. Note the decay in the joist end and severe deterioration to the damp-proof course
- 2 Internal elevation of stripped property. The horizontal lines are the upper section of each panel bent inwards to form the lip
- 3 Severe corrosion of a horizontal lip adjacent to a window opening. Heavy corrosion was found at this level even away from the window itself

- shows significantly more corrosion than the rear elevation
- contains more debris in the cavity
- demonstrates signs of timber decay to the joist ends and wall plate (see image 1), though none to the rear elevation elements.

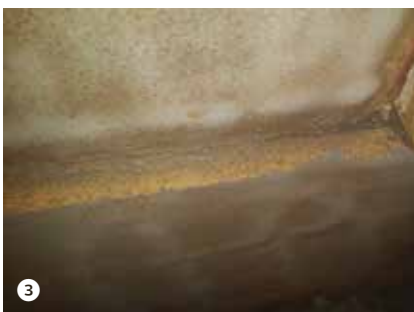
a property of this type is that the horizontal lips are the most vulnerable part of the fabric. As they are flat, there is very little chance of them shedding water and they will therefore retain moisture on their surfaces. The condition of the lips ranged from very good, that is, unaffected by corrosion, to extremely bad, with a severe loss of section, or in some cases had disappeared completely (see image 3).

There was a trend to the deterioration: the uppermost lips, at window-head level, were almost all in excellent condition, while those at sill level were the opposite. At this stage, we are unable to ascertain why this pattern occurred; however, the same pattern has since been identified in other similar properties.
