**SCOTTISH MARKET CROSSES:
THE DEVELOPMENT OF A RISK ASSESSMENT MODEL**

LINDSEY JANE THOMSON

School of Construction, Property and Surveying

July 2000

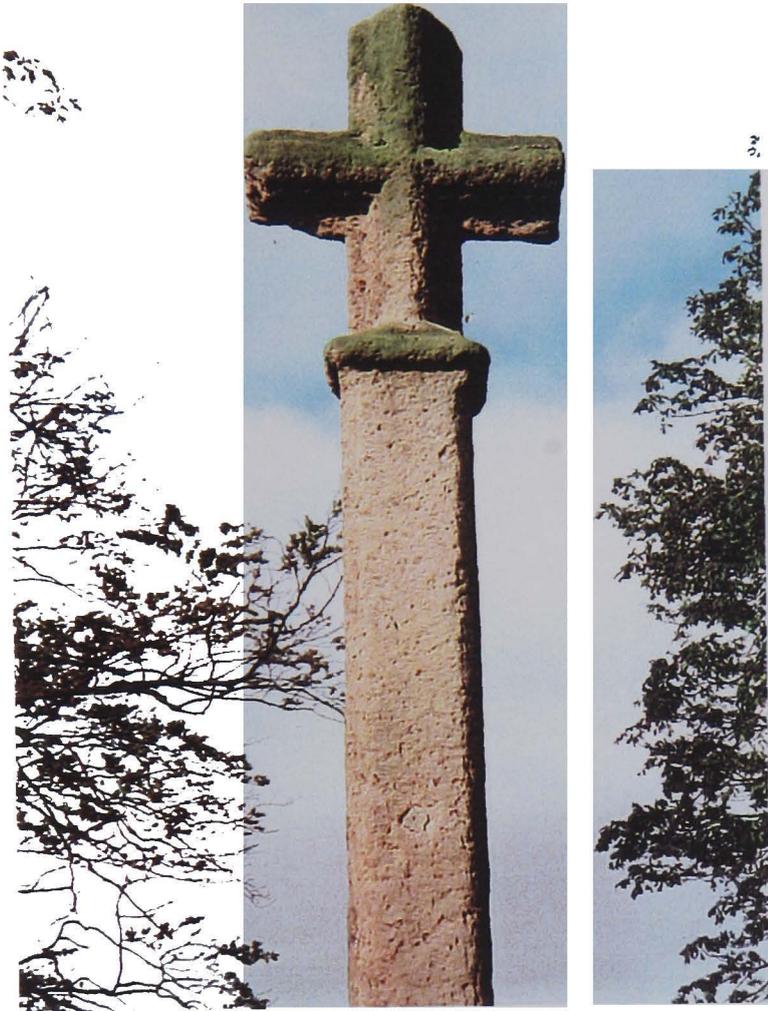
Plate 3.1 Heavy algal growth on Ormiston market cross finial.

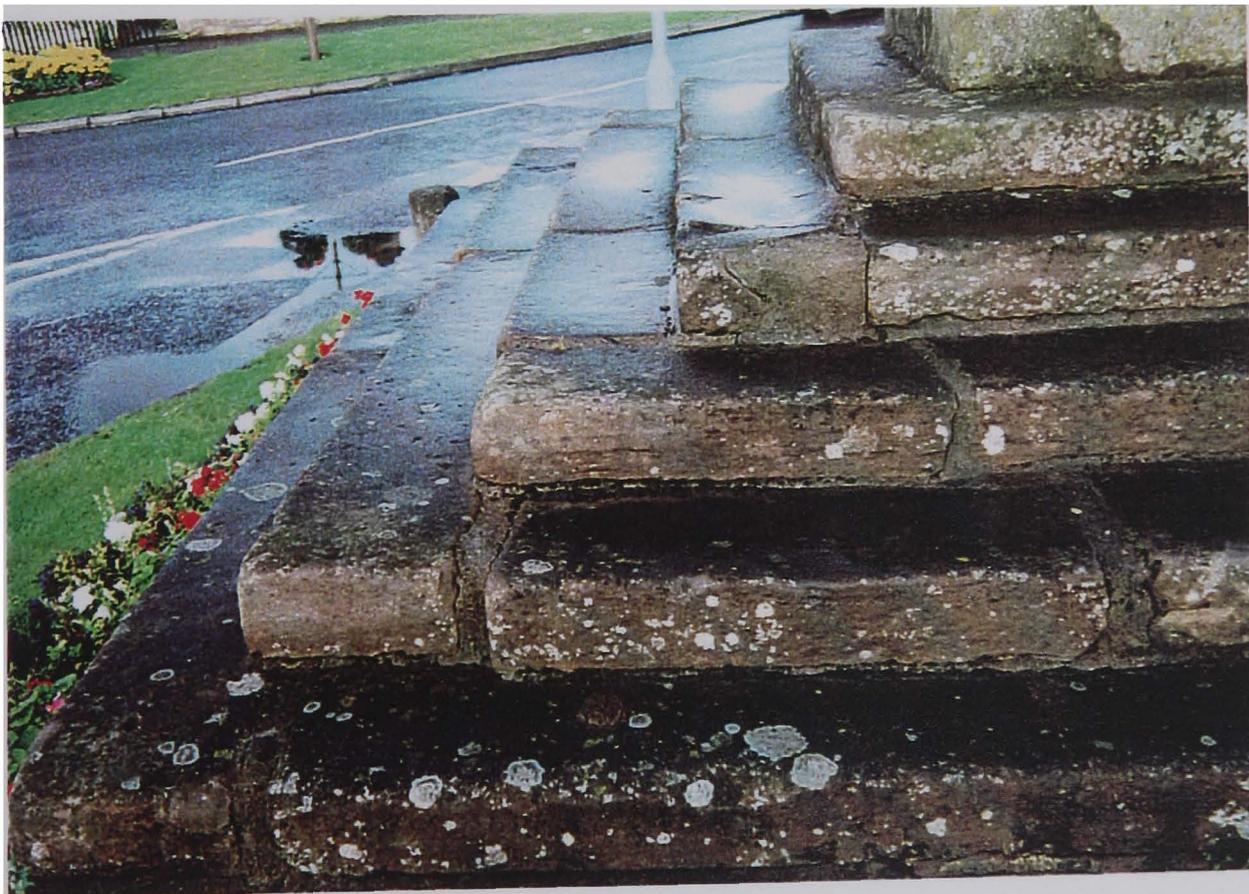
Plate 3.2 Moderate lichen growth on Pencaitland market cross steps.

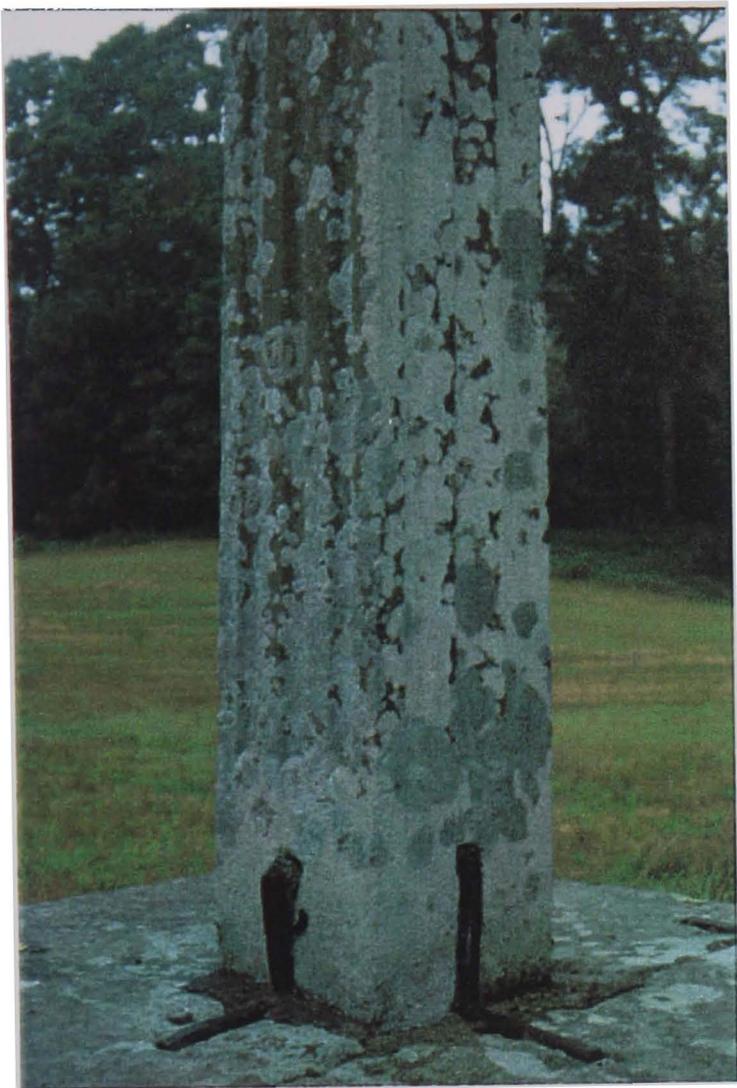
Plate 3.3 Dense lichen growth on Rossie market cross.

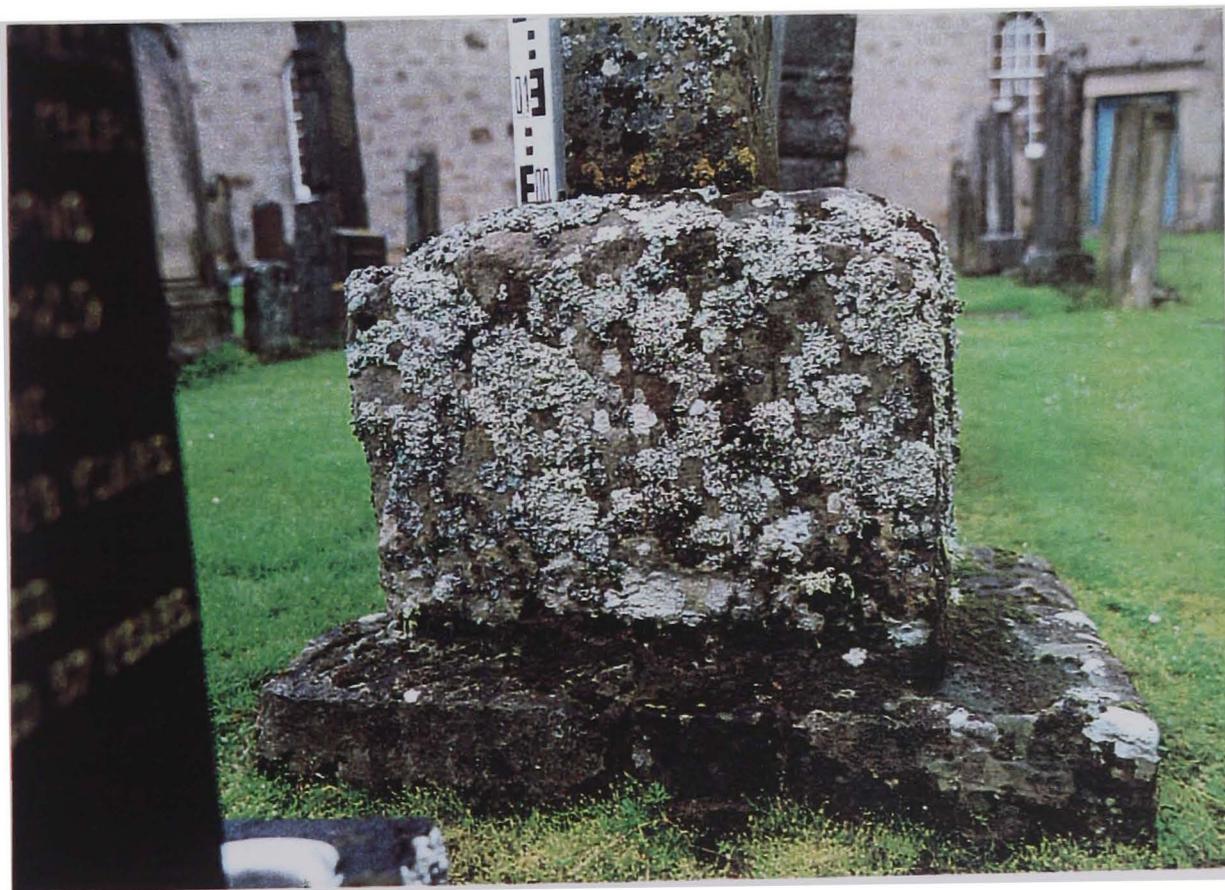
Plate 3.4 Dense lichen growth on Dallas market cross socket stone.

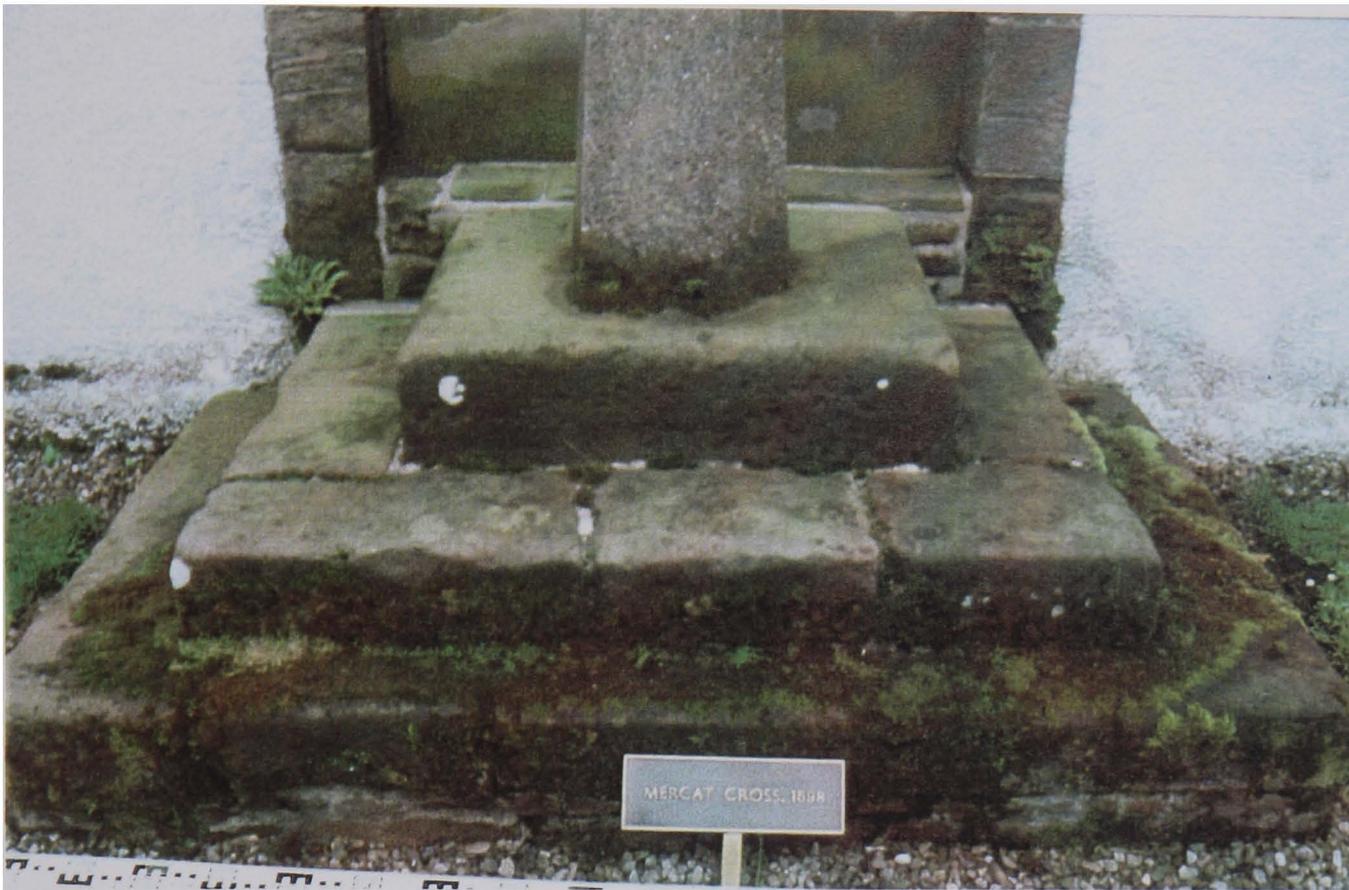
late 3.5 Dense moss growth on Cromarty market cross steps.

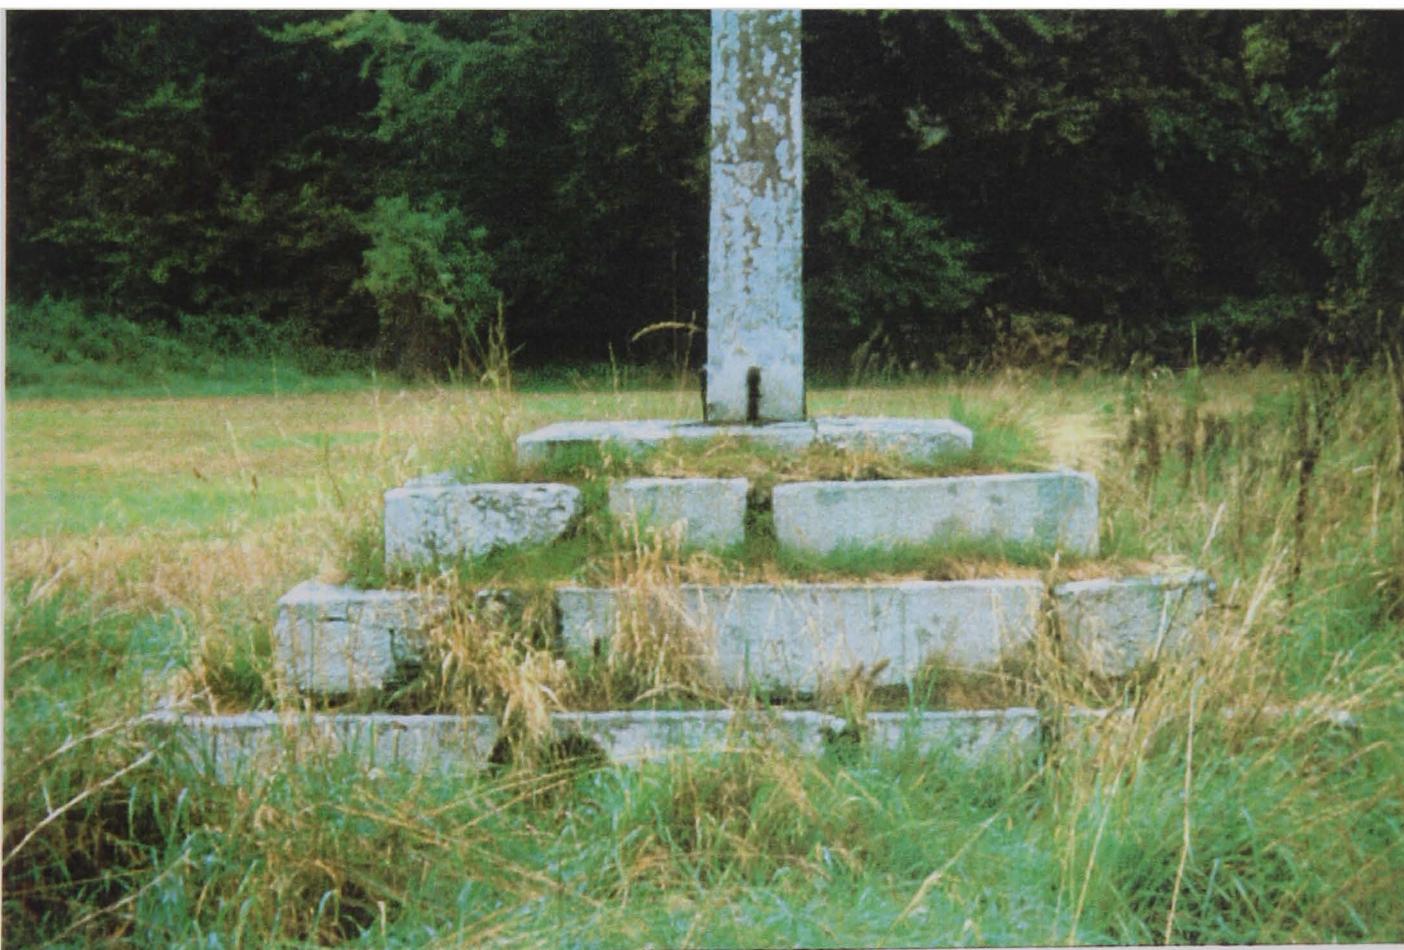
Plate 3.6 Dense growth of higher plants on Rossie market cross steps.

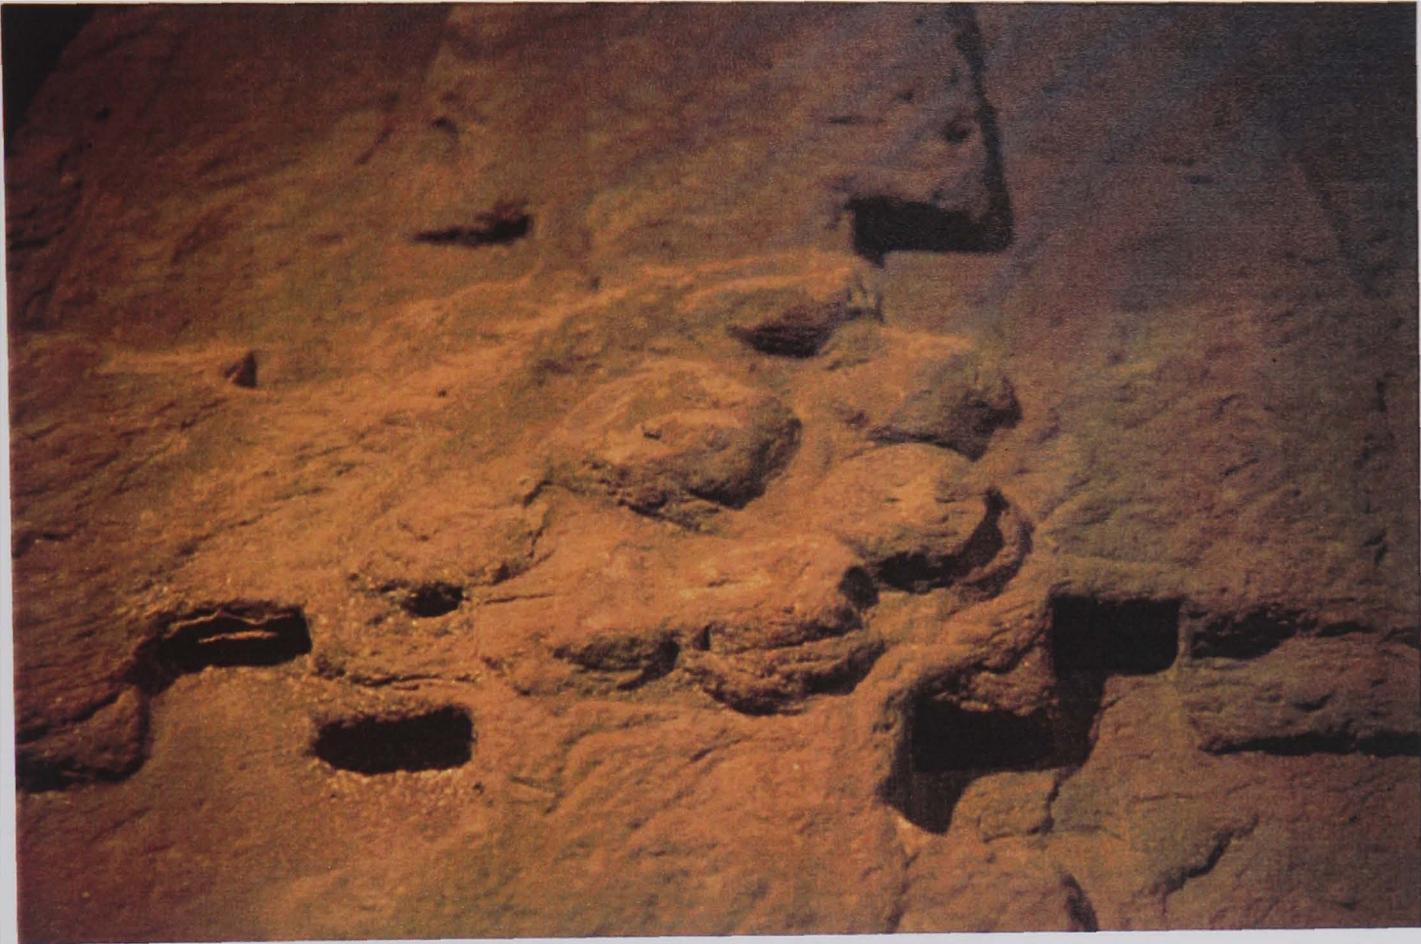
Plate 3.7 Small, white spots of fungal growth on Fowlis Wester cross-slab.

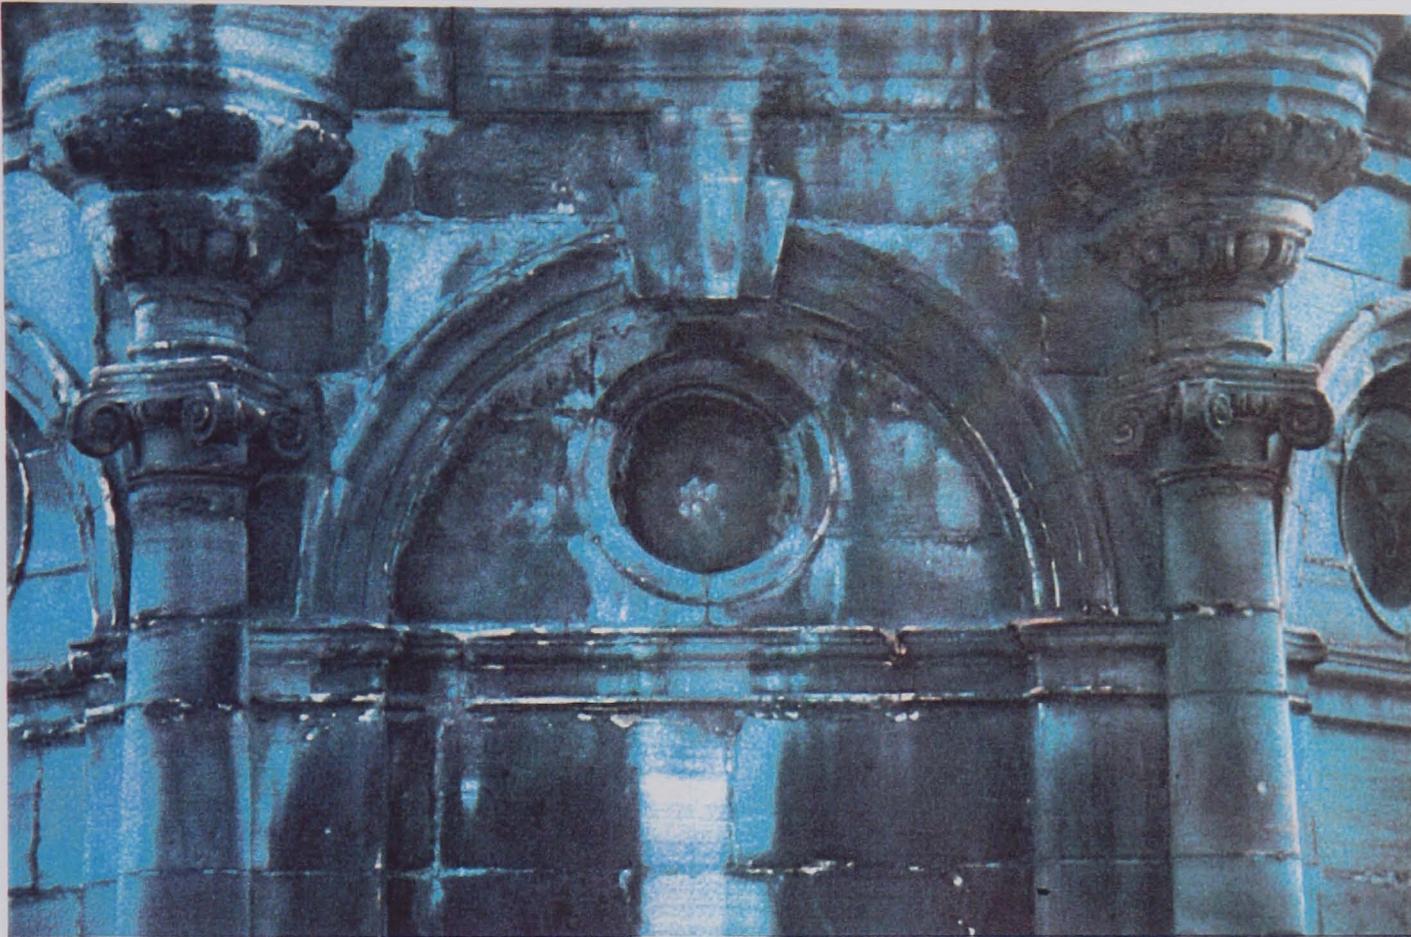
Plate 3.8 Severe, black gypsum crust on Edinburgh High Street market cross.

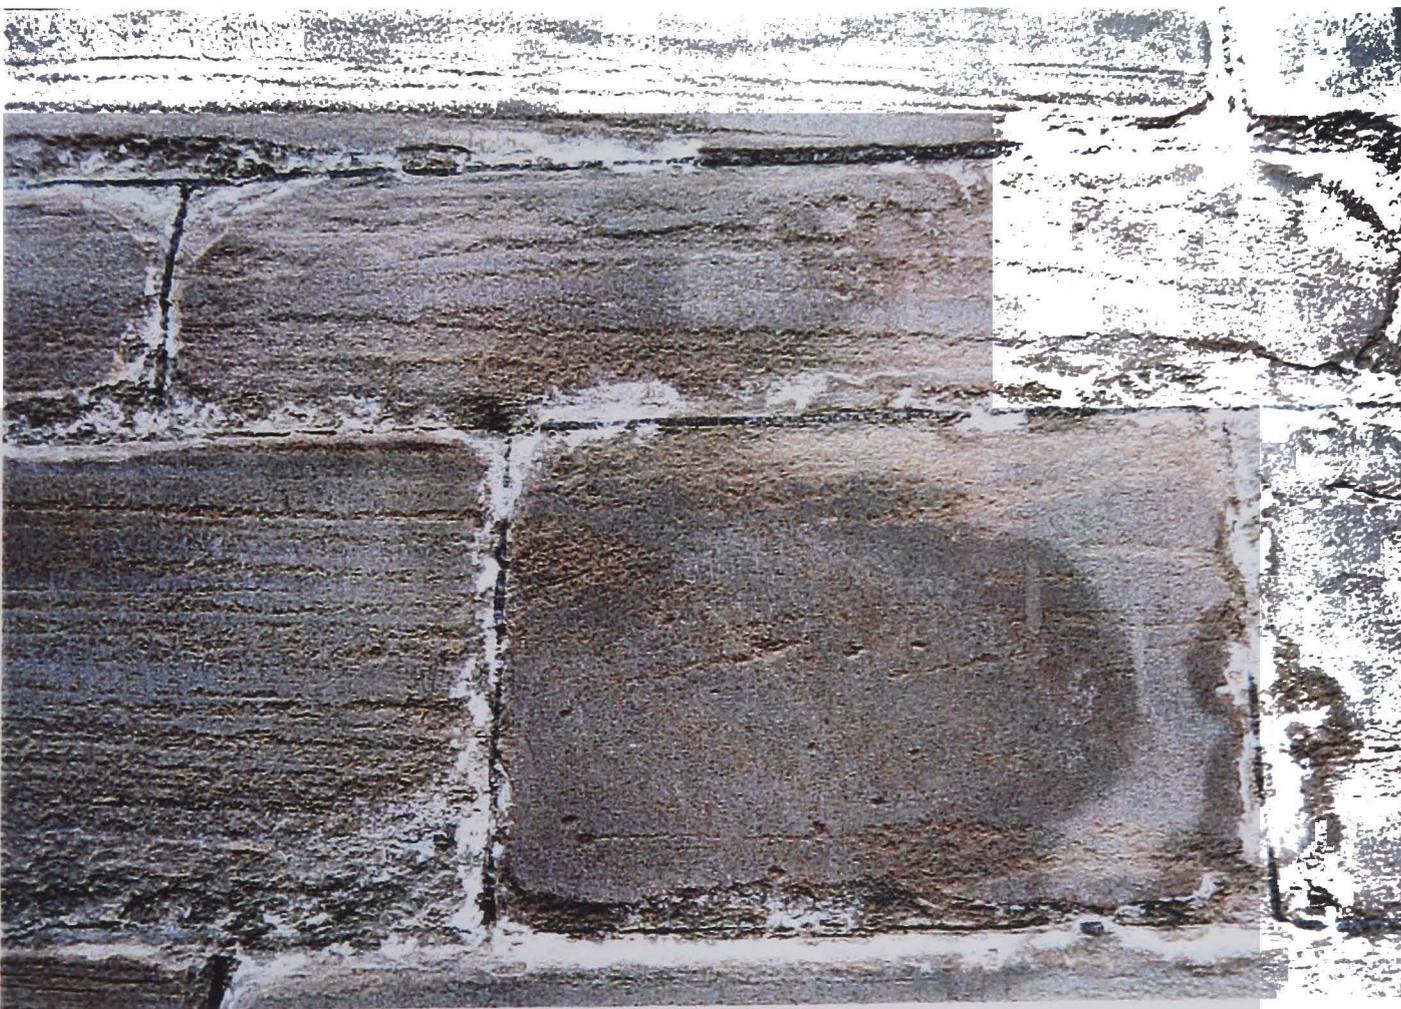
Plate 3.9 Dense efflorescence deposit on Edinburgh High Street market cross.

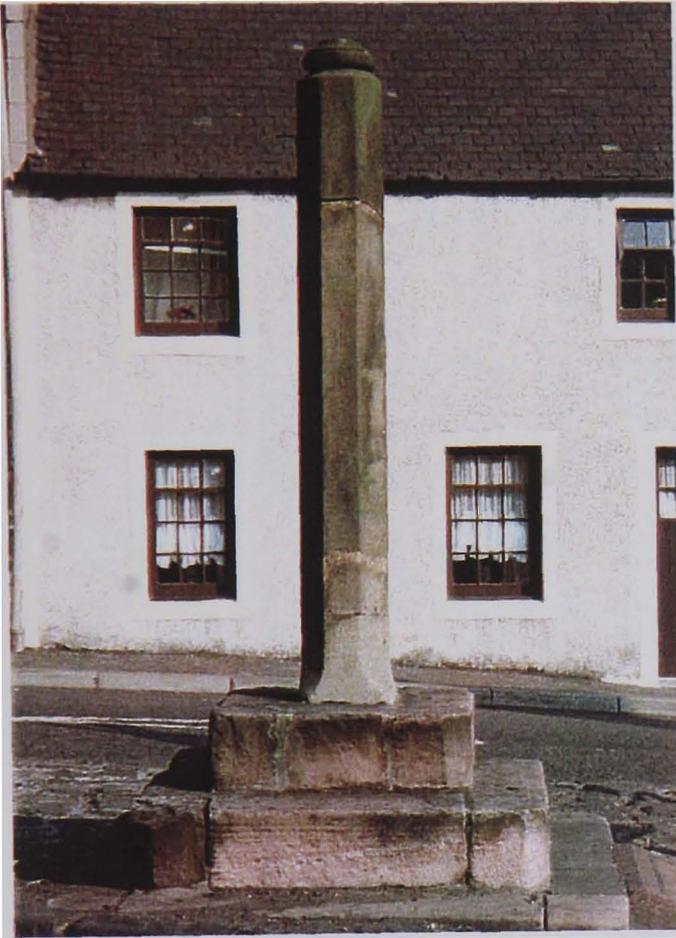
Plate 3.10 Moderately dense particulate soiling
Ochiltree market cross.

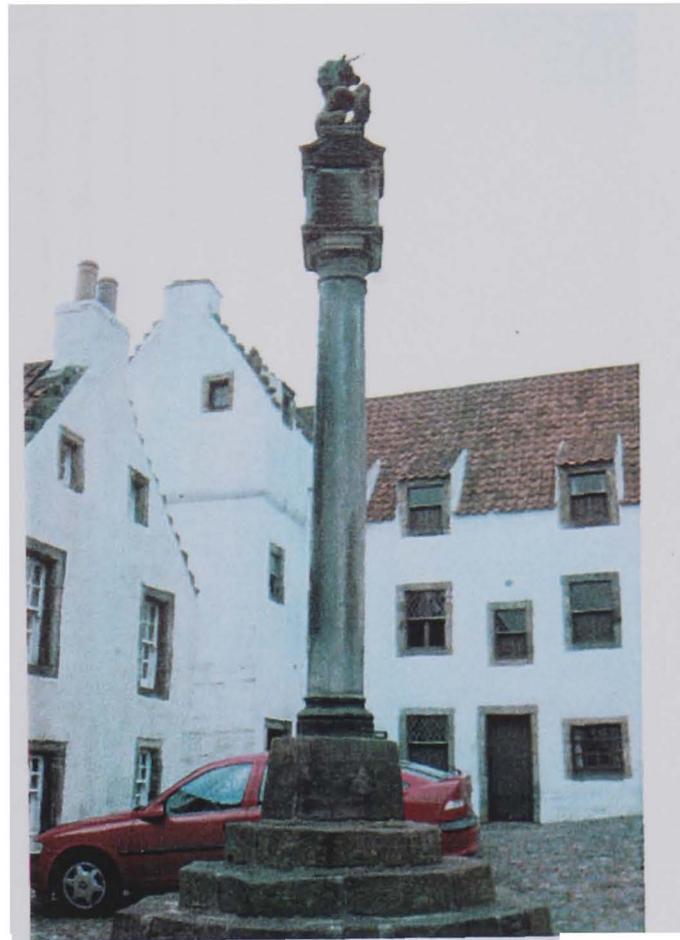
Plate 3.11 Dense particulate soiling on
Culross market cross.

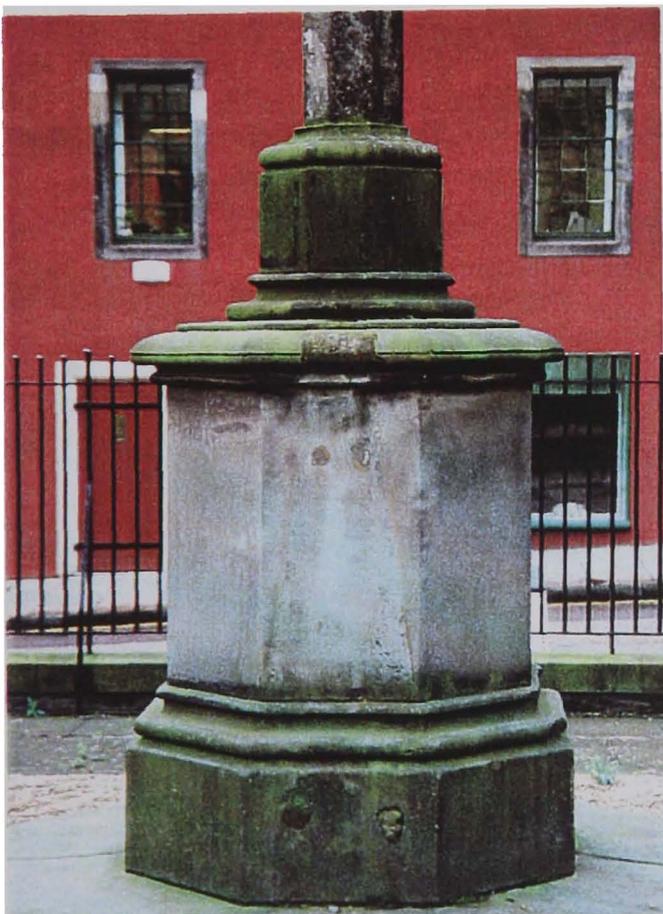
Plate 3.12 Moderate staining left by iron attachment
on Edinburgh Canongate market cross.

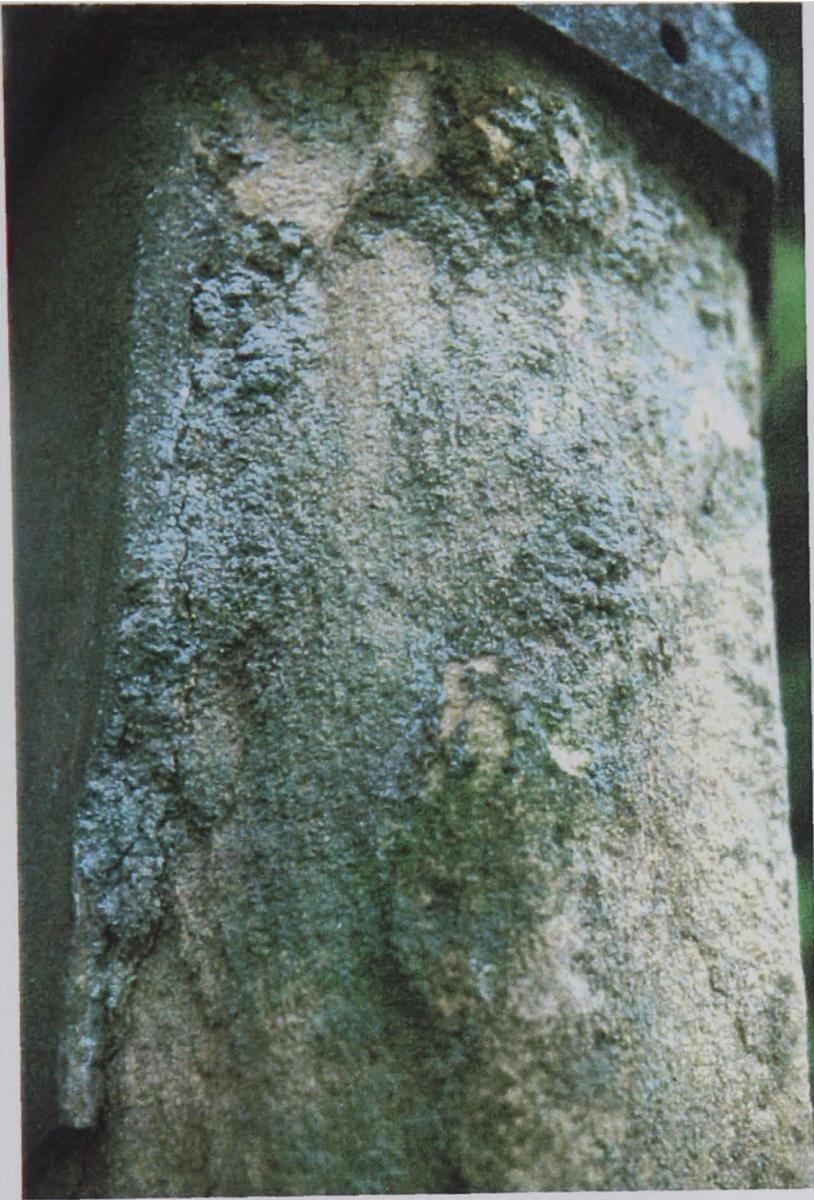
Plate 3.13 Severe crumbling on Cromarty market cross shaft.

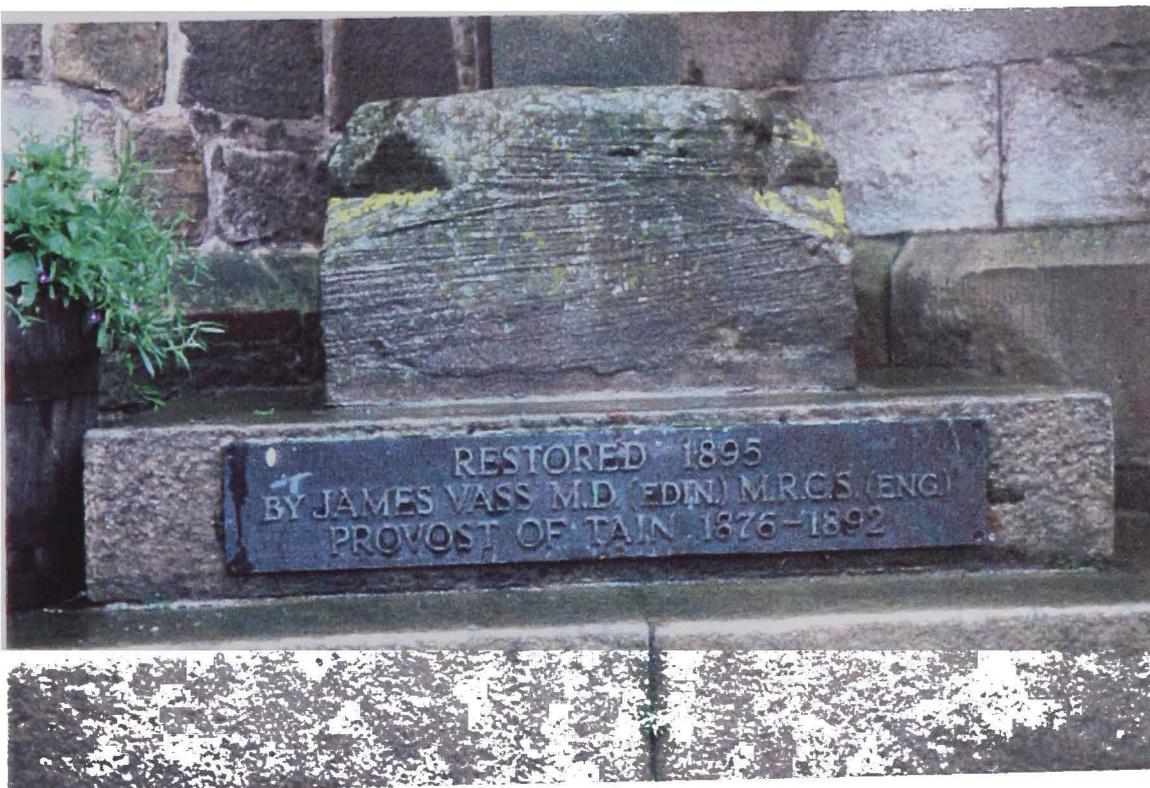
Plate 3.14 Moderate differential weathering on Tain market cross socket stone.

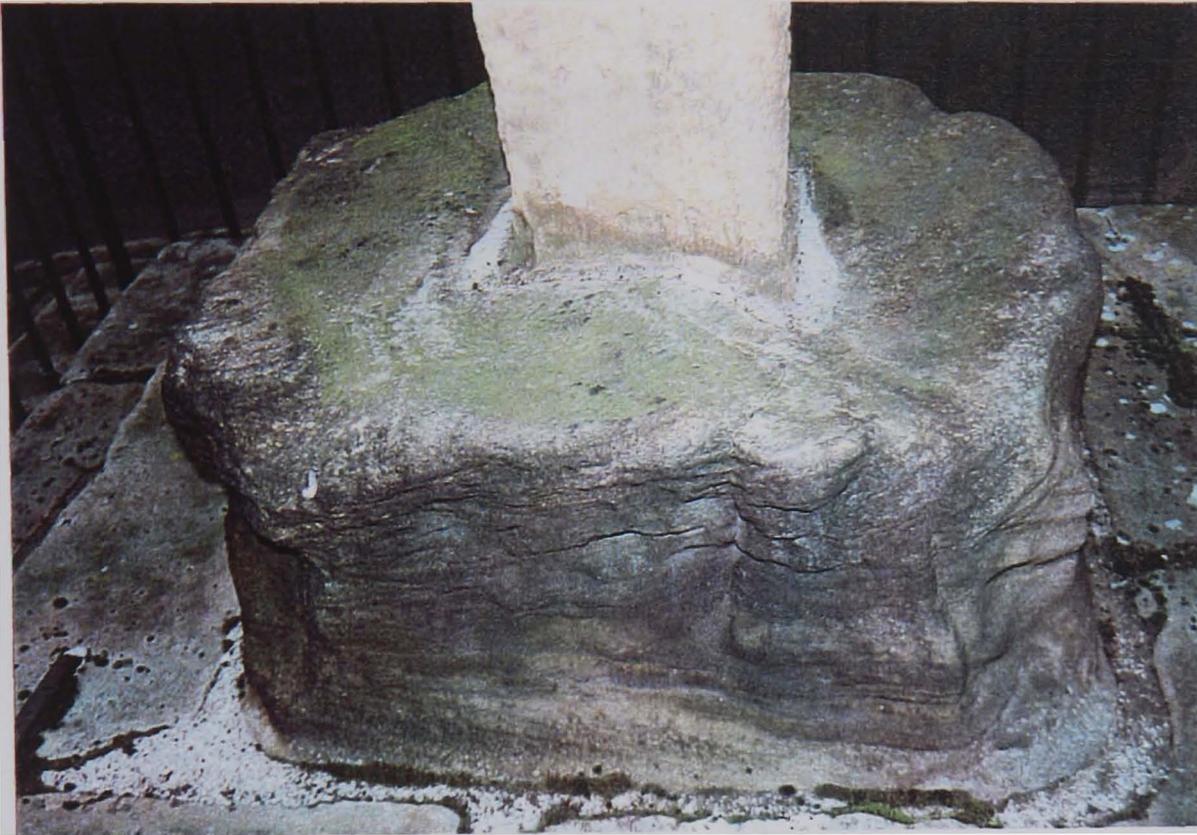
Plate 3.15 Severe differential weathering on Ormiston market cross socket stone.

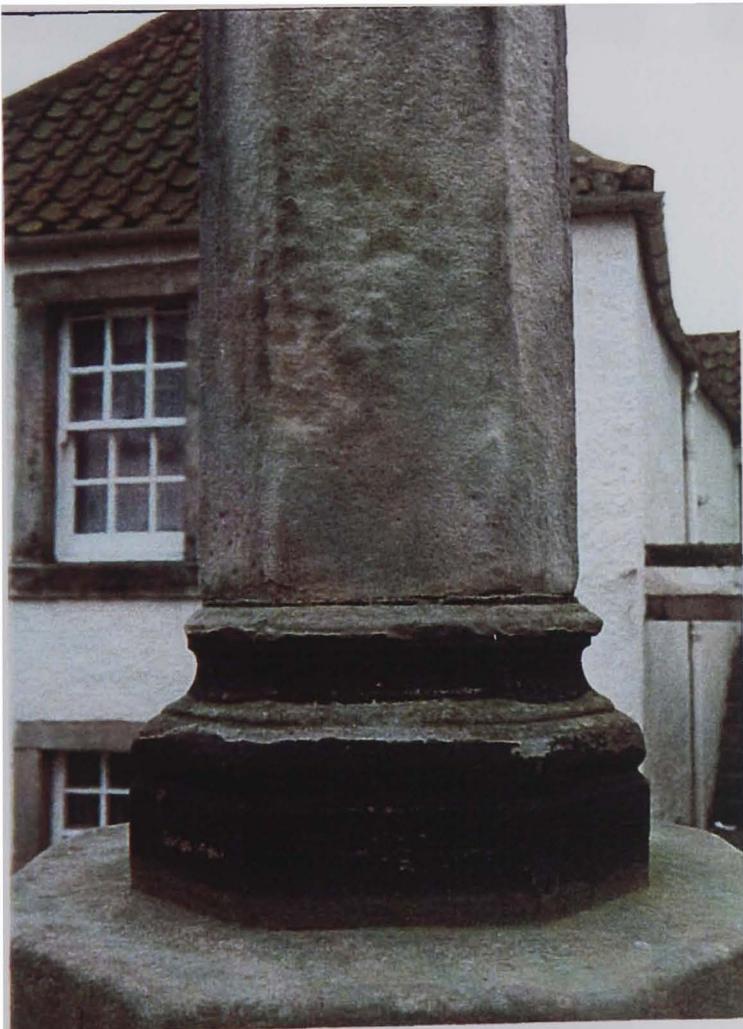
Plate 3.16 Light granulation on Culross market cross shaft.

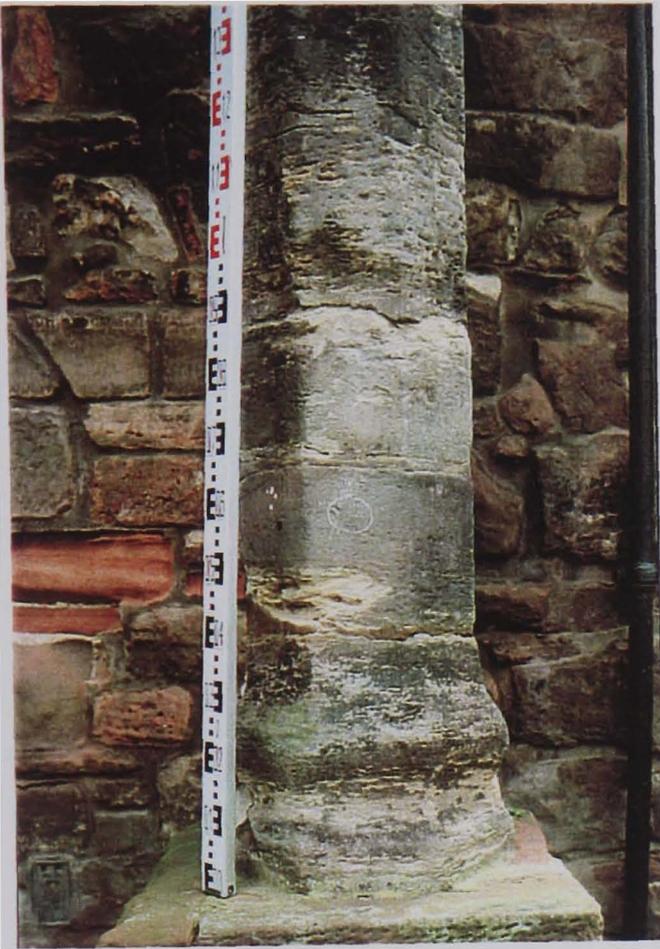
Plate 3.17 Severe granulation on Dunbar market cross shaft.

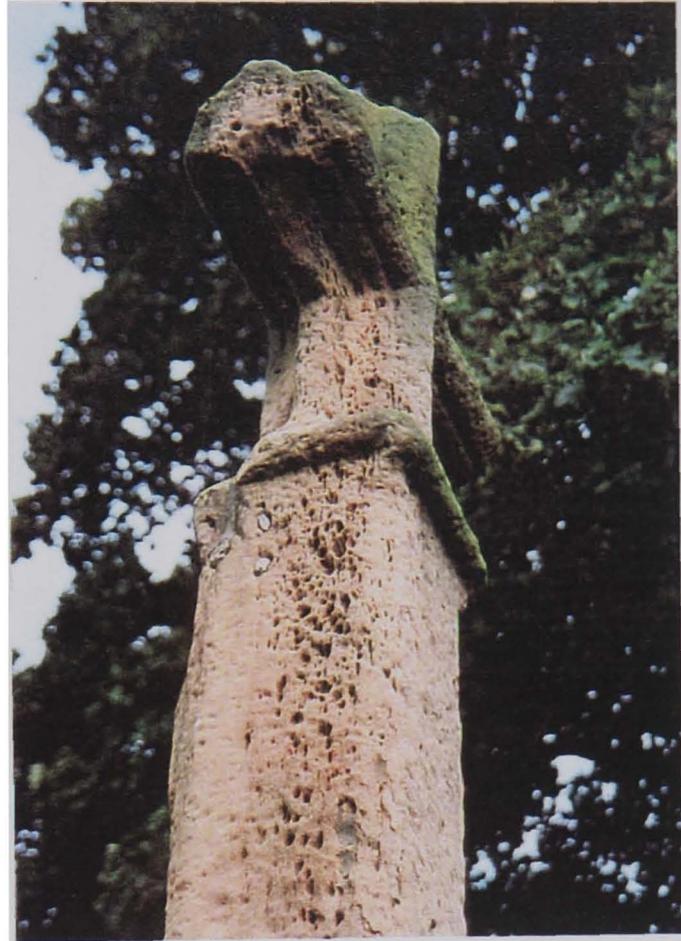
Plate 3.18 Moderate honeycomb weathering on Ormiston cross-shaft.

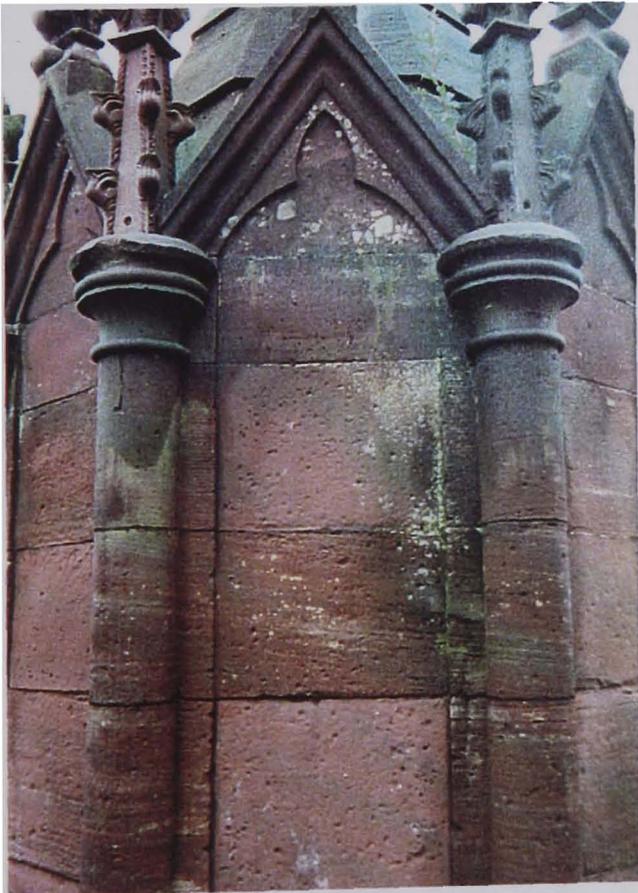
Plate 3.19 Moderate pitting on Turriff market cross pedestal base.

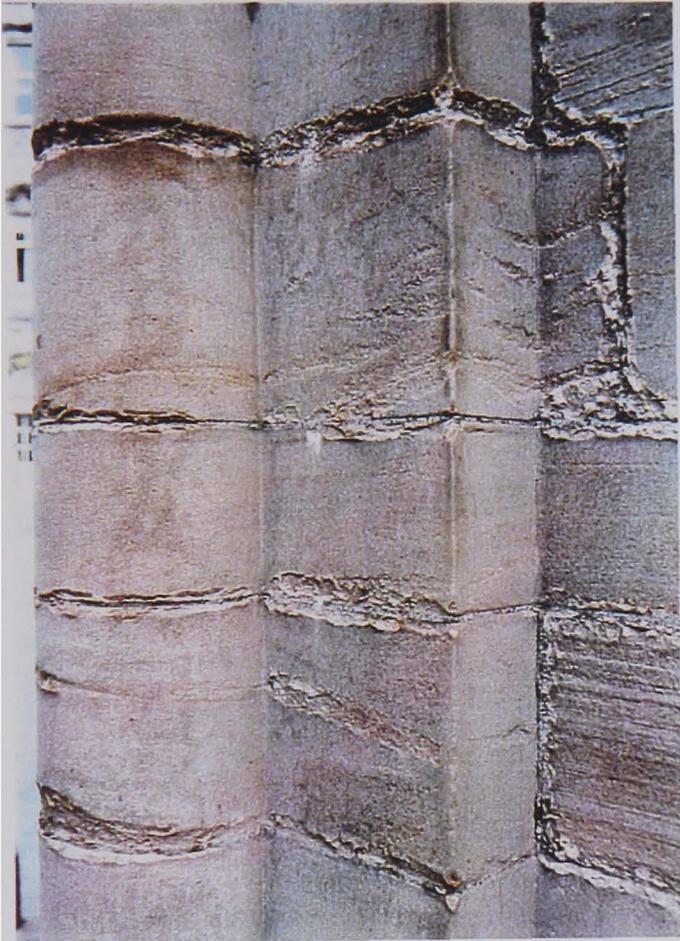
Plate 3.20 Severe blistering on Edinburgh High Street market cross.

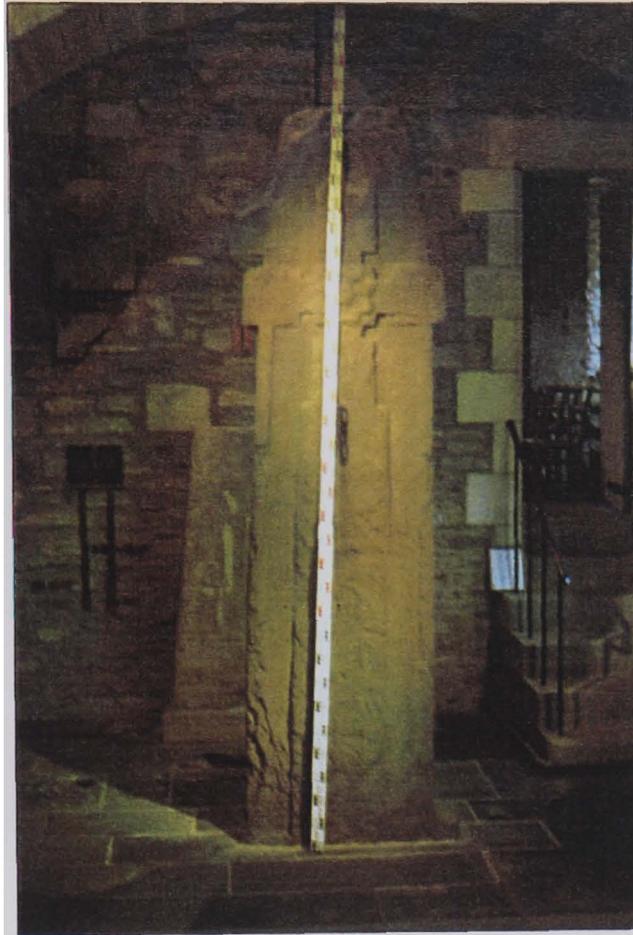
Plate 3.21 Severe delamination on Fowlis Wester cross-slab.

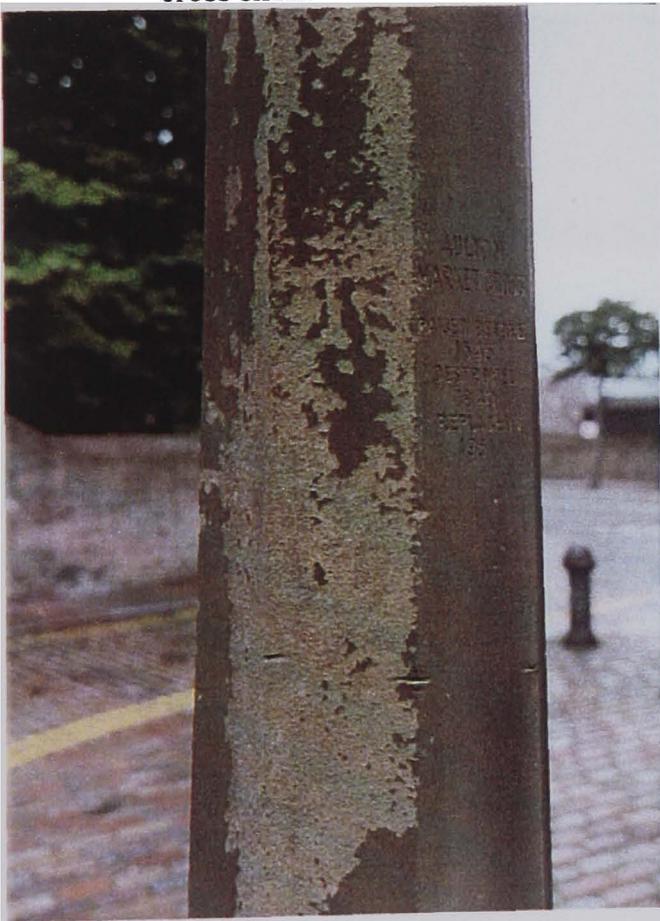
Plate 3.22 Severe flaking on Old Aberdeen market cross shaft.

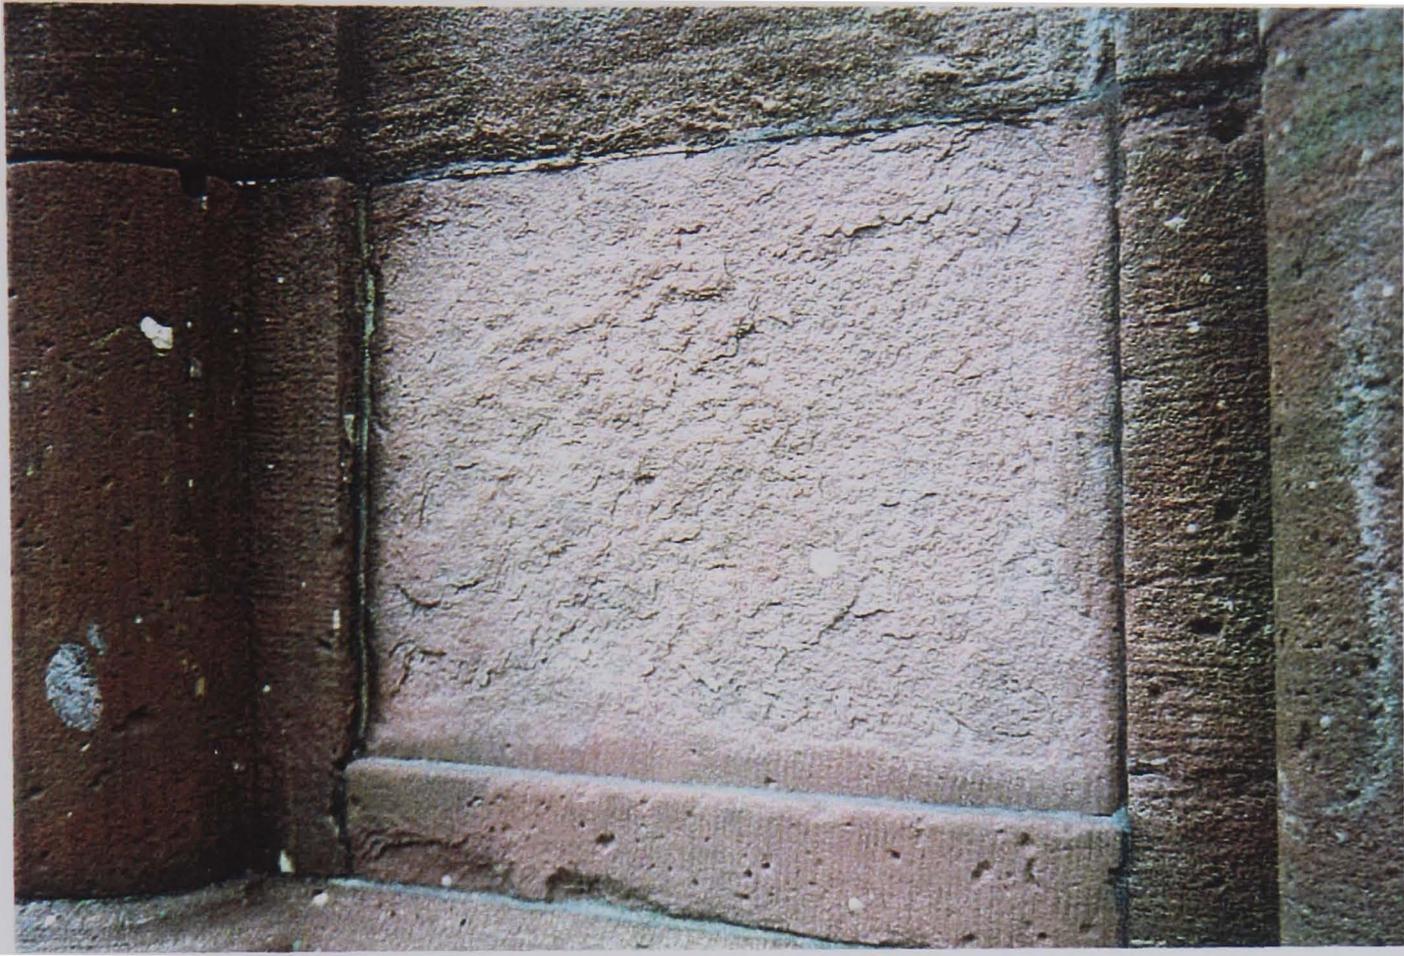
Plate 3.23 Severe scaling on Turriff market cross pedestal base.

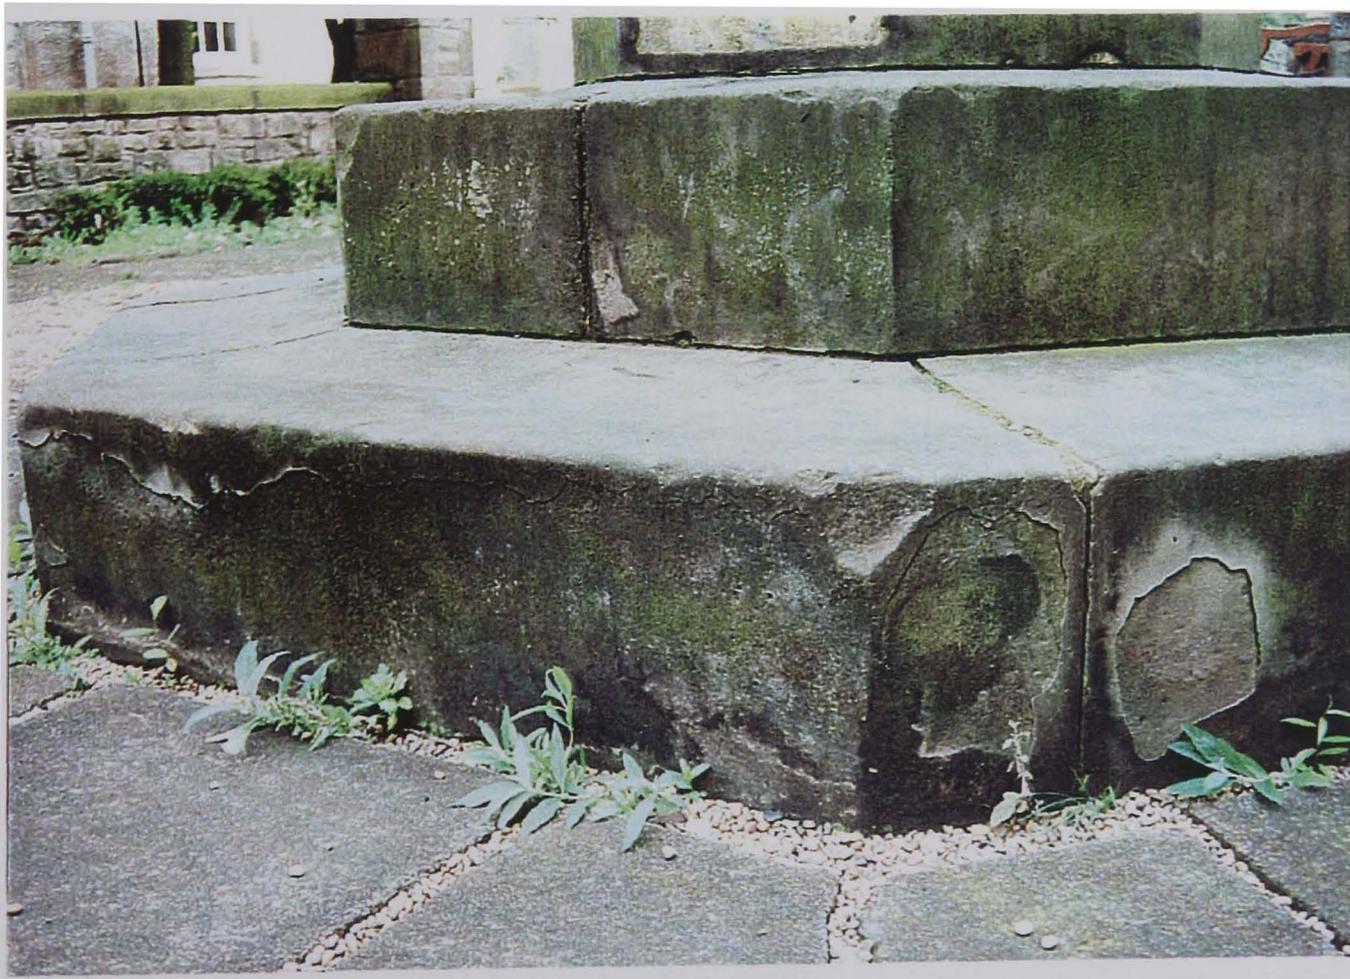
Plate 3.24 Severe spalling on Edinburgh Canongate market cross steps.
