**SCOTTISH MARKET CROSSES:
THE DEVELOPMENT OF A RISK ASSESSMENT MODEL**

LINDSEY JANE THOMSON

School of Construction, Property and Surveying

July 2000

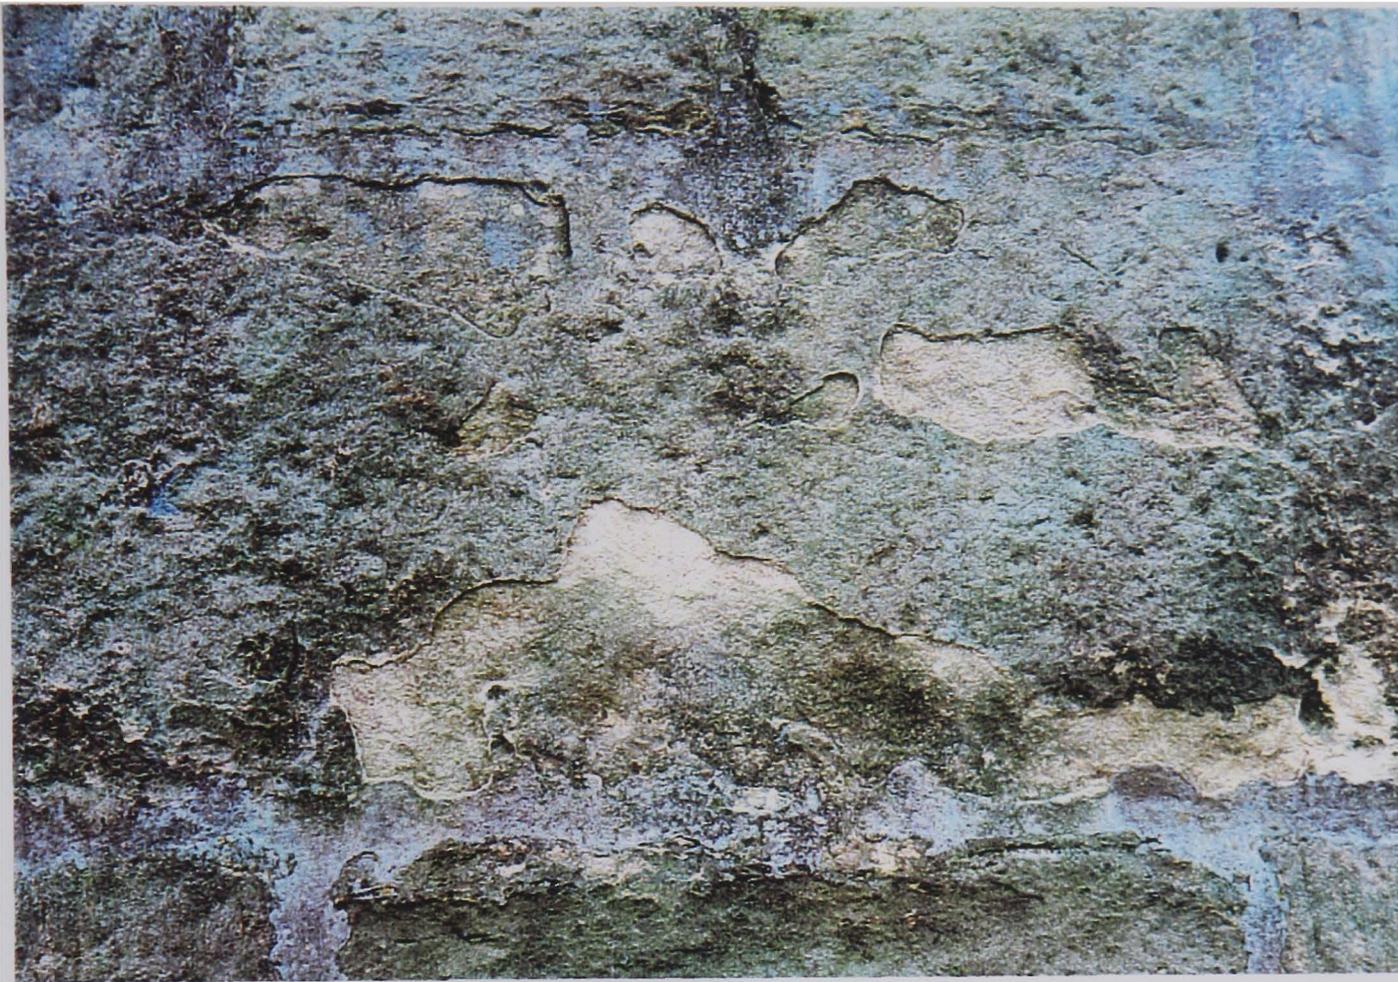
Plate 3.25 Severe spalling on Pencaitland market cross pedestal base.

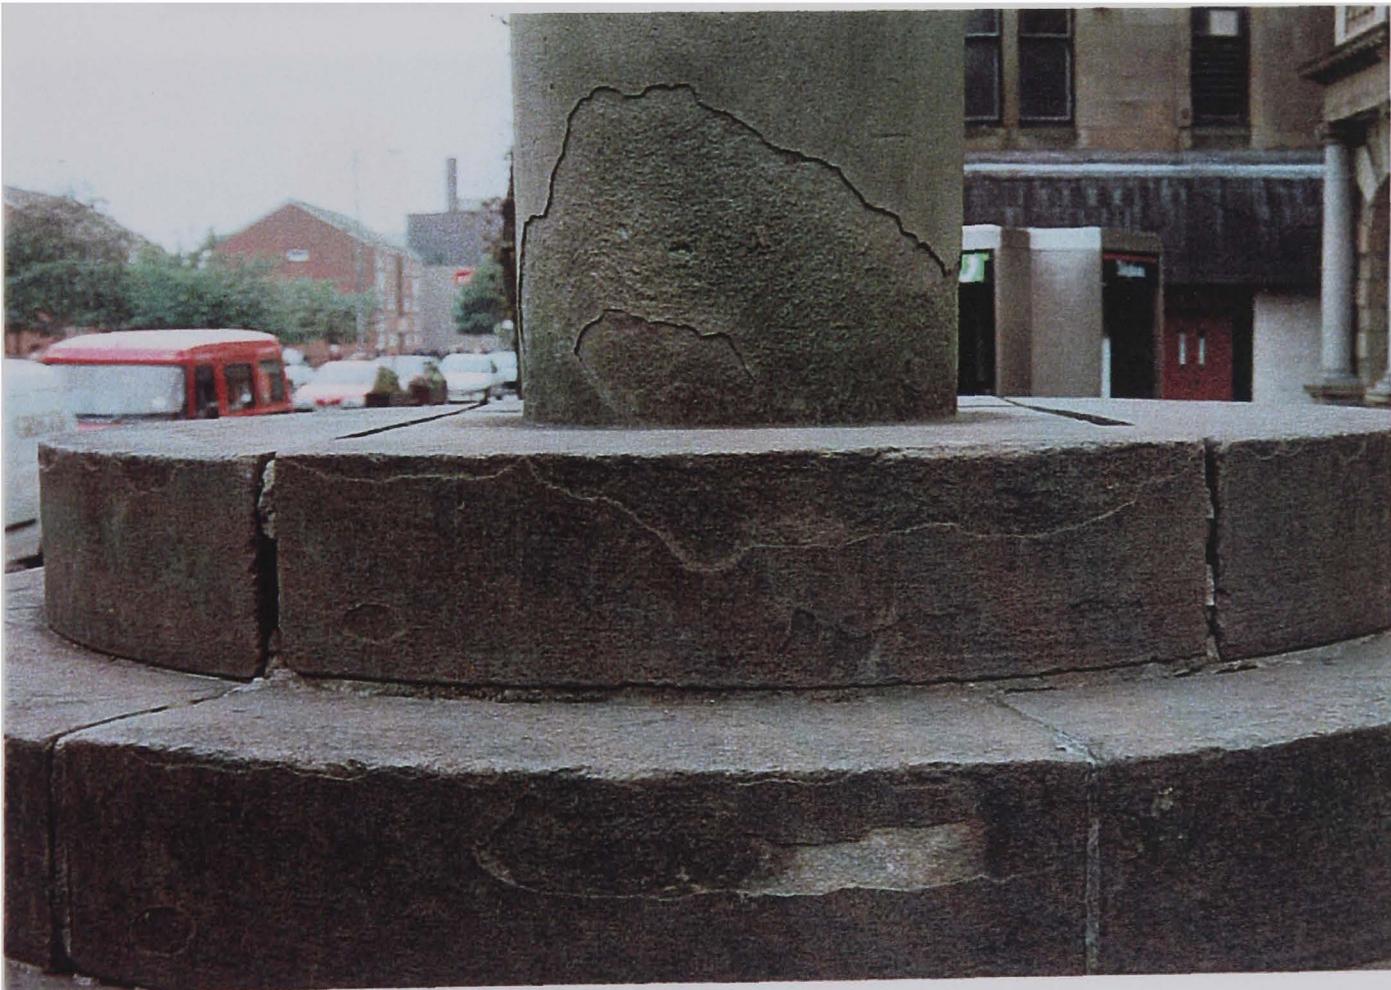
Plate 3.26 Severe spalling on Rutherglen market cross steps and shaft base.

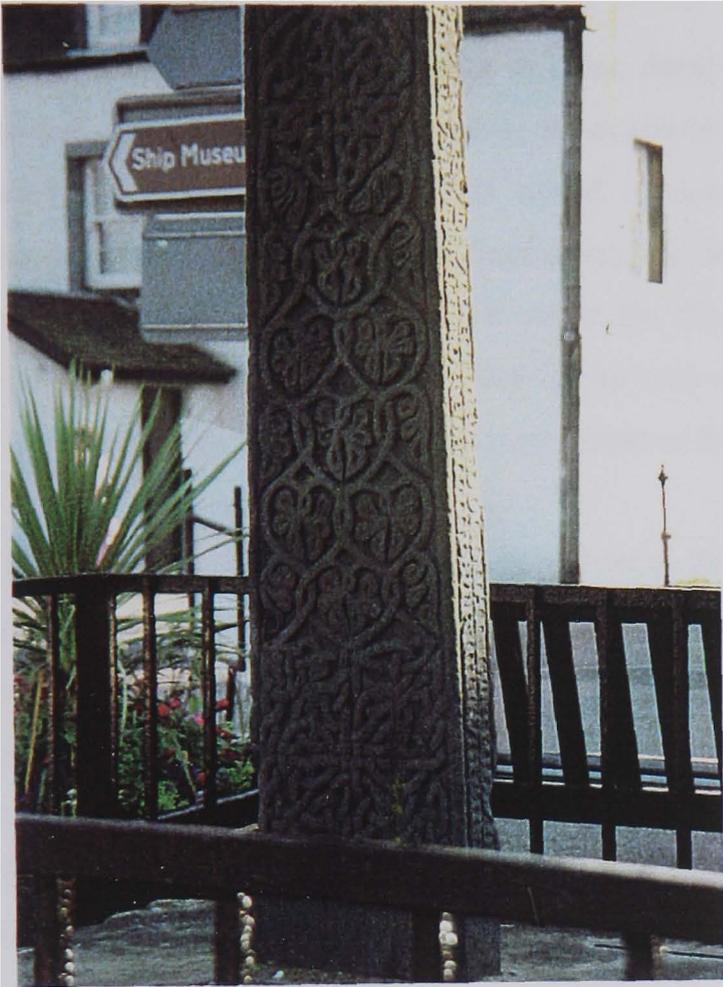
Plate 3.27 Moderate mechanical damage on Inveraray cross-shaft (see right-hand profile).

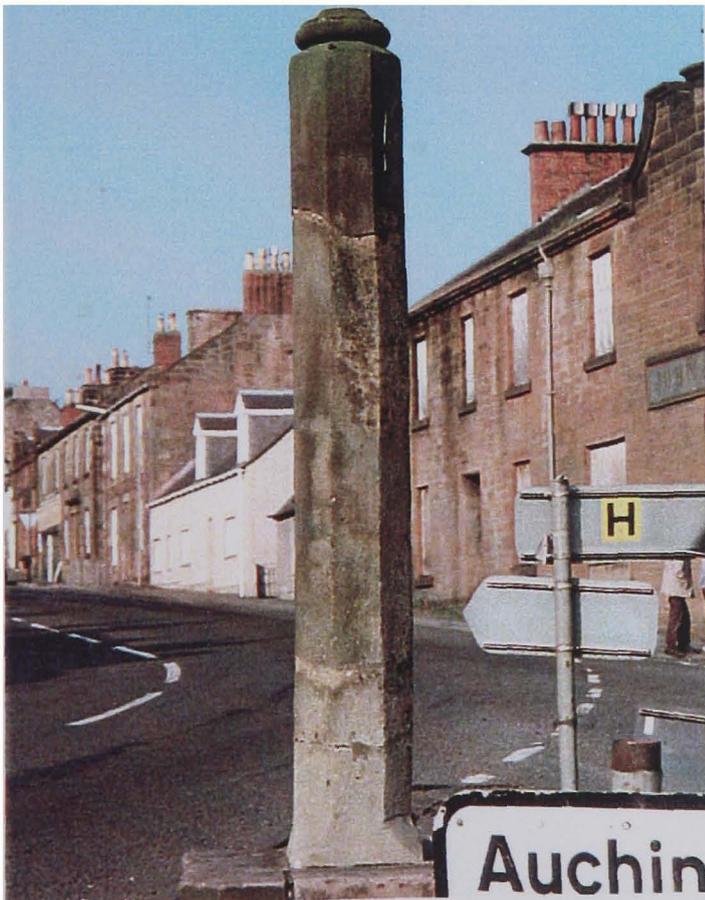
Plate 3.28 Severe mechanical damage on Ochiltree market cross, breakage of shaft.

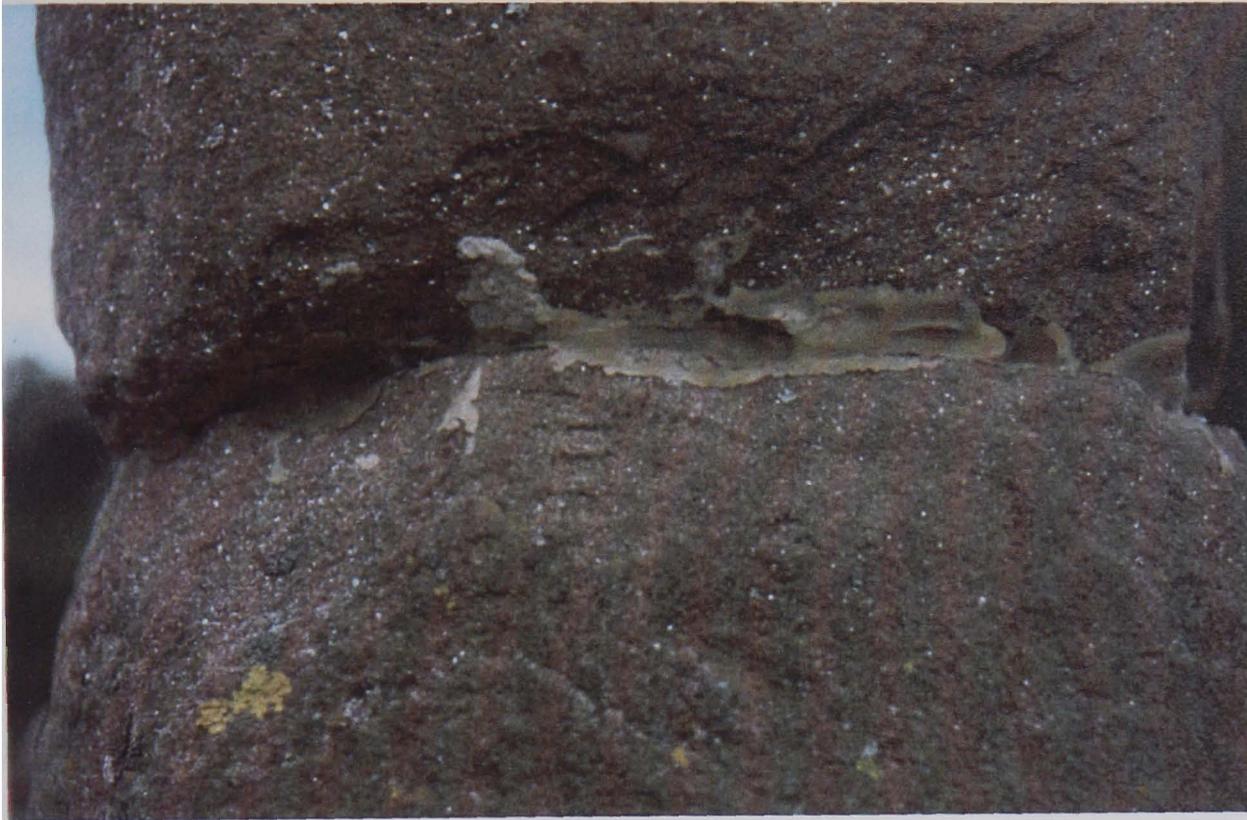
Plate 4.1 Epoxy resin used to strengthen the joint between shaft sections on Beauly market cross.

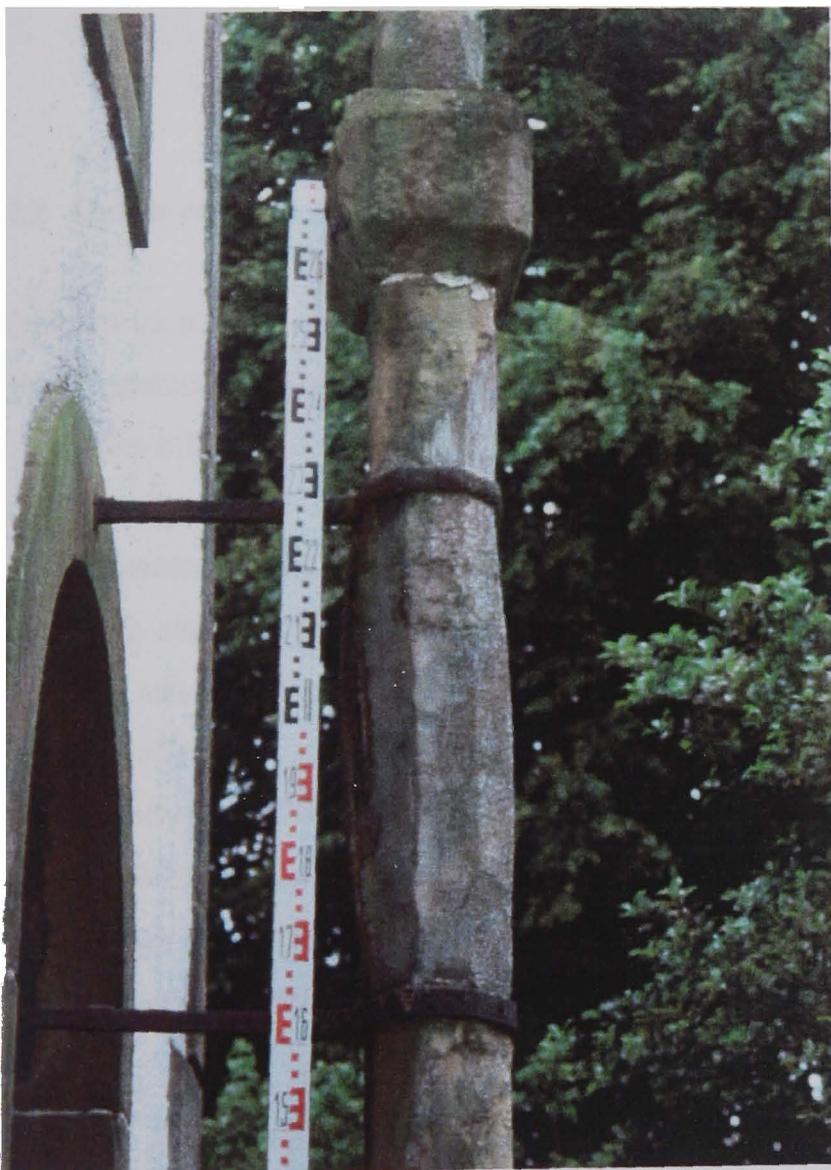
Plate 4.2 Cromarty market cross: inappropriate conservation materials.

unchecked at the shaft base, although this part of the shaft may not have been subject to resin repair in 1969.

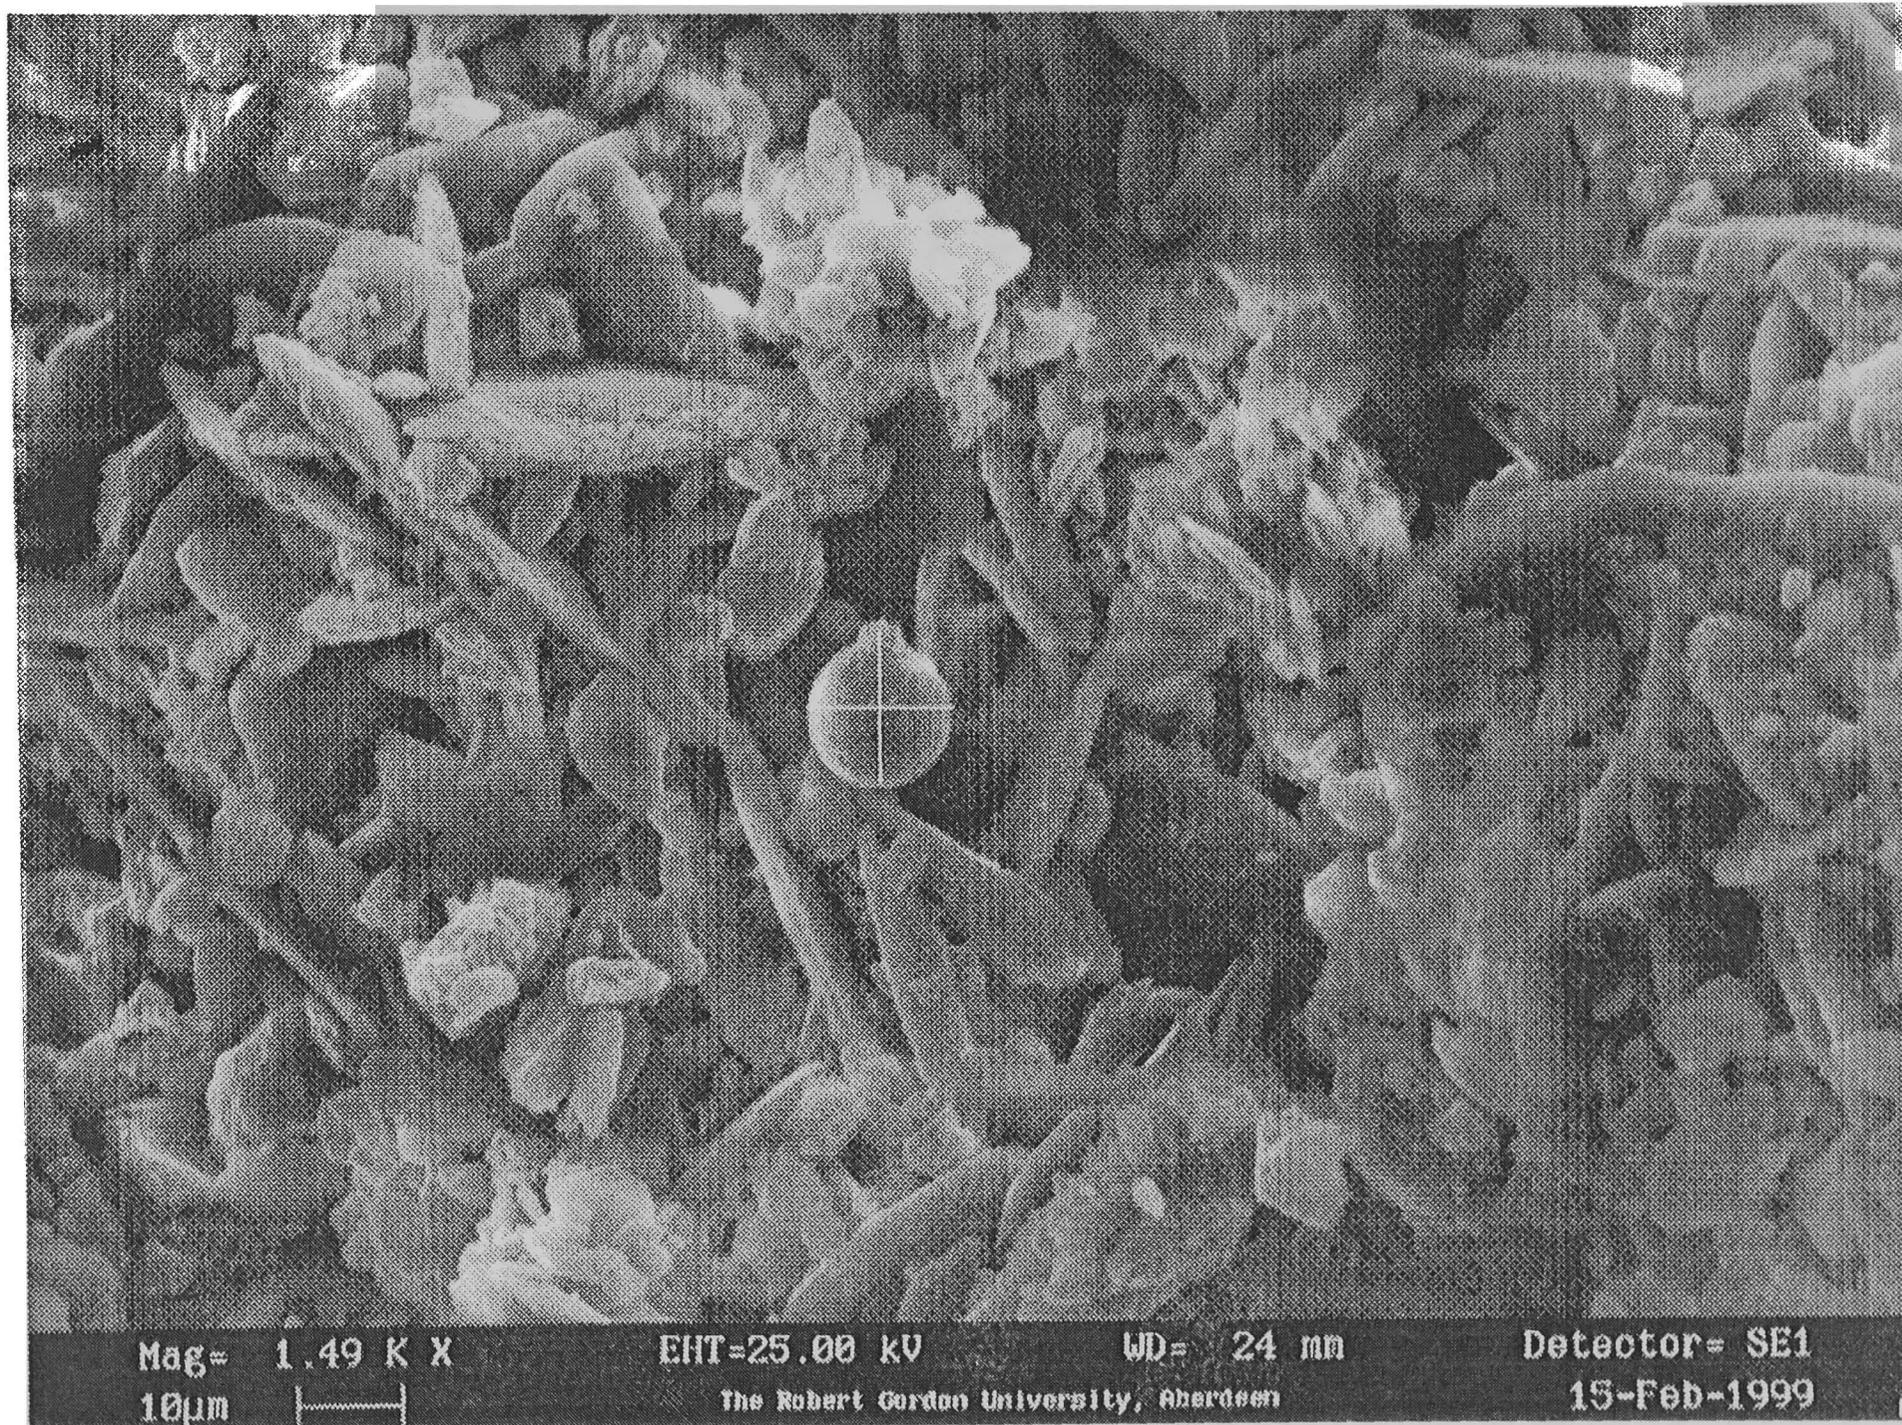
Plate 4.3 SEM image of gypsum crust sample from Edinburgh High Street market cross. A soot particle is marked by a cross in centre.
