<b>MOUTI, Z., WESTWOOD, K., LONG, D. and NJUGUNA, J. 2013. An experimental investigation into localised low-velocity impact loading on glass fibre-reinforced polyamide automotive product. <i>Composite Structures</i>, Vol. 104, pp. 43-53.</b>
---

# **An experimental investigation into localised low-velocity impact loading on glass fibre-reinforced polyamide automotive product**

Zakaria Mouti<sup>1</sup>, Keith Westwood<sup>2</sup>, Darren Long<sup>2</sup> and James Njuguna<sup>1\*</sup>

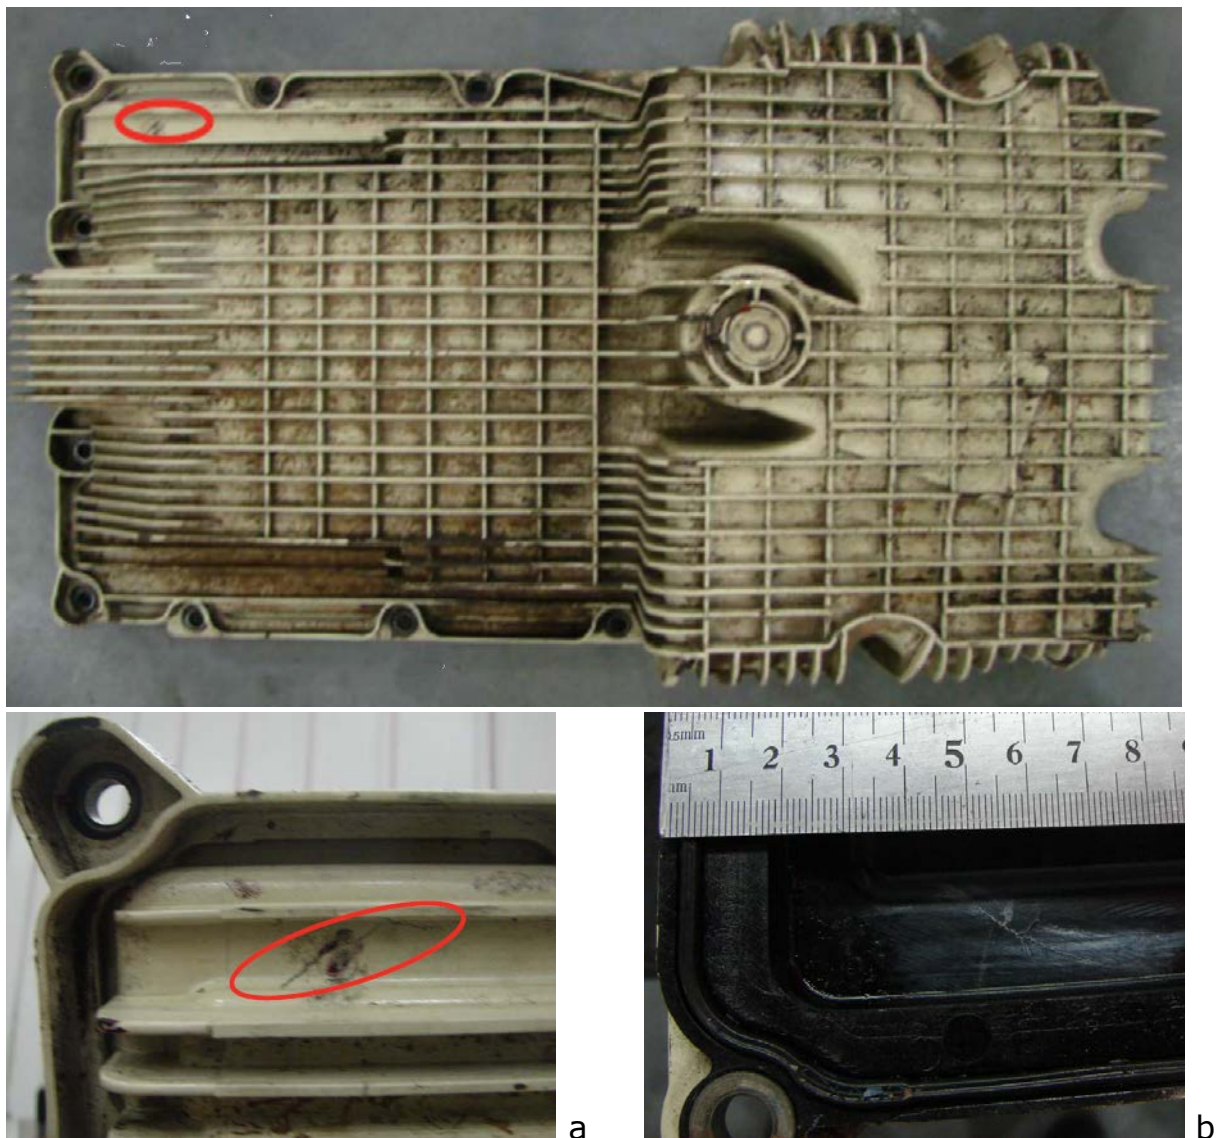
The under carriage of any road going production vehicle contains many vulnerability components. Driving on gravel surfaces, tough roads, near construction sites or during road maintenance can cause stones to be ejected from the wheels which then are projected into the air and could possibly damage the under carriage area of a vehicle or the vehicle can hit a boulder with potential serious consequences on low-fitted components. The main concern of this research is the impact performance and damage caused by those stones to a recently converted engine oil pan for light utility vehicles into PA66 reinforced with 35% of short glass fibre. Figure 1 shows an early version of the thermoplastic oil pan that has being damaged by foreign flying debris, identified as a stone by the fragments left on the impacted surface (Figure 1-a). The engine oil was seeping out through the crack from the inner side (Figure 1-b) to the outer side of the pan (Figure 1-a).

Figure 1 - Thermoplastic oil pan crack failure, a) outer side, b) inner side [2]

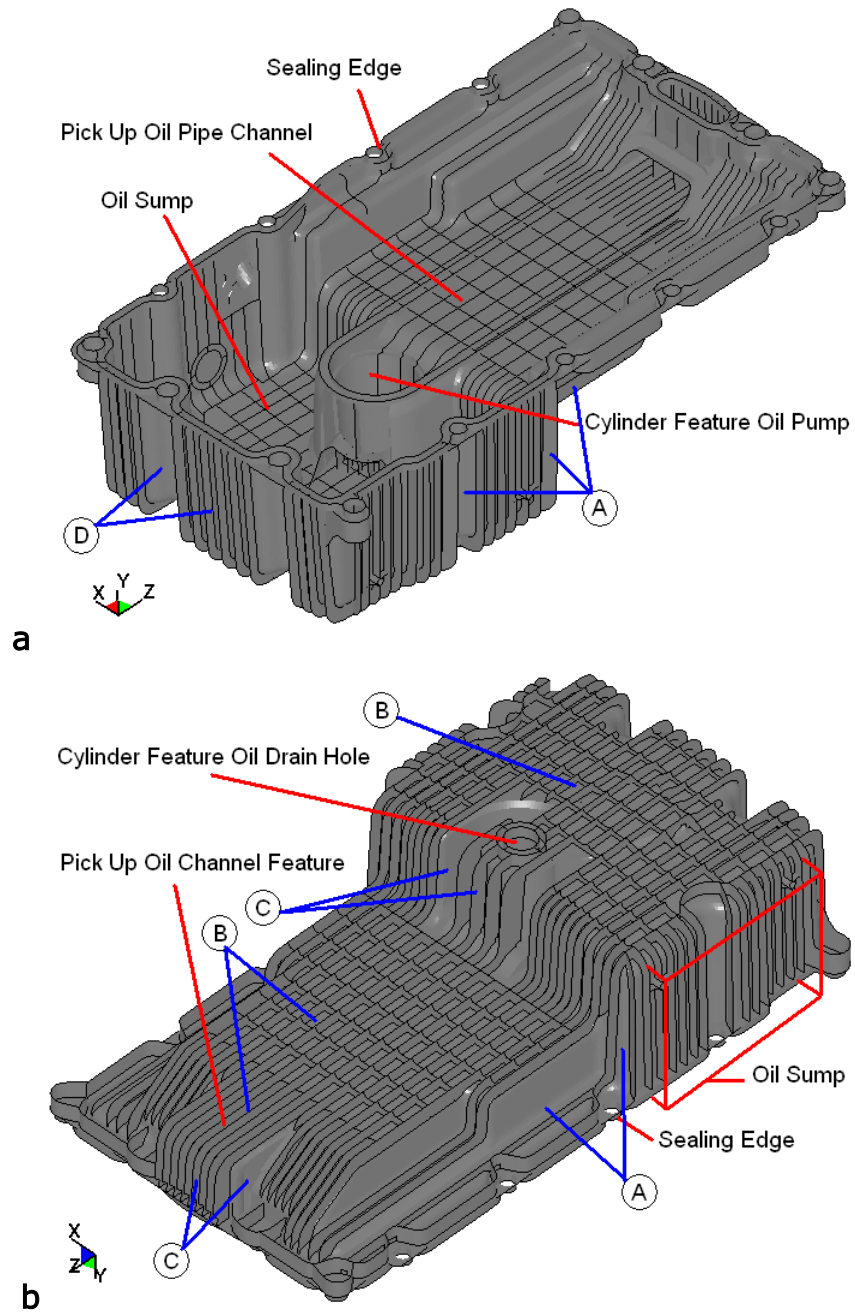
- Areas in (A) are covered with flat walls, groove walls (25 mm diameter) and walls with Y-axis ribs (spacing 10 mm, height 6 mm). Areas in (A) must resist to a 7 J impact. However, 80% of flat walls failed at 3 J because walls are directly exposed; 100% of groove walls failed at 3 J because concave shape are fragile and uncovered; and 60% of walls with Y-axis ribs failed at 7 J with damaged ribs because impacts between ribs can be directly reached by the projectile.

- Bottom walls in (B) are covered with ribbing mesh pattern (Z-axis ribs height 10 mm, spacing 15 mm; X-axis ribs height 5 mm, spacing 25 mm). Areas in (B) must resist to a 12 J impact. However, in the low density ribbing area 60% of walls failed at 12 J because of rib spacing too large; and in the high density ribbing area 20% of walls failed at 12 J at the bottom of the rib.

- Walls in (C) are represented by Y-axis ribs, flat and groove walls. Areas near the pick-up oil channel feature must resist 7 J but 40% of walls failed especially nearby uncovered sharp angles. Areas near the cylinder feature must resist 12 J but 80% of walls failed because of uncovered concave walls, tall ribs easily snapped and a lack of dense ribbing pattern. Transitions between areas (C) and (B) are at 90° and characterise zones of stress concentration.

- Walls in (D) are covered with Y-axis ribs (spacing 15 mm) and groove walls. Area in (D) must resist 7 J. However 60% of ribbed walls failed because of rib spacing too large; 80% of groove walls failed because of uncovered concave walls.

Figure 6 - Early version of the oil pan and key areas, a) inner view, b) outer view

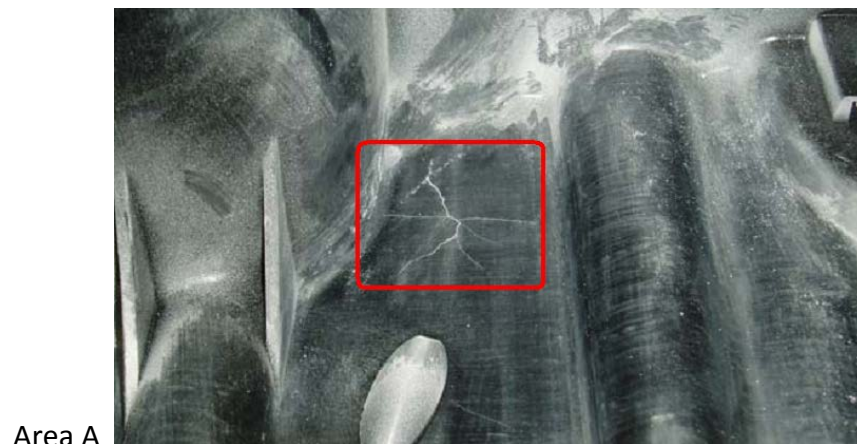
Impact resistance results of the early version of the oil pan are rather alarming. Figure 7 and Figure 8 show typical failures encountered in each area. Figure 7 displays crack failures in Area A, impact between two ribs, and in Area D, impact in a concave groove wall. Figure 8 displays broken ribs

Figure 7 - Typical failures encountered in Area A (7 J) and Area D (7 J)

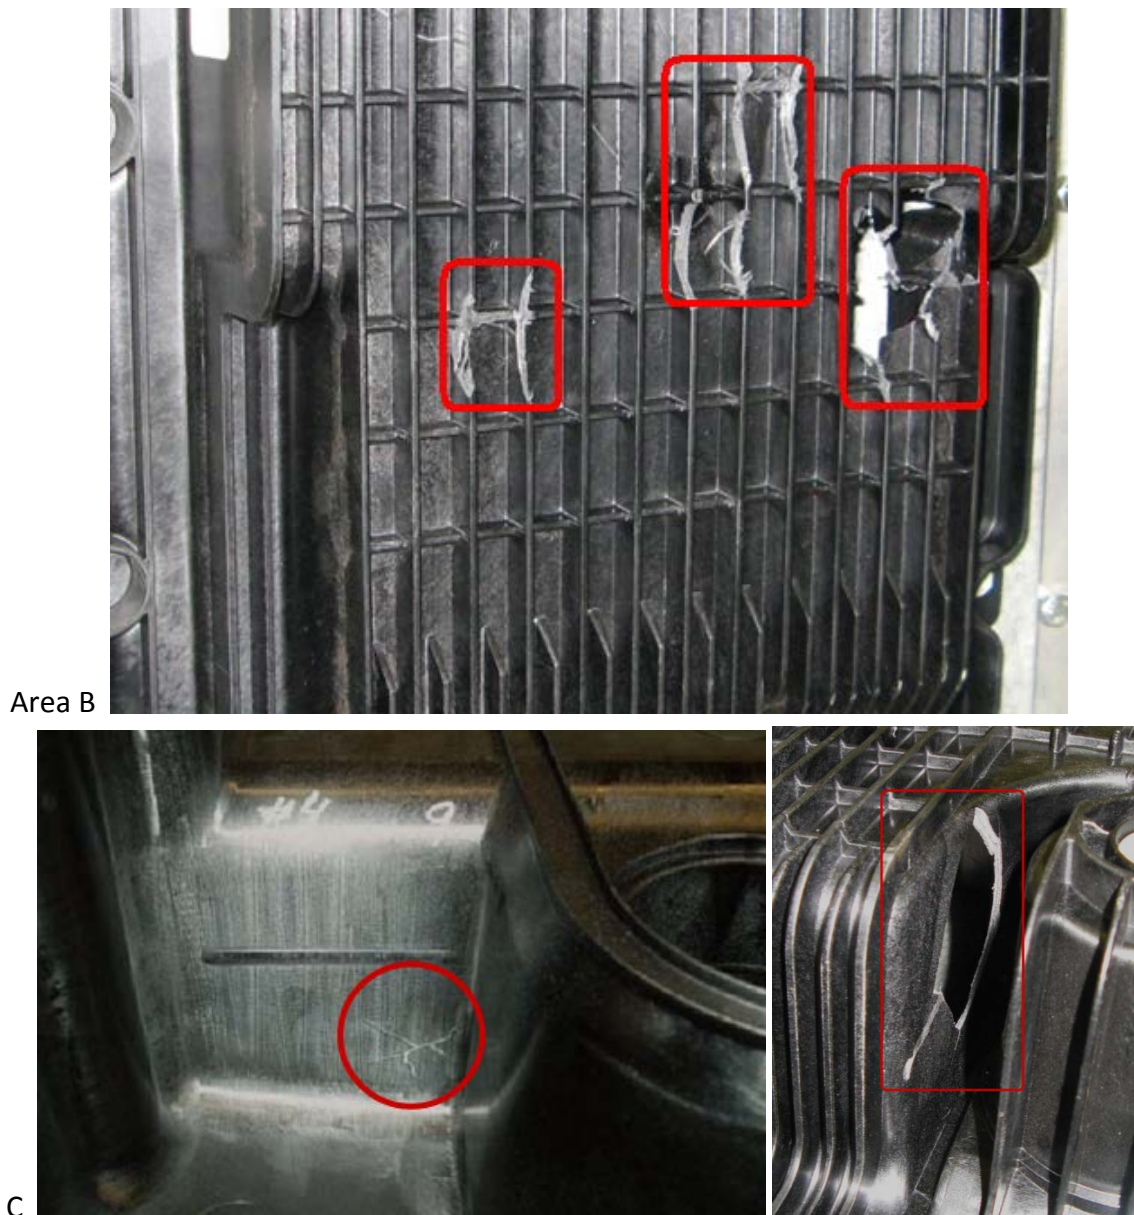
and perforation in Area B and crack (sharp junction between surfaces) and perforation (concave cylinder feature) in Area C. Almost all causes of failure were taking place on exposed areas, on unprotected walls and where the rib spacing is too large. Other failures were spotted on sharp transitions between surfaces resulting in long scale cracks along the separating line between each surface. Finally, 95% of ribs higher than 15 mm were snapped. Tall ribs are not enough stiff, they are deflecting too much which cause the removal of long portion of ribs whilst impacted. 90% of failures were cracks, 75% of them were only visible on the inner side of the oil pan and 15% were visible on both side of the wall. The rest 10% were perforations of the wall.

Figure 8 - Typical failures encountered in Area B (12 J) and Area C (12 J)

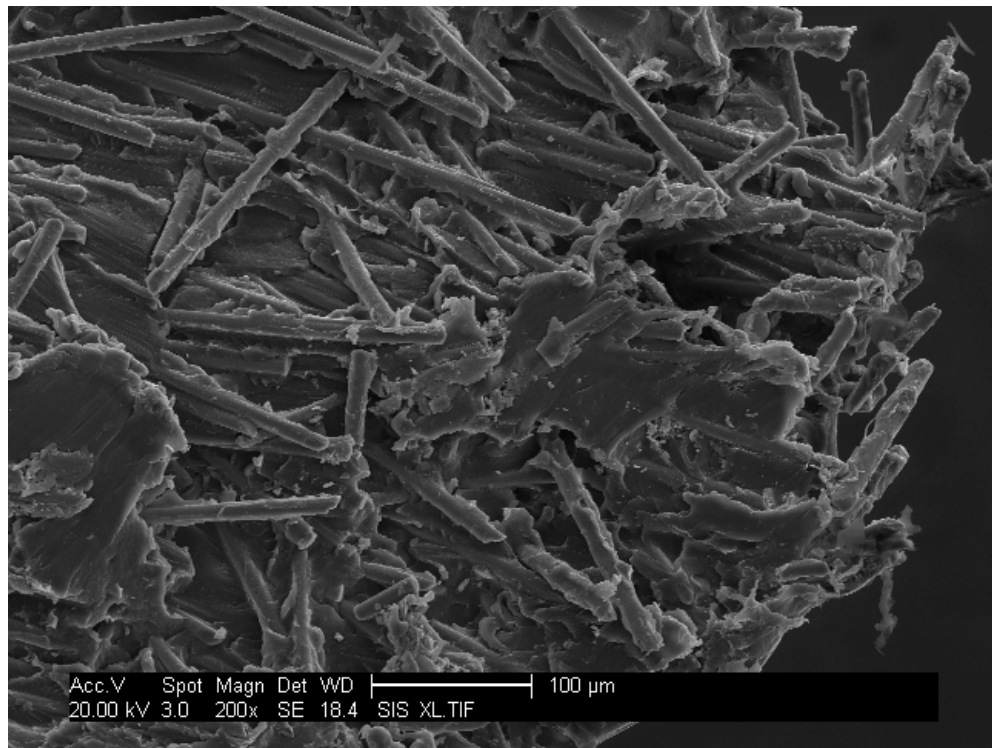
A broken off fragment from the Area B (PA66-GF35) was put under SEM observation. The magnitude of the following Figures varies from 200-4000. In Figure 9, the two constituents characterising the composite are clearly distinguishable that is to say short glass fibres and matrix resin wrapping the fibres. The picture reveals that there is a wide range of fibres

pointing in a general direction, the direction of the injection moulding flow (skin area). At magnitude of 200, fibres mostly appear entire (average length of 300  $\mu\text{m}$ ), some are uncoated but they seem unaltered whilst the matrix is unevenly distributed with some bits peeled or detached. Besides, fibres emerging from the fractured surface have been displaced and are completely de-bonded from the matrix precisely because of a lack of matrix. Unmistakably, it is a sign of a matrix cracking failure.

Figure 9 - Matrix cracking failure at magnitude 200 (Area B, 12 J)

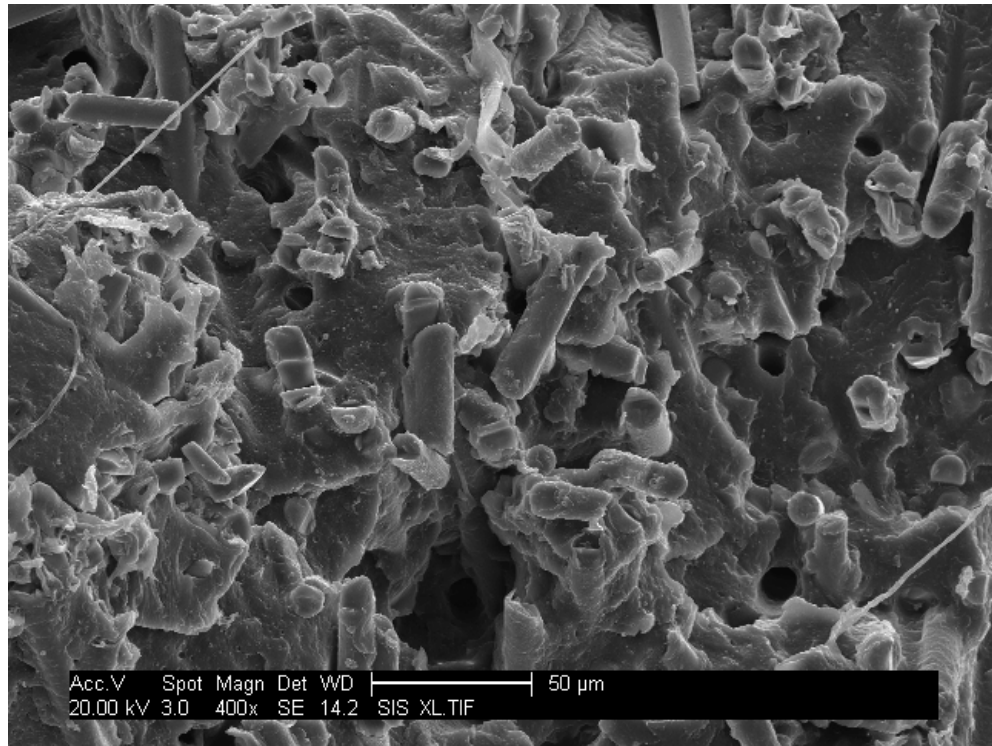
When the area towards the centre of the fragment is magnified, we stumble upon other type of breaks, but they are still localised in the impact point area. At magnitude of 400, Figure 10 shows failures surrounding the impacted surface. Both matrix and fibres have failed. The picture illustrates a net cut section of each material constituent. In this area, compression stress acted more than tension stress. Fibres are shorter than normal ( $<50 \mu\text{m}$ ) and are also randomly dispersed (core area). They are also few holes and hollows caused by fibres pulling out of the matrix but for the major part, matrix and fibres remained linked together.

Figure 10 - Matrix cracking, fibres fracture and limited fibres pull out at magnitude 400 (Area B, 12 J)

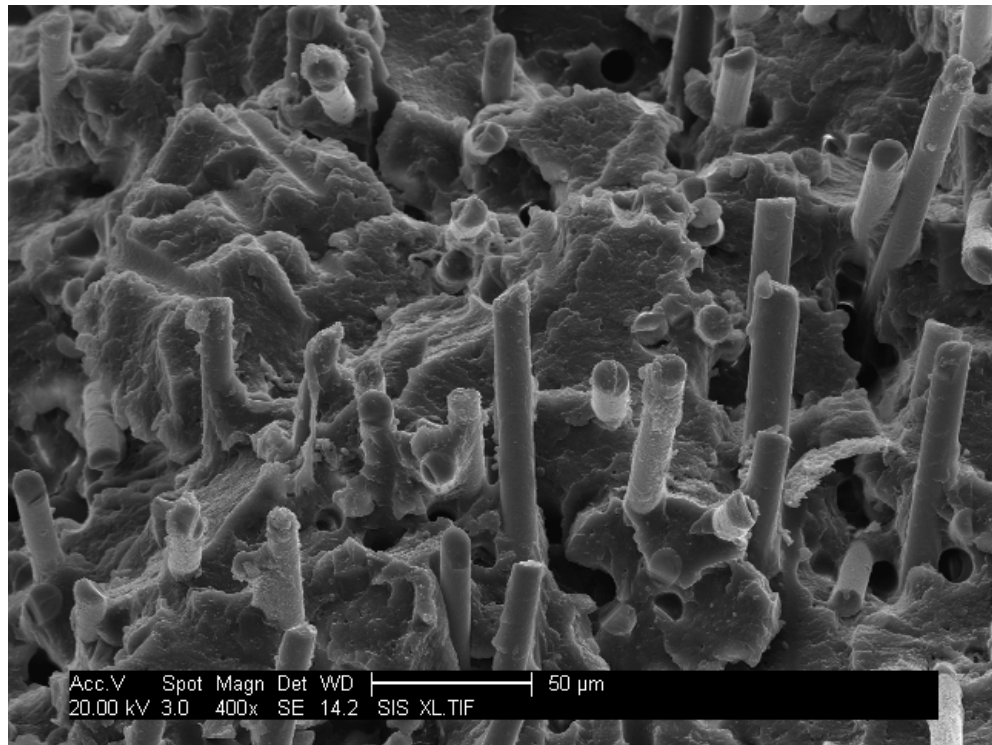
At the same magnitude of 400, Figure 11 shows failures taken from the backside of the impacted surface. Many hollows are visible from where fibres were filling them and also many uncoated fibres can be spotted. In this region of the fractured surface, the bond between fibres and the matrix has yielded first. This upshot illustrates the fact that in this area of the sample tension stress is bigger than compression stress. The system debonds and fibres are pulled out of the matrix during the fracture. Noticeably, the matrix has failed in its function. Fibres seem to have a general direction which confirms that the area is in the skin section of the sample (skin-core morphology during injection moulding).

Figure 11 - De-bonded and pulled out fibres at magnitude 400 (Area C, 12 J)

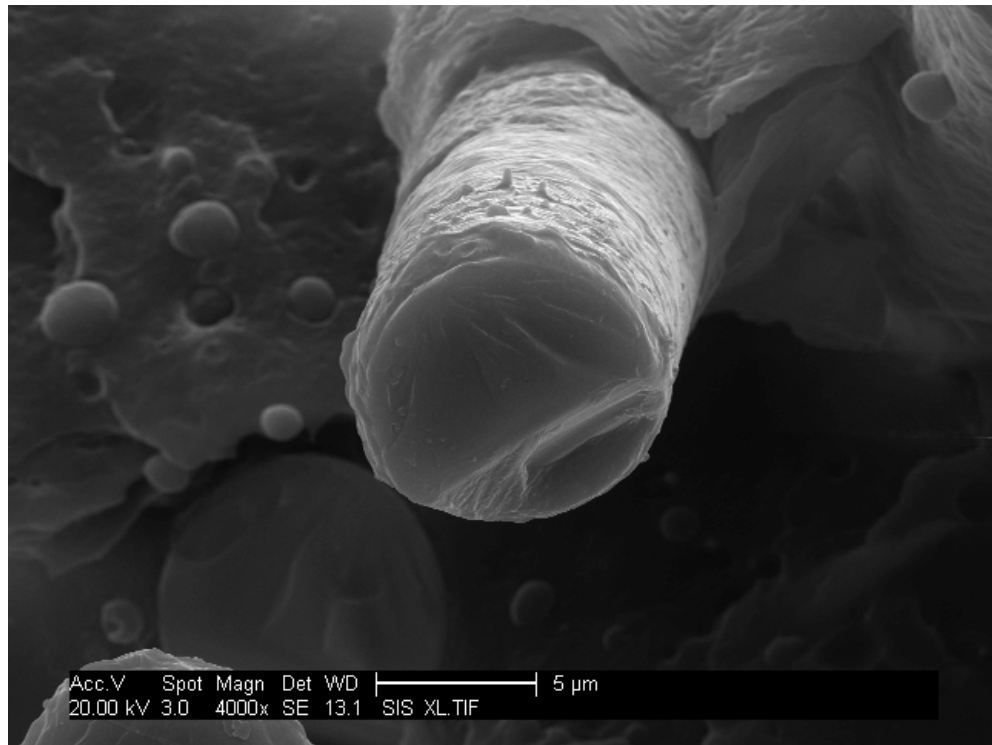
Figure 12 shows one end of a fibre which presents a tear on its surface probably resulting from a failure across the diameter of the fibre. The fractured fibre was perpendicular and in line with the general direction of the impact. The stress was so intense that it has removed the matrix and split the fibre in two with a peeled chip still attached to the fibre. Chopped fibres in their major part present a bevel-shaped fracture. For a matter of comparison, another fibre is visible at the bottom background that presents a clean flat end surface. Furthermore, the base of the matrix where the ruptured fibre is attached displays also a fissure.

Figure 12 - Close-up of a fibre fracture at magnitude 400 (Area C, 12 J)

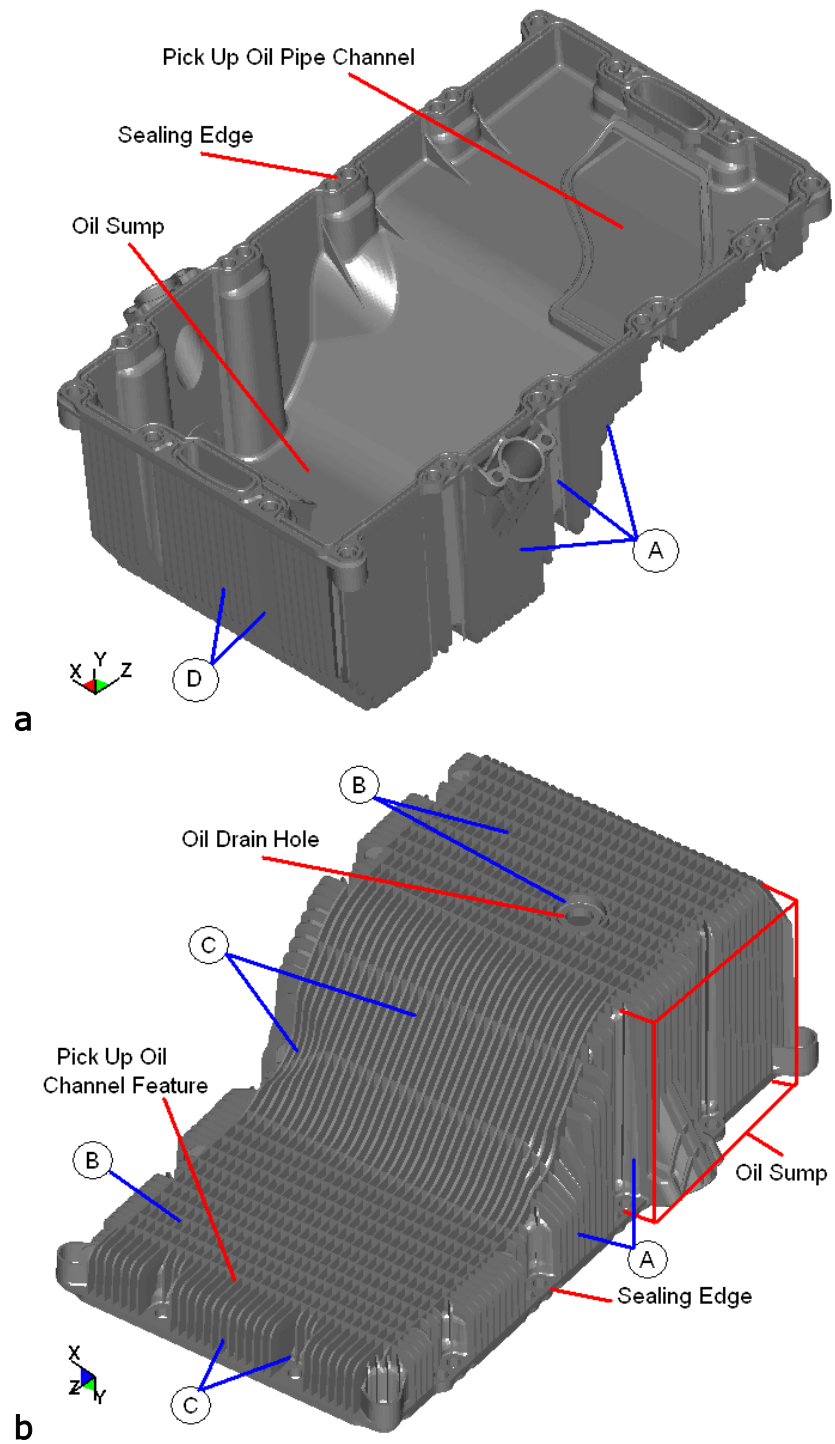
Figure 13 - Improved version of the oil pan and key areas, a) inner view, b) outer view

Figure 13 shows the latest improved version of the PA66-i-GF35 oil pan with key areas highlighted compared to the early version. Gas gun results are:

- Areas in (A) that were found weak received improvements. Flat walls are now covered with Y-axis ribs spaced by 8 mm (10 mm from the centre of each rib). Groove walls are reinforced by layered ribs from 10-5 mm in height around them. The pattern of ribbed walls was made denser with rib spacing of 8 mm and height of 10 mm. At 7 J, the only damage observed was crushed ribs by 2 mm maximum.
- Bottom walls in (B) received a denser ribbing pattern with homogeneous rib height of 10 mm (rib spacing in Z-axis is now 8 mm and 15 mm in X-axis). At 12 J, the base wall was never directly touched and no visible cracks were found.
- The main improvement in areas in (C) concerned the transition between the sump and the pan especially at the bottom transition. Instead of being at 90° which were zones of stress concentration, they

are now presenting a smooth rounded transition. This chamfer allows a better distribution of the effort in a much wider surface area. Another chamfer or recess was introduced on the transition edges to accommodate the height difference. The cylinder feature found in the previous design was extremely weak with large rib, large spacing and unprotected concave grooves. It was removed and the oil drain hole was moved off-centred to a position where it was feasible to integrate it. The pick-up oil channel is not straight anymore and has an S-shape look in accordance with the move of the drain hole. The other improvements are similar to areas in (A). No wall is left uncovered and Y-axis ribs were increased in density around grooves. The transition between sump and pan contains two X-axis ribs across the denser Y-axis ribs (spacing 8 mm). This was intended to reduce the broken-off fragments of ribs. At 7 J, no failure is visible, only marks, scratches or small crushes (1-2 mm). At 12 J, some Y-axis ribs are likely to be crushed (by 2-3 mm) but again no failures are observed.

- Walls in (D) received same improvements as in (A). Reduction of the rib spacing (8 mm), Y-axis ribs height to 10 mm, and grooves protected with layered ribs (10-5 mm height).

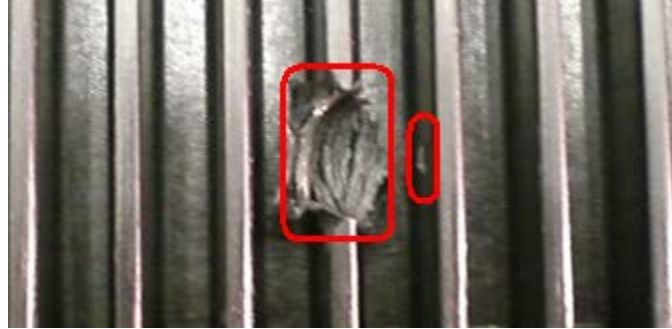
Figure 15 shows forces histories of each structure impacted at 7 J (drop tower) in the same area as before but on a blank spot of impact. In the 7 J impact on the early version, the wall deflects and begins to show signs of damage at 2.4 ms till it eventually fails at 3.5 ms. Crash appeared on both sides of the wall. In the 7 J impact on the improved version, the two ribs are successively touched and crushed till their walls stop to crush at 0.75 ms. From then, they resist, deflect and push back the impactor. No failure is visible on the wall but only damaged ribs. Figure 16 illustrates an example of a 3 mm crushed rib on the pick-up oil channel feature.

Figure 16 - Rib crushed after impact on rib at 7 J (PA66-i-Gf35)
