Investigation of wave propagation pattern in a multilayer planar structure.

RAJENDRAN, V., PRATHURU, A., FERNANDEZ, C. and FAISAL, N.H.

This file contains the full-text paper, published in the e-Journal of Nondestructive Testing, followed by the slides used during the presentation at the conference.

Investigation of Wave Propagation Pattern in a Multilayer Planar Structure

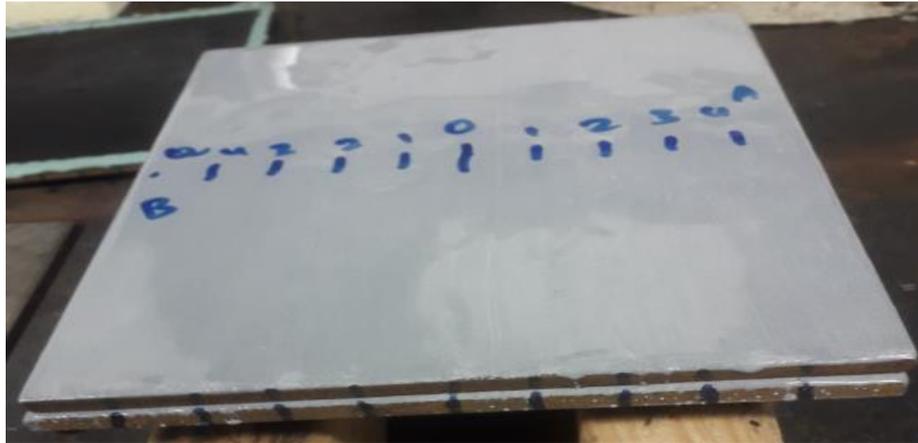
a)

The multilayer experimental conditions and PLB test on various layers with locations are listed in **Table 1**. The experimental samples are shown in **Fig 1(a)**. In all the experimental conditions, AE sensors were placed on the first layer's locations O (S1), and Q (S2) and PLB tests were carried out on the surface and cross section of the multilayer structure. The distance between two PLB test points was 15 mm in all directions. A schematic diagram is shown in **Fig 1(b)**. OA, OB direction was on the top surface of the layer 1, WA, WB codes the cross section of layer 2 and 4. RA, RB denotes the bottom surface side of layer 4 (exactly opposite to the layer 1 surface points). As shown in **Fig 1(b)**, PLB test was carried out on the cross sections of two plates parallel to the surface PLB test points on layer 1 and layer 4. Due to the limited access and low thickness, no PLB test was performed in layer 3.

Figure 1. (a) Experimental sample, and (b) schematic of multilayer PLB test point locations.

The PLB test points on the cross-section of layers 2 and 4 are shown in **Fig 1**. Time-domain analysis (**Fig 3(a,b)**) shows that the wave propagation pattern changes based on the layer of wave initiation. An apparent wave pattern change is observed in the wave decay time and maximum peak amplitude. Wave initiation from Layer 4 has a low maximum peak amplitude with a longer decay time because the damping behavior of layers mitigated the maximum peak amplitude. The wavelet transform (WT) of layers 2 and 4 (**Fig 3(c,d)**) shows a dominant level in lower frequency and minimized amplitude level above the 100 kHz frequency level. The wave propagation continues for a longer time on layer 4, which can be observed here. The energy level below and above 100 kHz frequency levels with standard deviation is shown in **Fig 3(e,f)** [note: AE signal energy (E) was calculated using

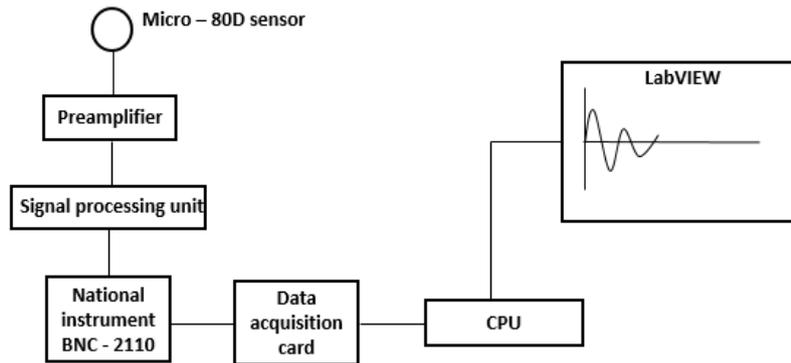
A Physical Acoustics supplied Micro – 80 D sensor with a frequency range from 100 kHz to 900 kHz and a resonant frequency of 320 kHz was used. The block diagram of the AE instrument is shown in **Fig 2**. Mistras group preamplifier with three-level of amplification levels of 60 dB, 40 dB, and 20 dB. The sensor was connected to the differential input point, and the amplified signals passed through the power signal cable to the signal processing unit. The signal processing unit had a four-channel system. It amplifies or de-amplifies the signals based on the further selection of the -12 dB, 0 dB, +6 dB, and +12 dB gain. The National Instrument BNC (Bayonet Neill Concelman) – 2110 (connector block) was used to connect the signal processing unit to the data acquisition card, which can record the signals at 2.5 MS/s (million samples per second) per channel. A LabVIEW visual interface (VI) was built to enable the choice of a number of channels, the number of scans, sampling rate, trigger channel, pretrigger scans, pretrigger level. In the experiment, the preamplifier gain was set at 60 dB, signal processing unit gain is +12 dB, and the number of scans and sampling rate were 100000 and 2500000, respectively, with the trigger level of 0.2.

Figure 2. Block diagram of the AE instrument and testing.

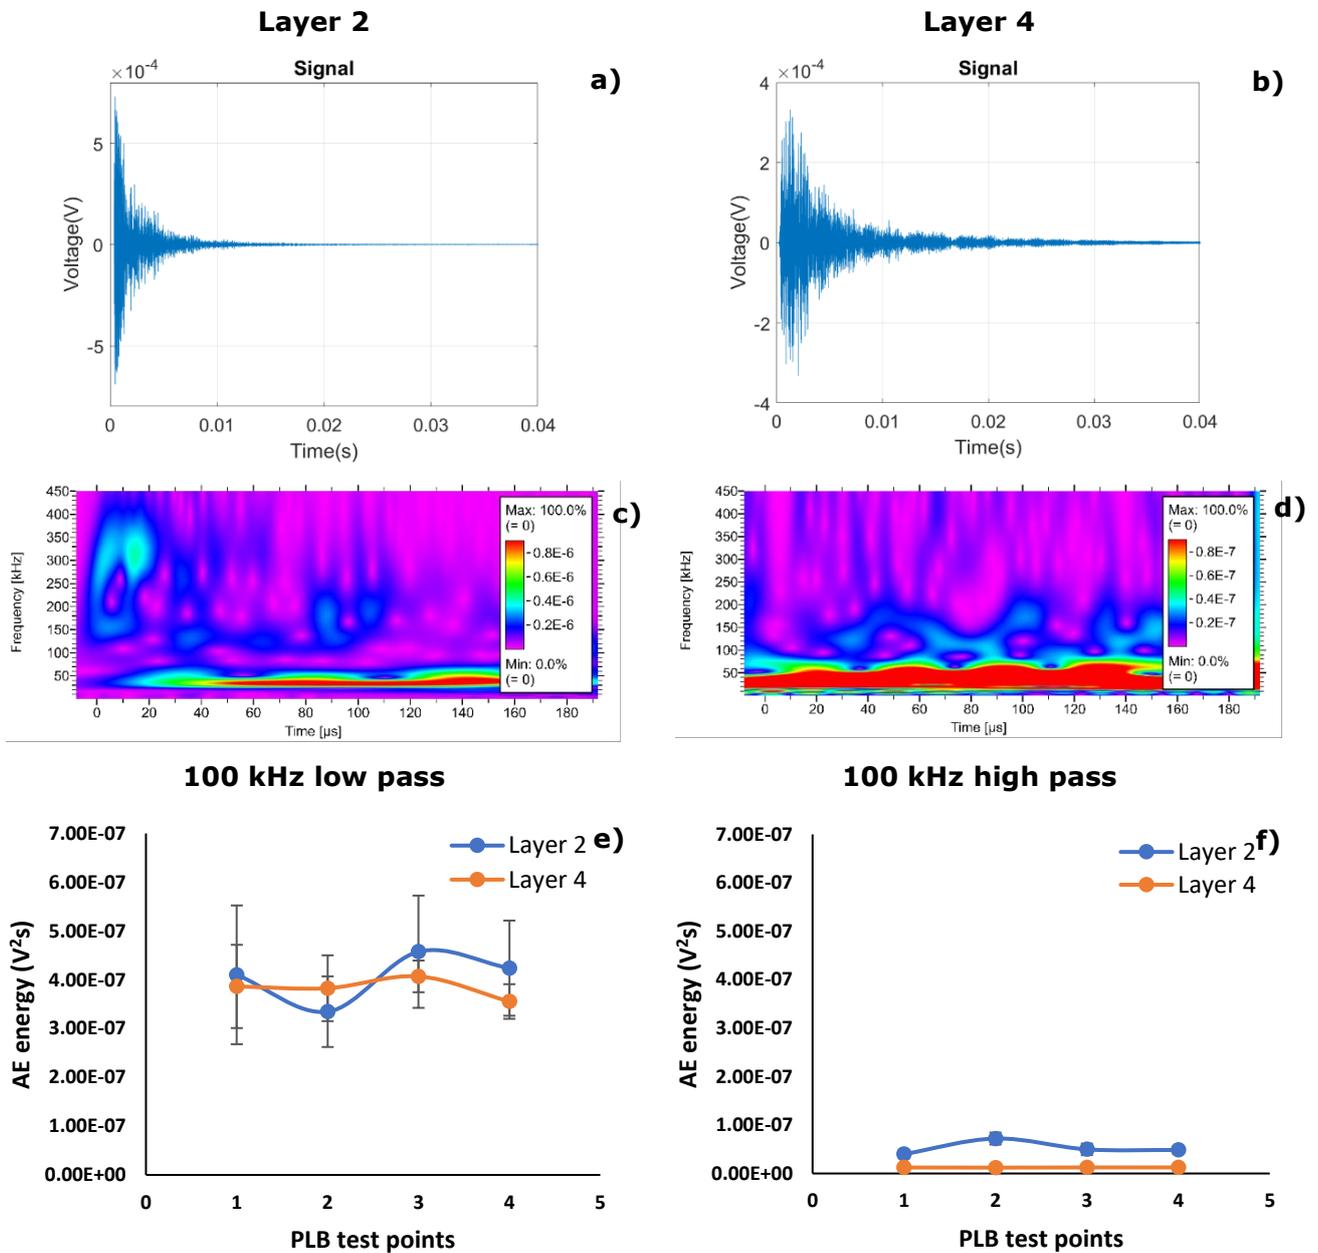
Figure 3. AE time domain signals and energy analysis: (a) layer 2, (b) layer 4, Wavelet transforms: (c) layer 2, (d) layer 4, (e) 100 kHz low pass energy, (f) 100 kHz high pass energy.

At lower frequencies, layers 2 and 4 points have mixed energy levels with no significant changes. However, layer 2 shows higher energy at higher frequency energy levels than layer 4. From layer 4, the wave needs to travel through another three layers to reach the sensor on top of the first layer. The properties and thickness of each layer

affect the wave propagation and restricts a high frequency wave. The overall energy level of the two layers is mixed. Due to the domination of low-frequency wave energy, the energy is high on layers 2 and 4. The low-frequency wave has propagated more on the multilayer structure, even in wave propagation initiated from the cross-section of the structure.

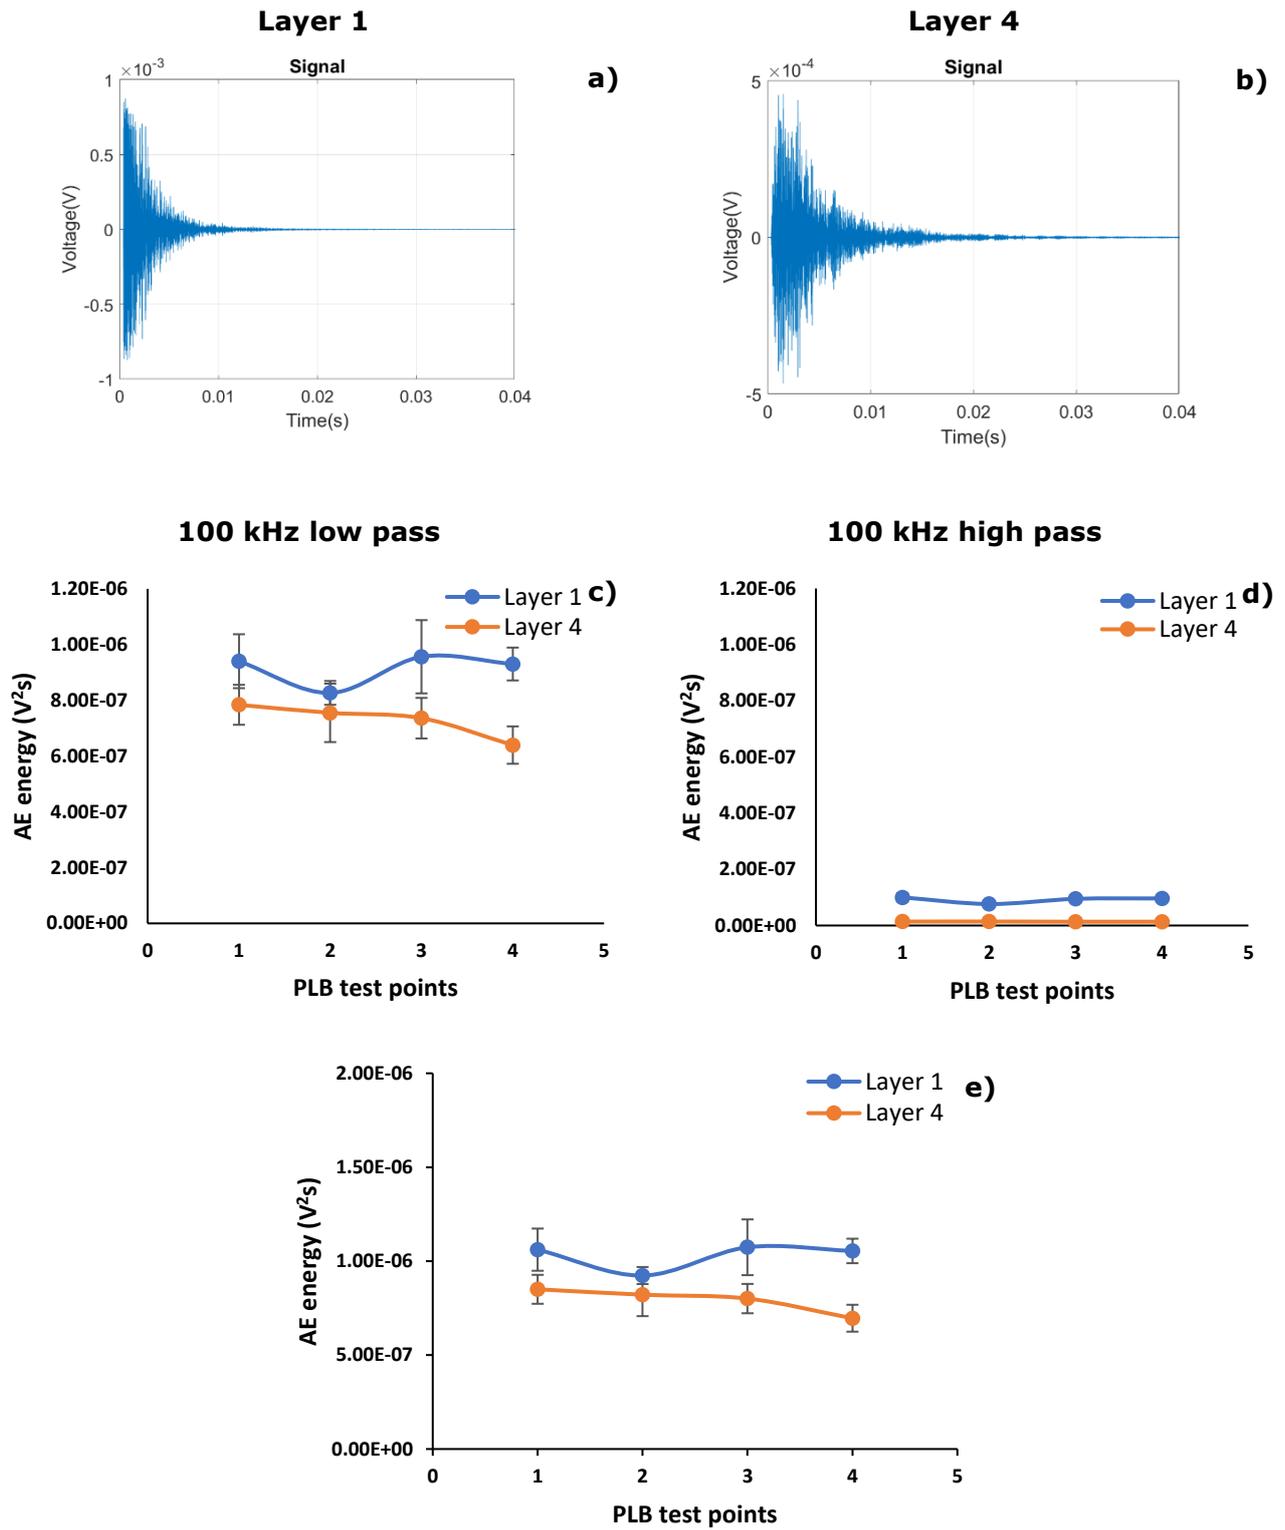
The results of wave initiation from the surface of layers 1 and 4 are compared and analysed. Clear changes in wave propagation are observed based on the wave initiation layer, as shown in the time domain analysis (**Fig 4(a,b)**). Considerable changes are observed in the wave decay time and peak amplitude of the wave initiated from different layer surfaces. **Figure 4(c,d)** shows the AE energy level comparison of layers 1 and 4 based on a digital filter of 100 kHz low pass and high pass with standard deviations. No significant changes in the energy level below 100 kHz are observed between the two layers, and both exhibit a similar level of energy. However, layer 1 shows a dominant energy level compared to layer 4 above 100 kHz frequency level. The wave initiation from layer 4 results clearly shows minimized high-frequency waves due to the material properties of the different layers. Overall, the surface PLB test points show a small difference between the energy levels of different layers (**Fig 4e**). The dominant level of low-frequency waves resulted in an overall energy level similar to the below 100 kHz energy level. As seen above, the peak amplitude is reduced in layer 4 compared to layer 1, and above 100 kHz energy level is low in layer 4 compared to layer 1. The sensor is on the surface of layer 1, and the wave needs to travel through the multilayer to reach the sensor. The travel on the multilayer structure enhances the wave dispersion, as seen in the time domain analysis peaks of layer 4 surface and cross section PLB points. Low frequency waves are a recommended analysis to disguise wave initiation layer on the multilayer structure compared to other properties of AE analysis.

Figure 4. AE time domain signals and energy analysis: (a) layer 1, (b) layer 4, (c) 100 kHz low pass energy, (d) 100 kHz high pass energy, and (e) total energy level.

The wave pattern changes with the wave initiation on the surface and cross section on the multilayer structure, which can be observed in the time-domain analysis of layers 1 layer 2. In particular, the comparison of energy levels clearly explains changes with respect to the wave initiation layers due to the love mode wave propagation on the plate structure. Love waves are horizontally polarized shear waves that have velocity changes based on the depth of the solid materials (Matikas and Aggelis, 2022). Low frequency waves show a dominant response on the multilayer structure, regardless of the wave initiation locations (i.e., surface, cross section). The wave pattern changes could be a possible way to monitor physical changes in multilayer structure.

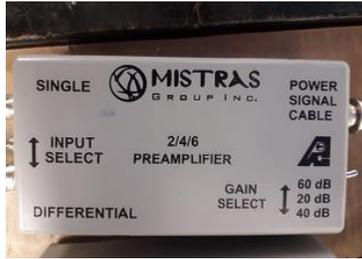
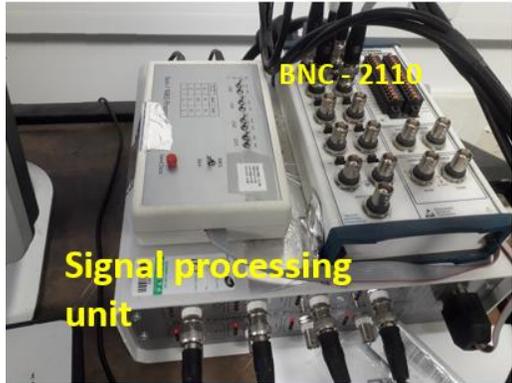
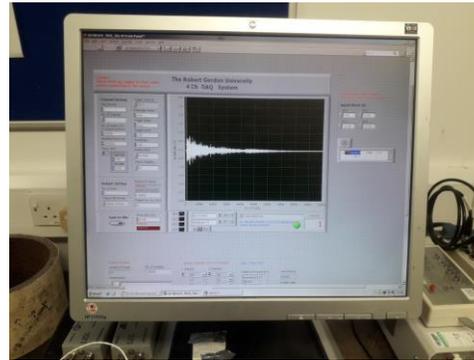
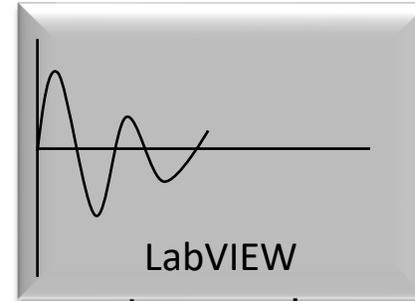
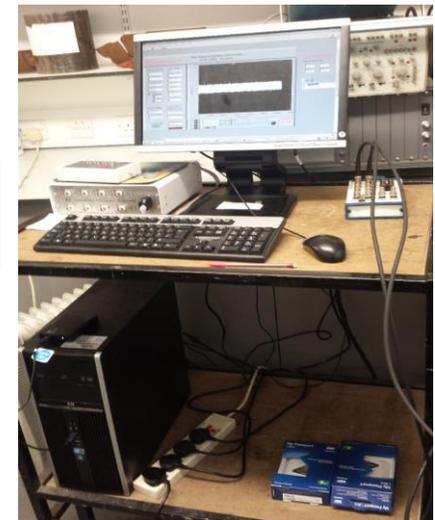
AE instrument block diagram

Micro – 80D AE sensor

Preamplifier – 2/4/6

- 60 dB
- 40 dB
- 20 dB

Signal Processing Unit (SCU)

- Number of channels
- Trigger channel
- Sampling rate
- Number of scans
- Trigger level
- Pre trigger scans

Connector block BNC - 2110

**Data Acquisition Card (NI 6115)
4-Channel, 10 MS/s**

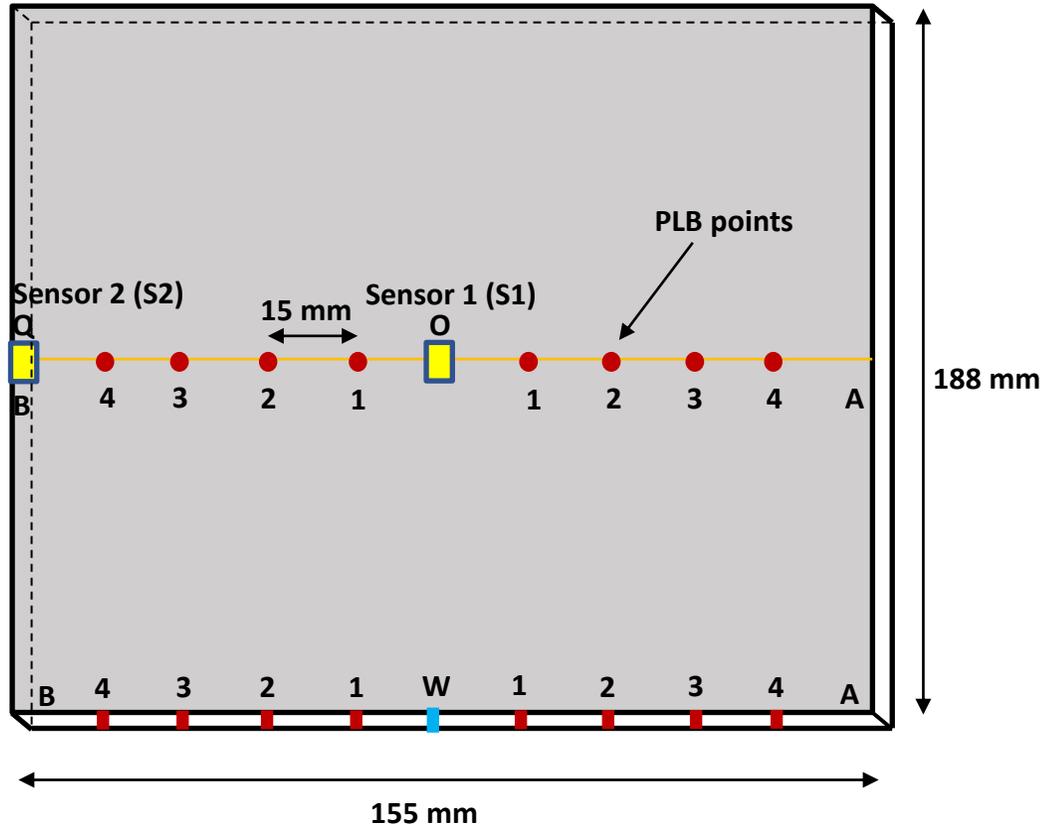
Top view – Plate with coating

- To understand wave propagation with single layer (i.e., coating).
- Mild steel (ASTM A106) and epoxy phenolic coating are used in industry most for storage purposes.
- PLB test is performed on **surface and cross section** of the bare and coated plate.
- Each point PLB test was performed 5 times repeatedly.

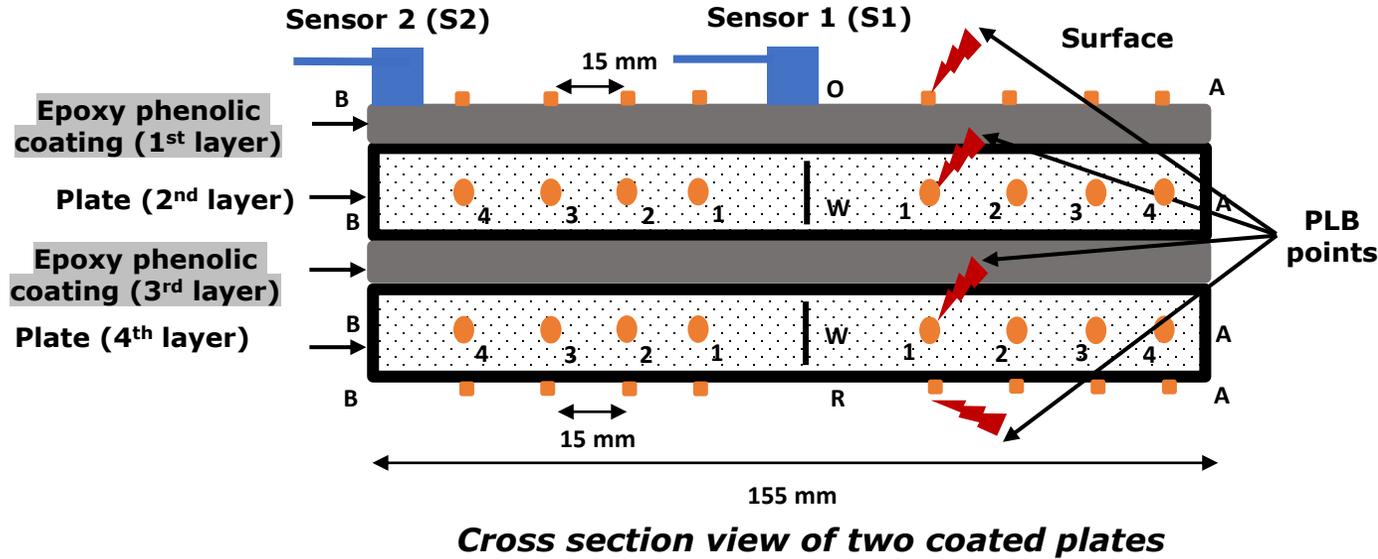
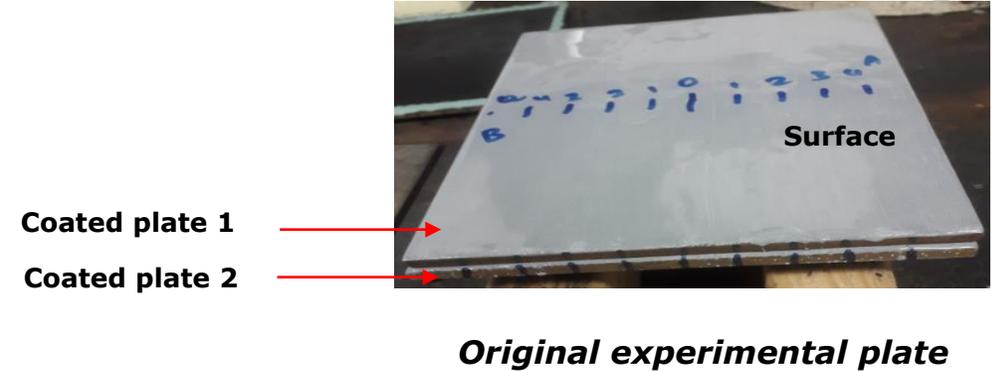
Experimental Conditions – Two Coated Plates

- To understand wave propagation with multilayer structures and wave initiation from different layers.
- Plate size is 155 mm (L) * 188 mm (W) * 5 mm (H).
- The coating thickness is 0.272 mm (layer 1) and 0.270 mm (layer 3).
- **No adhesion** between two coated plates (similar to nuclear storage containers condition).
- PLB tests on surface and cross sections of layers 1, 2, 4.

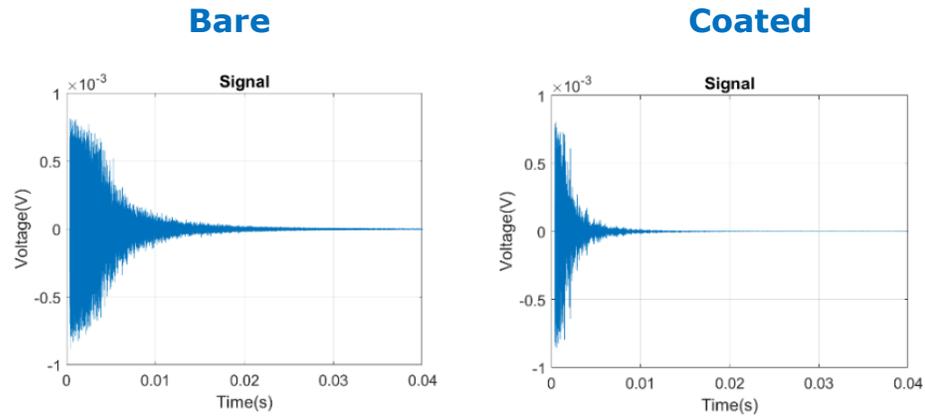
Time domain analysis

- Time and frequency domains are changed based on the plate conditions (bare, coated).
- Wave propagation pattern depends on the **layer properties of Young's modulus, density and shape** (Mild steel – 190-210 GPa, 7800-8000 kg/m³, Epoxy coating: 2.7-4.1 GPa, 1200-1400 kg/m³).
- Coated plate shows minimized peak amplitude, low decay time and number of rises compared to bare plate.
- Coating layer act as a **damping layer** and restricts wave propagation in the form of dispersion.

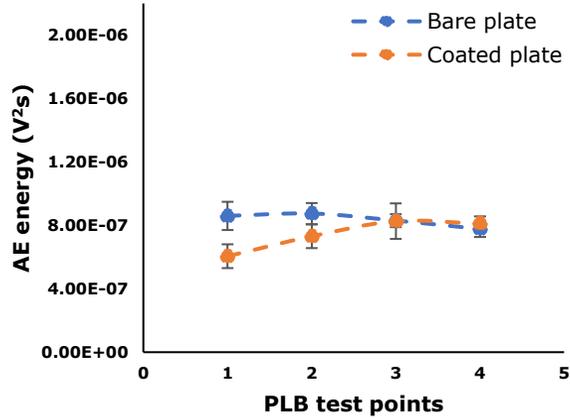
100 kHz low pass

- **Digital filter** is applied below and above 100 kHz.
- Mixed response in a low frequency level (below 100 kHz)
- Coated plate has low energy level in high frequency level (above 100 kHz).
- Wave velocity decreased with coating.
- Overall, the wave **propagation parameters and pattern changes with layers** on the primary material.

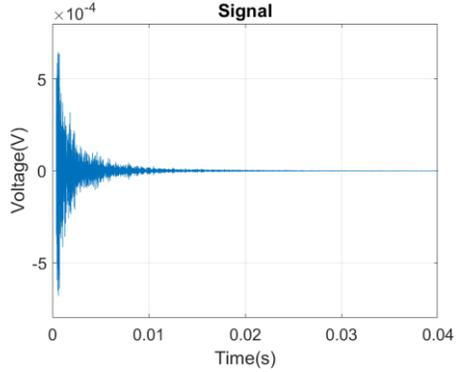
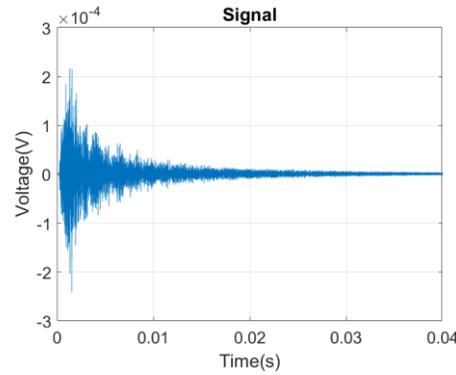
Time domain analysis

- Wave propagation pattern and frequency changes with layer of wave initiation.
- Maximum peak amplitude level decreases as PLB test points move away from the sensor location.
- Layer 4 shows a high decay time and number of rises as a result of low frequency wave domination.

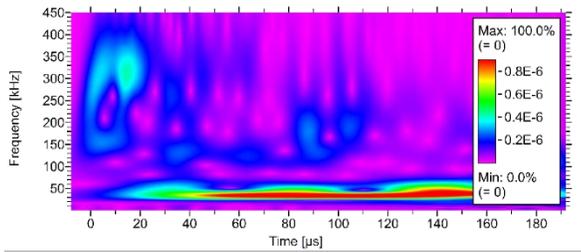
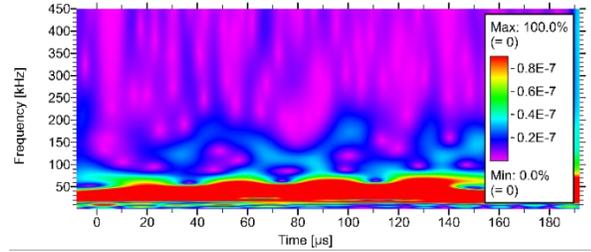
Wavelet transform

- **Wavelet transform** is a combination of time and frequency domain
- Showed the distributed energy zones across the frequency level, however **low energy** level in layer 4.
- Low frequency waves are not affected by multilayer structures and wave initiation points.
- Minimisation of high frequency waves is dominated in multilayer structures compared to single structure.

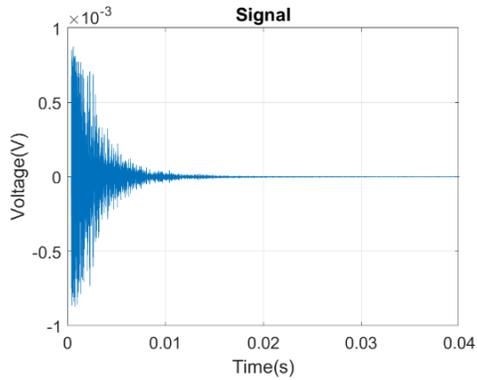
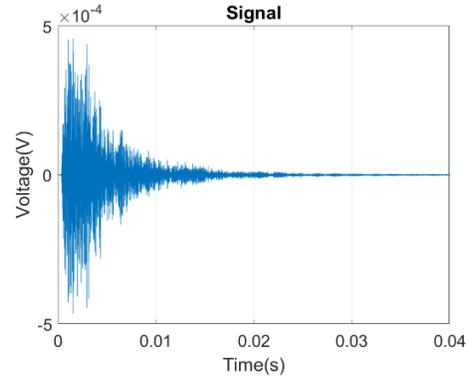
Time domain analysis

- Layer 1 and 4 surface points have different wave propagation patterns.
- Significant reduction in the **high frequency** energy level (no peaks).
- Similar to cross section points, the peak amplitude decreases with the addition of layer.

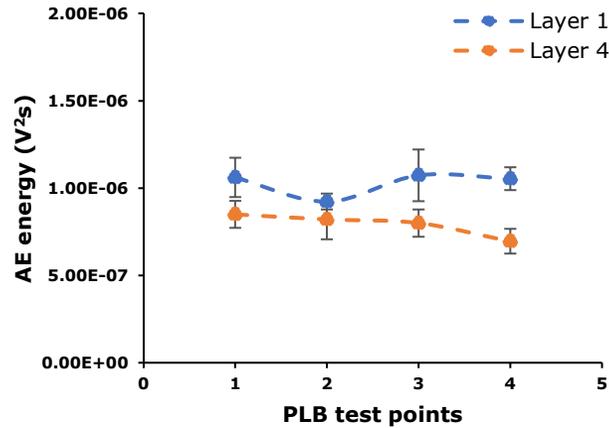
- High frequency waves are fully absorbed when wave initiation from layer 4 with domination of low frequency waves.
- Overall, AE energy level does not show much change, however, the **AE parameters** are changed based on the source initiation layers and points.
- Sensor placement on the **outer layer of storage container** could help find the degradation in layers.
