Academic feasibility study:

Testing of a method for insulation of masonry and lath walls in existing Domestic Scottish Construction

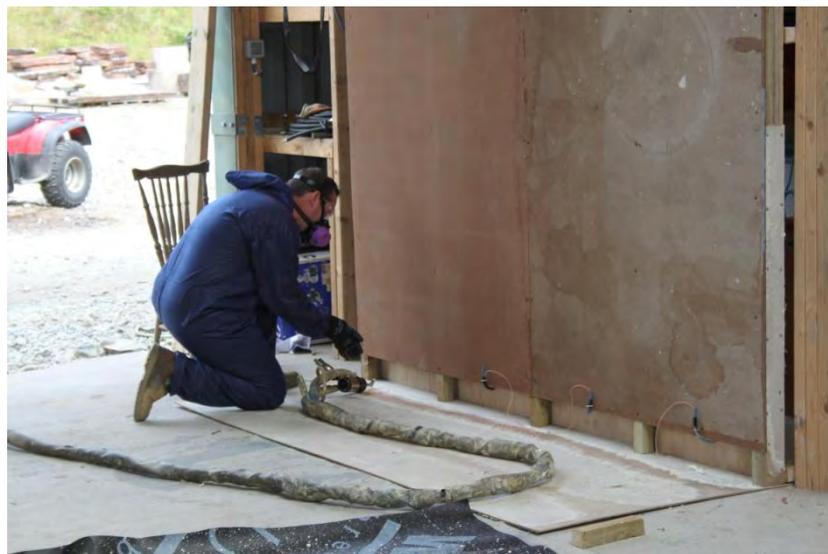
Trial in the workshop

Prior to the trial, lot of discussion took place between the researchers, local architects/SME and the company who agreed to supply the insulation material and its implementation using the proposed method agreed by the team. The agreed method was tested in a workshop by KDL on the 19th August before its application on the real wall. This trial involved the construction of a wall representing same characteristics of the real wall in term cavity dimension. The spray foam sealed the area behind where the skirting boards would be fixed, resulting in no loss of pour material. The pour material was capable of being injected down a 2800mm pipe and expanded vertically between and behind the vertical studs, leaving no voids. No deflection in the hardboard was detected. This trial was deemed to be successful, and a decision was made to adopt this method at house at Fettercairn

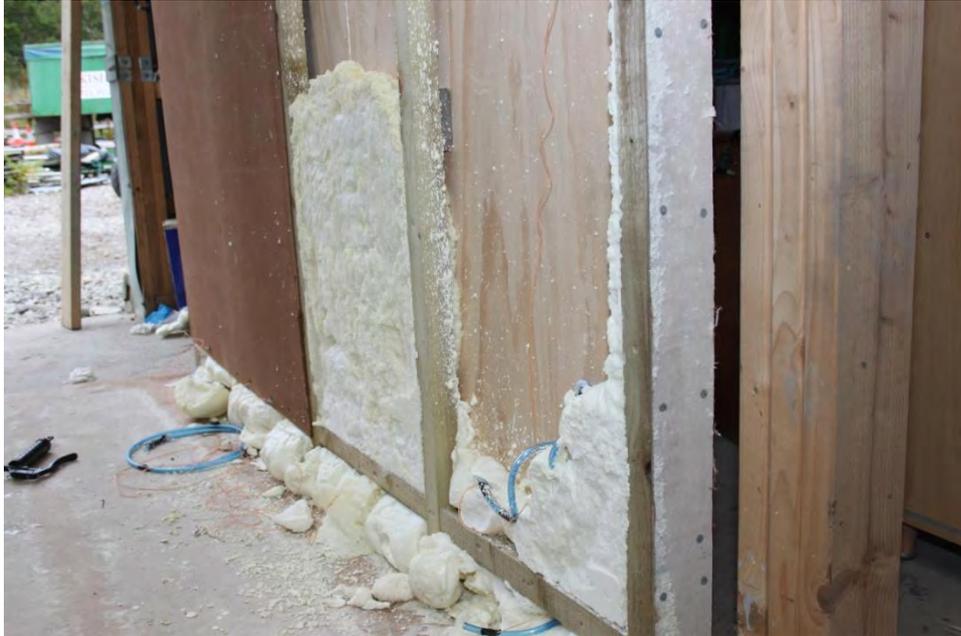
Observation of the outcomes

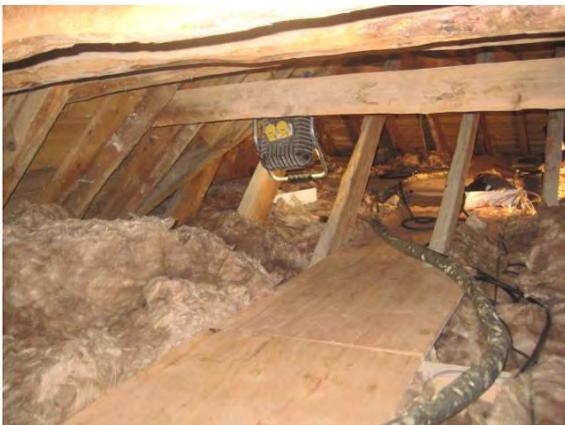
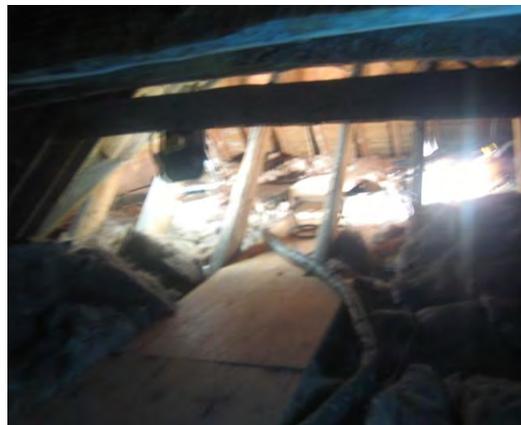
Floor covering and lighting installed for safety and easy access to the loft

- Before the arrival of the team in charge to implement the insulation operation, we made sure to prepare the site. The site preparation involved the installation of boards in the loft; installing some lighting as this was not in place before; the removal of the skirting boards and removing all the dust that might have gathered in the wall cavity in the last 2 centuries.

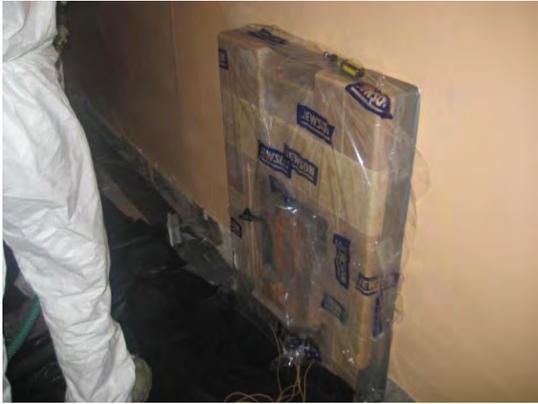
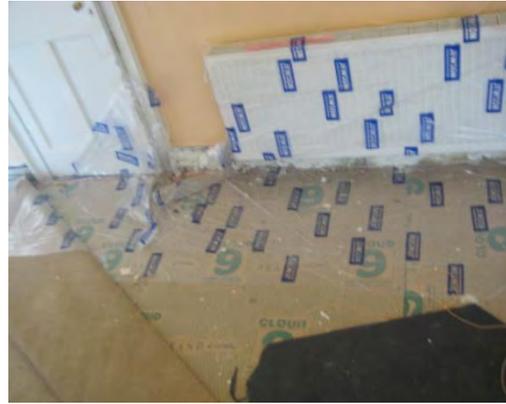
Covering of the floors, features for projection against the foam that might be damaged by accident

- Other preparations involved the carpet removal in the room that will be insulated, the covering of the floors in the corridors and staircase as lot of walks will happen during the trial that we didn't really know how long it will take.
- Covering all original features such as fire place and windows.

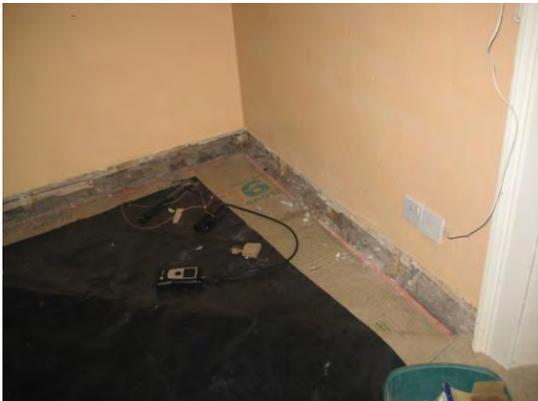
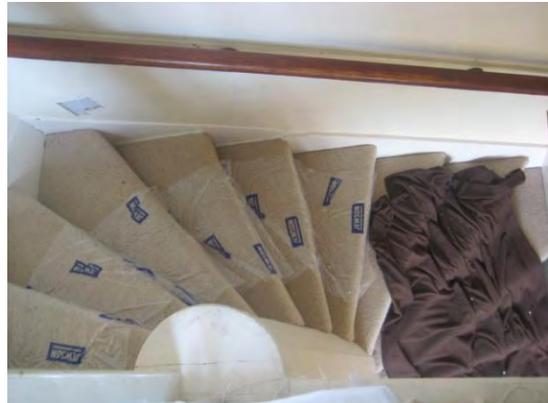
Stairs and corridors where covered to as many people were on site and lot of movement in and out the premises took place.

- Using industrial vacuum cleaner debris from behind the skirtings were removed to leave the cavity wall as clean as possible to avoid any thermal bridge.

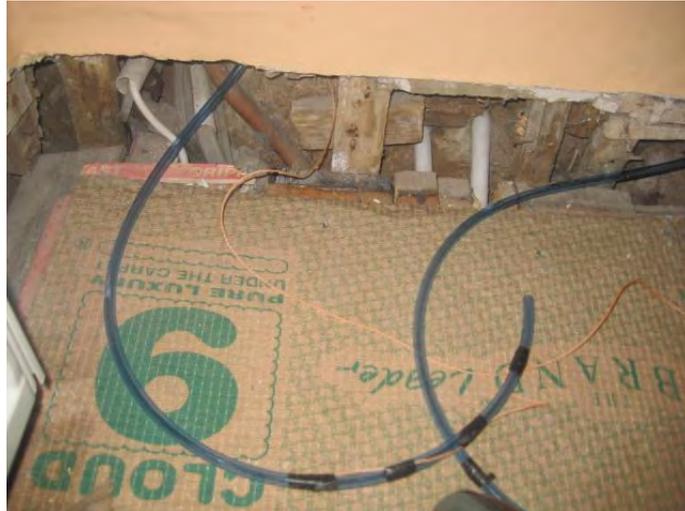
Pipes attached to cords

- The draw cords were attached to the 10mm polyurethane pipes and the pipes pulled down, and then retracted 200mm, then secured. A pipe was inserted between each stud. The site supply of polyurethane pipe ran out and the only available pipe, locally, of the same diameter was a PVC pipe, this was used to 4 bays. This type of pipe appeared later on to be more difficult than the previous one to work with.

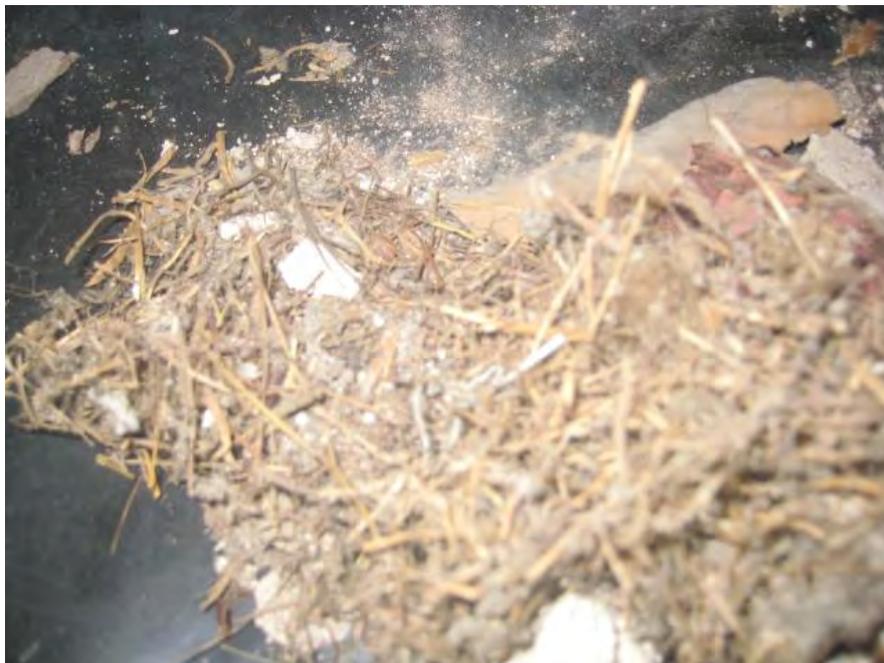
Sample of debris removed from the wall during this phase of the trial despite the cleaning prior to the start

- As the pipes were installed it was noted that debris was falling down when disturbed. To ensure no bridge within the cavity was caused, which could lead to damp problems in the future, it was decided to clean the cavity. This was achieved by moving the fibreglass probes around to dislodge trapped debris, assisted by an airline inserted into the cavity. The result was that approximately a pale full of debris was removed, which consisted of plaster lumps, fine dust and wooden twigs, presumably put there by birds making nests. The void was then cleaned by vacuum and brushing.

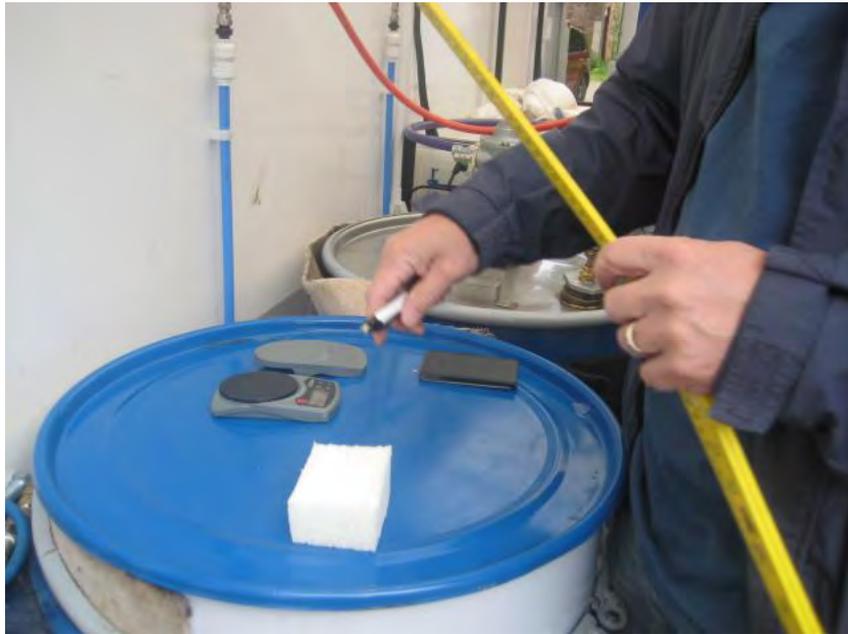
Quality check of the foam

- The equipment was changed over from the spray foam material to the pour foam material, and samples taken to prove the correct rate of expansion.

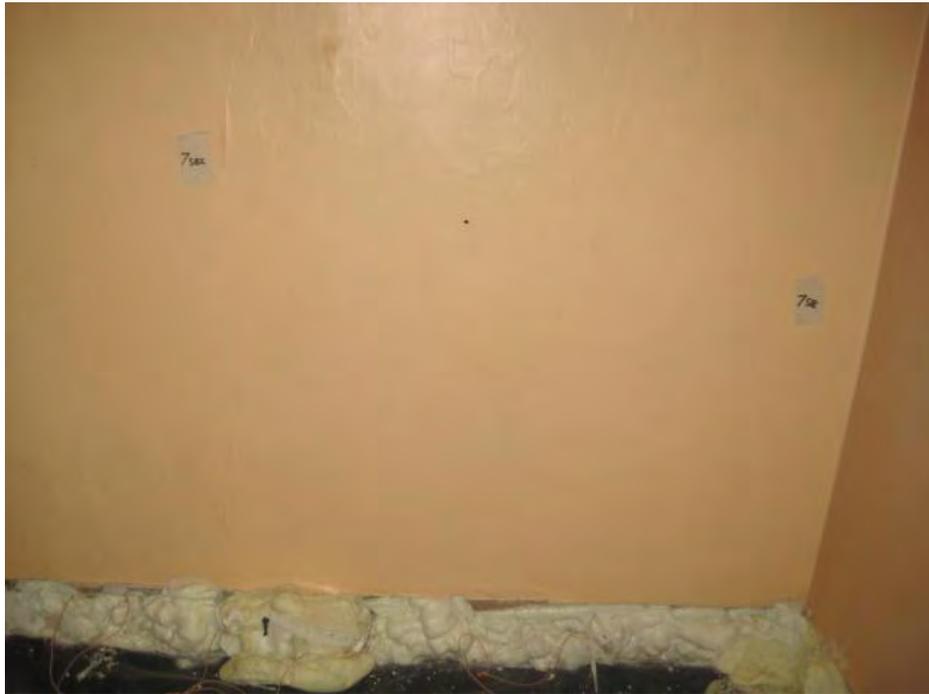
Leak of the foam at the bottom part of the wall

leaked out while still in liquid form, these areas were plugged using expanded spray foam pieces.

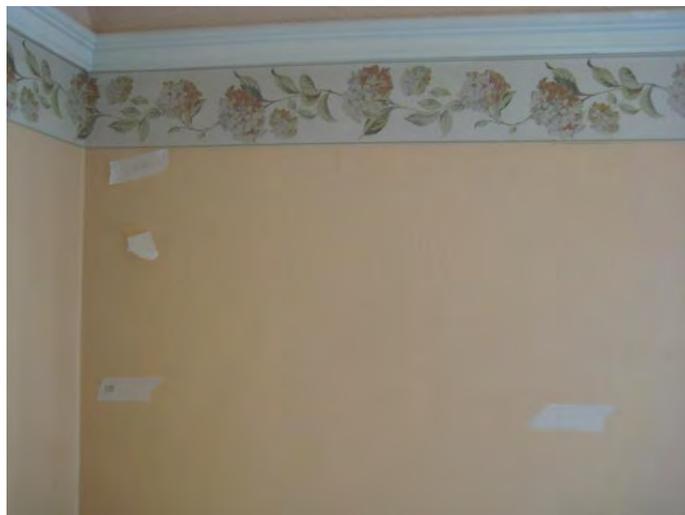
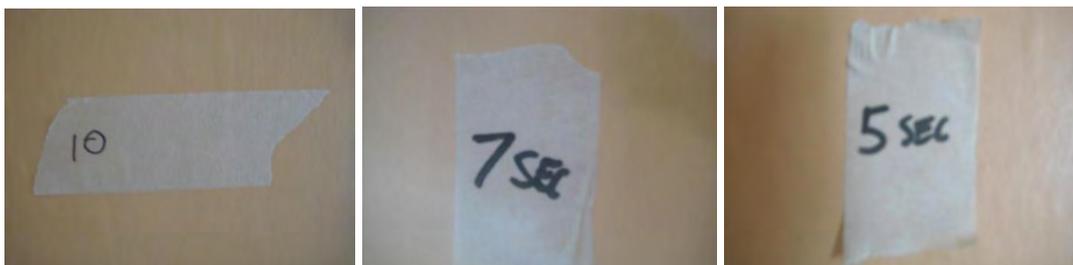
Alternation of bays and localisation of the foam level on the wall

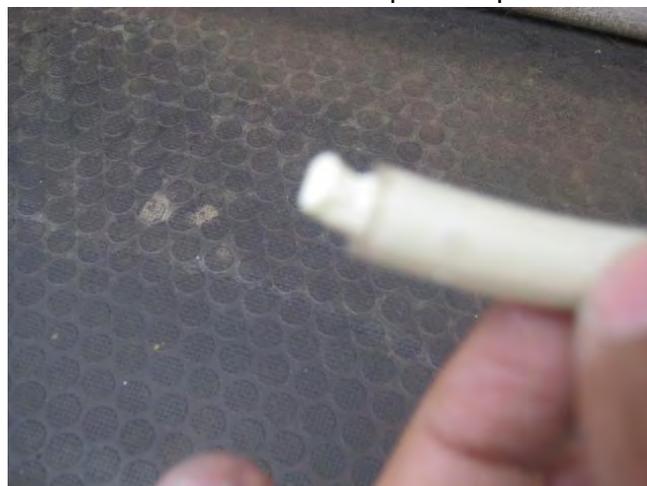
Pipe blockage

- 10 second Injections were then made to the missed bays, and the pipes blown clean.
- When all the heat created during the pour foam expansion, further 10 second injections were made to alternative bays. With the missing bays returned to when the heat had dissipated. It was found that the PVC pipe would not take a second injection without blocking, (which in turn caused a blockage in the gun), requiring four of the bays with polyurethane pipes to have the pipes removed and re-installed in the bays with the PVC pipes.
- This was achieved by taping the pipe to the fibreglass probes and inserting down the cavity while the injection took place. This method was also required in instances when the draw cords became fast within the expanded pour foam.

- During the trial it was discovered that the PVC pipe was not capable of more than one injection without blocking, and therefore not suitable for this application.
- The debris behind the lath and plaster should have been cleaned of debris before the draw strings and pipes installed. This would have made installing the pipes much quicker and easier.
- It was determined that in some locations the draw cords for the delivery pipe were not required and the pipe could be inserted, positioned and withdrawn while attached to the fibreglass probes. This would make the process quicker in certain circumstances.
- It was found that the Icynene insulation added rigidity to the wall.

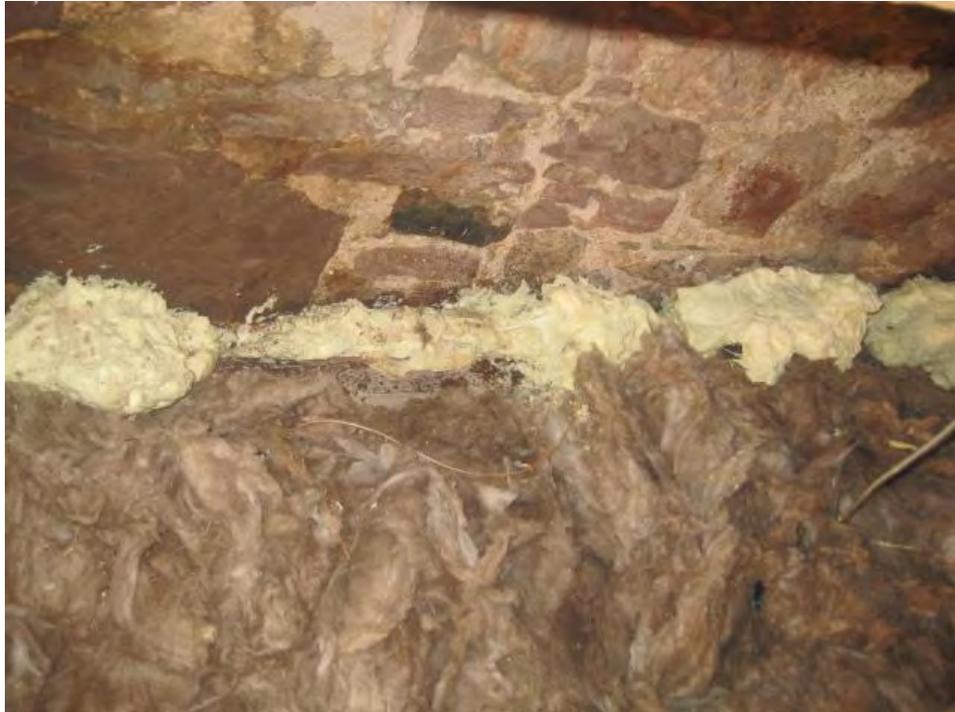
Top of the gable wall, foam seen from the attic

- The process was repeated until the pour foam was visible in the attic space. Once this was achieved the material was changed back to spray foam and in the area of the comb, spray foam was installed to join the existing fibreglass insulation to the newly placed Icynene.

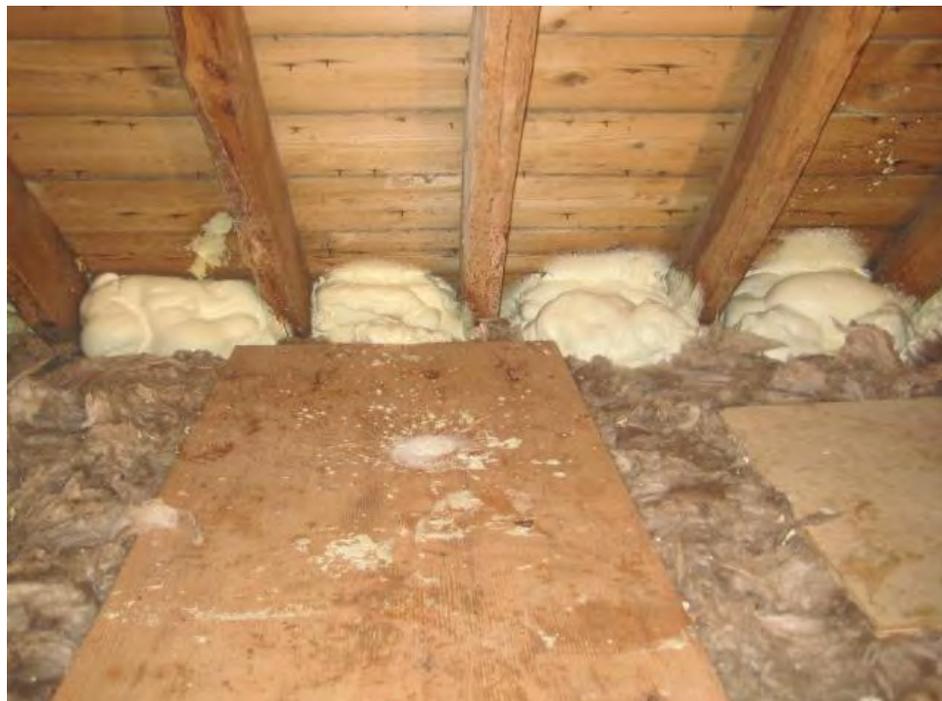
Foam seen at the eave level

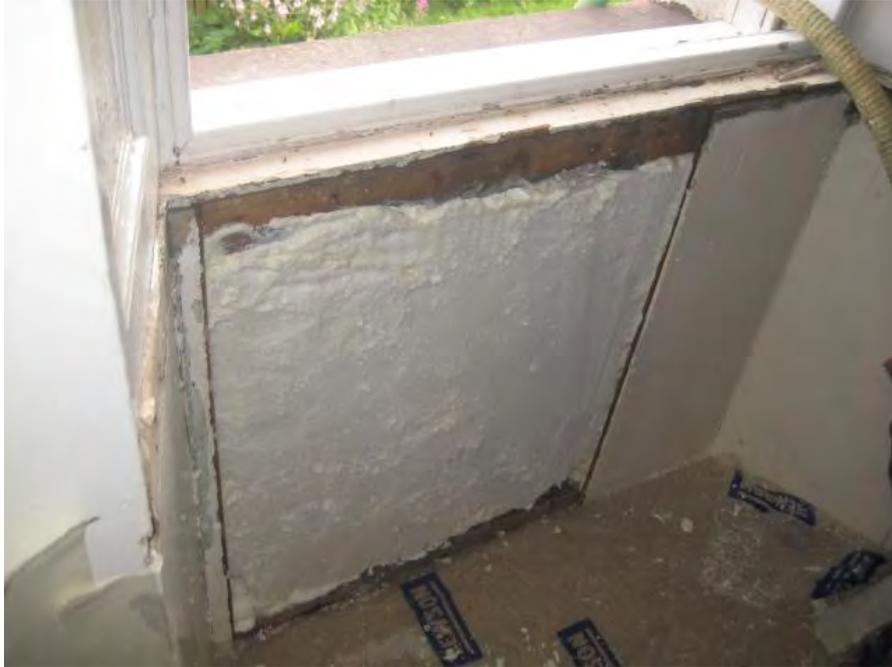
Insulating the wall under the window

- Other area proven to be in need to be insulated was discovered during the trial such as under the window. The team decided to insulate it using the spray method.
