# Comparative Study of Corrosion Performance of HVOF-Sprayed Coatings Produced Using Conventional and Suspension WC-Co Feedstock

**Abstract** Corrosion properties of nanostructured coatings deposited by suspension high-velocity oxy-fuel (S-HVOF) via an aqueous suspension of milled WC-Co powder were compared with conventional HVOF-sprayed coatings. Microstructural evaluations of these coatings included x-ray diffraction and scanning electron microscopy equipped with an energy-dispersive x-ray spectroscopy. The corrosion performance of AISI440C stainless steel substrate and the coatings was evaluated in a 3.5 wt.% NaCl aqueous solution at ~ 25 °C. The electrochemical properties of the samples were assessed experimentally,

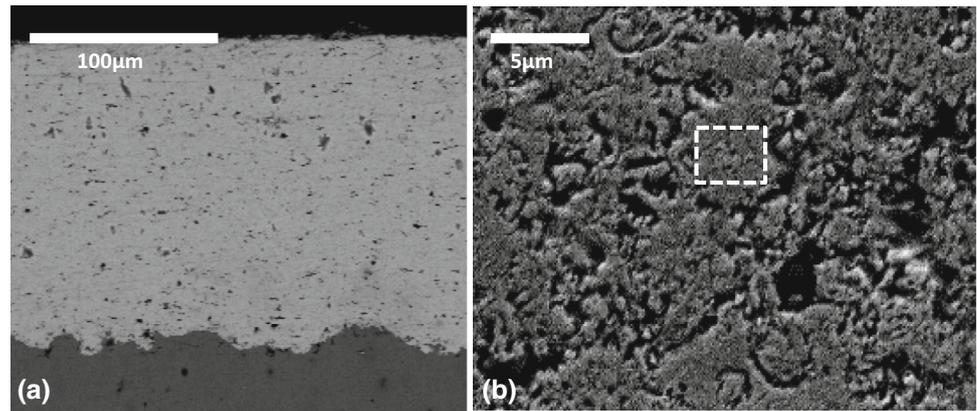
**Fig. 1** Cross-sectional (a) and (b) polished plane-view SEM micrograph of the as-sprayed S-HVOF sample

The average coating thickness before corrosion test was  $134 \text{ }\mu\text{m}$ . No cracks were found but the coating cross section is characterized by many pores and lamellae formations (Fig. 1a). On the polished surface, numerous large pores with diameter up to  $2.5 \text{ }\mu\text{m}$  were observed (Fig. 1b). EDS analysis on the denoted surface area revealed that it contains 25 at.% Co and 75 at.% W. Carbon was not detectable from the EDS analyzer because the EDS detector had Be window which absorbs low-energy x-rays; thus, only elements with atomic number greater than carbon were detectable.

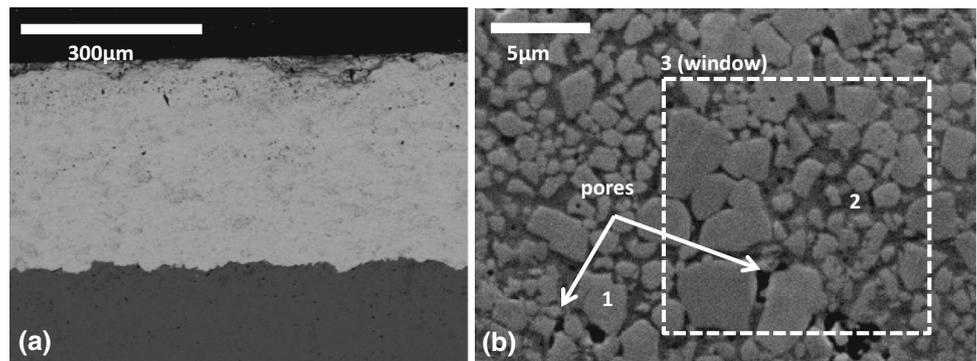
**Fig. 2** Cross-sectional (a) and (b) polished plane-view SEM micrograph of the as-sprayed HVOF-JK sample

The average coating thickness before corrosion was  $326 \text{ }\mu\text{m}$ . No cracks or large connected pores were found. Its cross section is characterized by less pores compared with S-HVOF and lamellae formations (Fig. 2a) which form longitudinal dark formations in S-HVOF coatings. The polished surface morphology is composed by characteristic angular WC grains (light areas) embedded in a Co-

W matrix (darker areas) (Fig. 2b). This was verified by the EDS analysis denoted in Fig. 2(b) which revealed that area 1 is mainly composed of W while area 2 is composed of 28 at.% Co and 72 at.% W. The denoted window in Fig. 2(b) was found to contain 90 at.% W and 10 at.% Co in total. The number of large pores is significantly less compared with the S-HVOF coating.

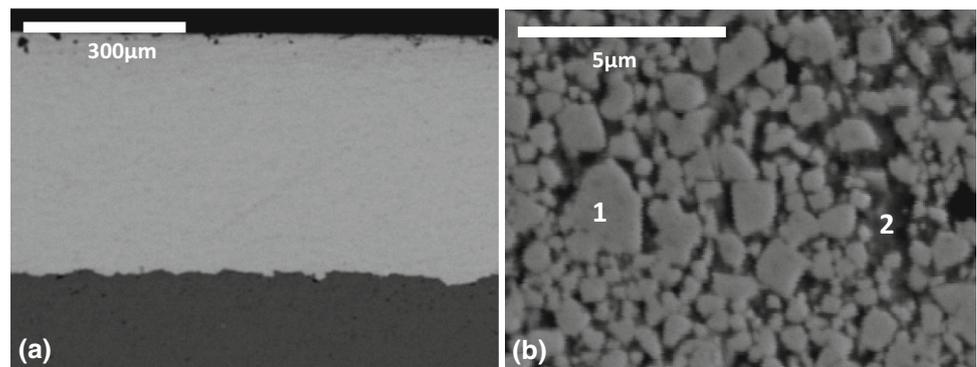
**Fig. 3** Cross-sectional (a) and (b) polished plane-view SEM micrograph of the as-sprayed HVOF-JP sample

The average coating thickness before corrosion was 383  $\mu\text{m}$ . No cracks or large connected pores were found. Its cross section shows relatively lower pore content between the three

coatings (Fig. 3a). The pores are mainly restricted to the upper region of the coating, while lamellae formations are hardly observed. The polished surface morphology is similar to HVOF-JK with micron-sized WC particles embedded in Co-W matrix (Fig. 3b). EDS results on the denoted areas in Fig. 3(b) revealed that area 1 is mainly composed by W while area 2 is composed of 63 at.% Co and 37 at.% W.

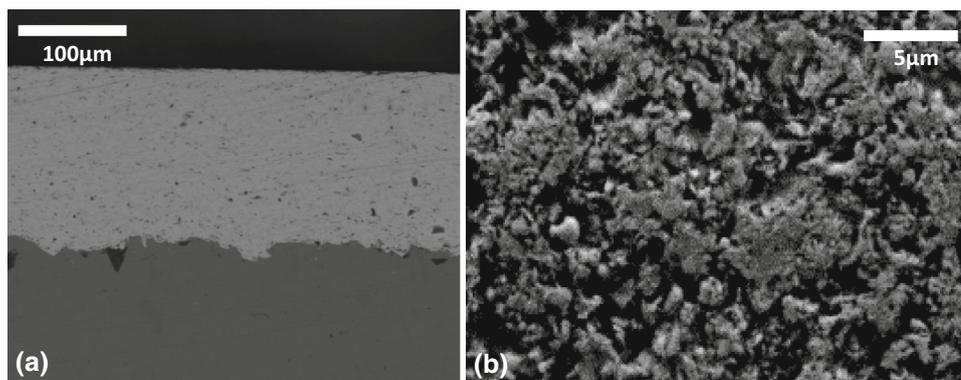
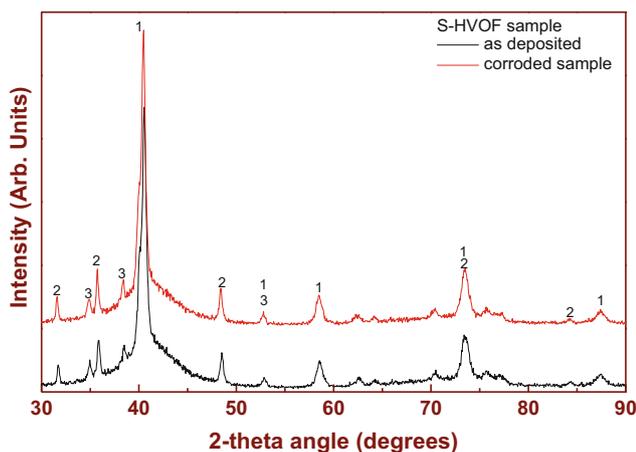
**Fig. 4** Cross-sectional (a) and plane-view (b) SEM micrograph of the corroded S-HVOF sample

After potentiodynamic measurements, the thickness of the corroded S-HVOF coating (Fig. 4a) still corresponds to the

as-sprayed state (Fig. 1a). However, in the plane-view SEM micrograph (Fig. 4b), the surface roughness was found to increase as more craters are observed to have been formed compared with the as-sprayed state (Fig. 1b). This can be attributed to some material loss due to corrosion. EDS analysis performed on different areas of the surface showed that no corrosion products could be detected.

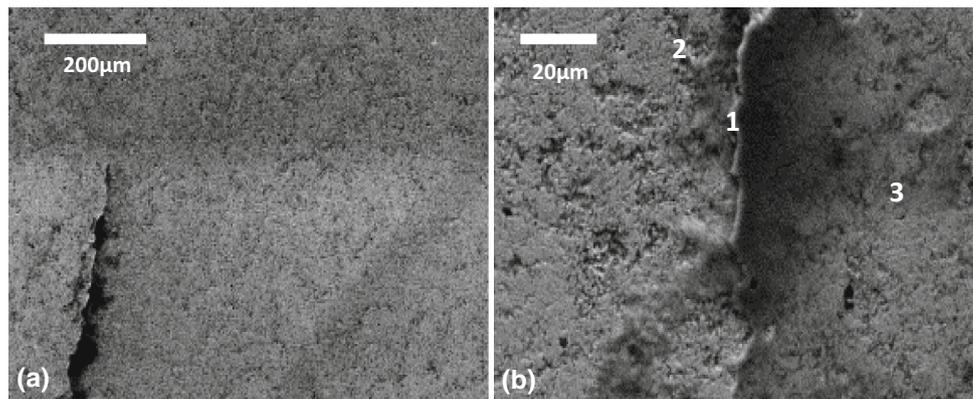
**Fig. 6** Plane-view SEM micrographs of the collapsed corroded areas of S-HVOF sample in different magnifications

**Table 2** EDS results from the denoted areas in Fig. 6(b). All values are in at.%

Area nr.	O	Na	Cl	Fe	Co	W
1	42.7	2.0	3.6	37.2	1.5	12.9
2	3.7	0	0	0.3	5.9	90.1
3	14.1	0.6	0.3	0.6	4.7	79.7

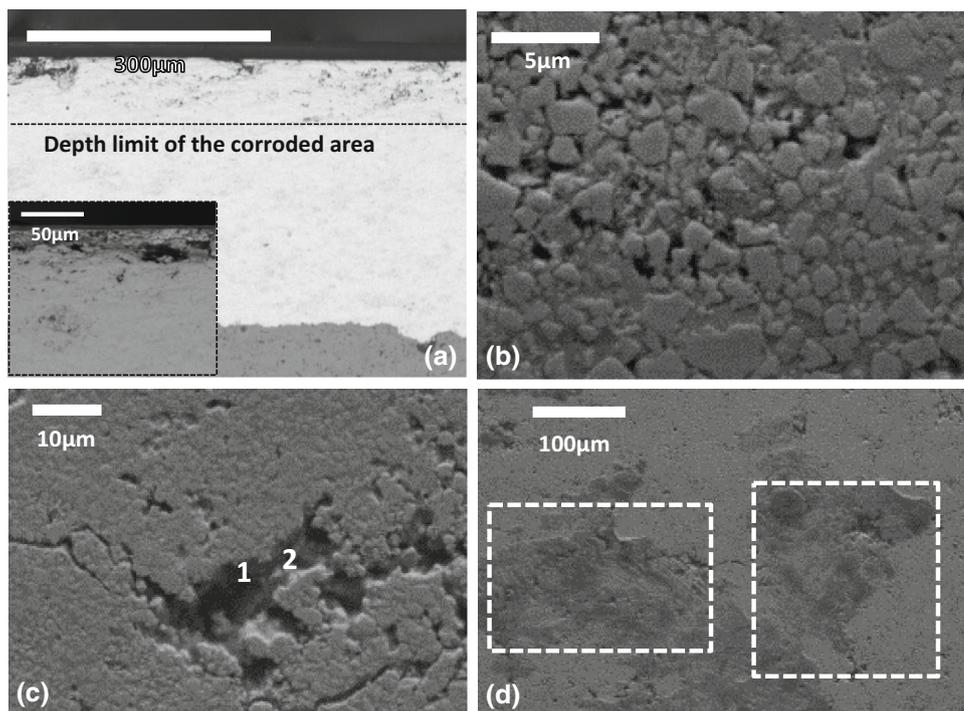
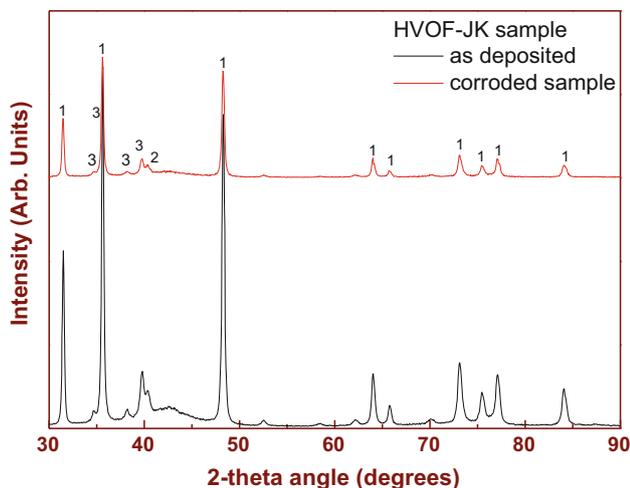
**Fig. 7** Cross-sectional (a) and plane-view SEM micrographs of the corroded HVOF-JK sample (b: general view, c: area with deep craters, d: area with noticeable Na and Cl)

After potentiodynamic measurements, the thickness of the corroded HVOF-JK sample remained nominally stable compared with the as-deposited one in Fig. 2(a) (Fig. 7a). In some areas on the surface, several corroded regions were observed (dark areas at the top coating areas) where the pore network was enlarged by the effect of the corrosive environment, leaving easy path for its penetration from the corrosive agents. Particularly, in these areas the presence of Cl and Na was detected with EDS up to a depth of 80  $\mu\text{m}$  (inset image of Fig. 7a). In the plane-view SEM micrograph (Fig. 7b), numerous craters were observed which in some cases have significant depth (Fig. 7c). The material loss at these areas was extreme as EDS in these craters revealed the existence of Fe (21 at.% O, 8.5 at.% Na, 43 at.% Cl, 10.5 at.% Fe, 6 at.% Co, 11 at.% W). These deep craters were found at spotted areas and do not characterize the general situation of the sample after corrosion, and hence, they were not found in the cross-sectional image. However, their existence can be considered in order to evaluate the corrosion resistance of HVOF-JK coatings. Finally, some isolated areas were found containing high concentrations of NaCl (denoted areas in Fig. 7d). Their existence is probably the result of some corrosive agent which has adhered on the surface with the help of the preexisting pores.

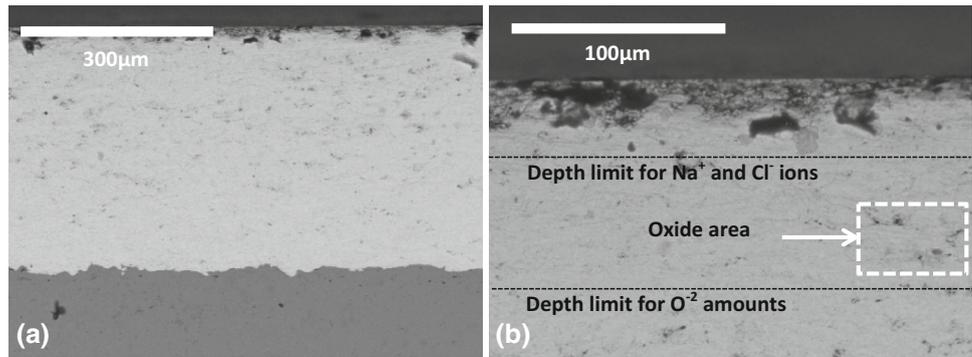
**Fig. 9** Cross-sectional SEM micrograph of the corroded HVOF-JP sample (a) and magnification of the surface area (b)

The corroded HVOF-JP sample, similar to the previous samples, maintains its initial thickness after deposition compared with the as-deposited one in Fig. 3(a) (Fig. 9a). EDS analysis performed on the cross section revealed in some cases significant penetration of the corrosion agents

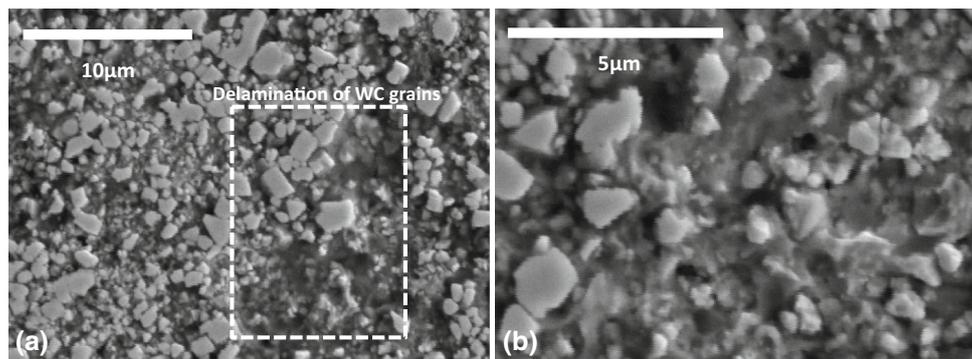
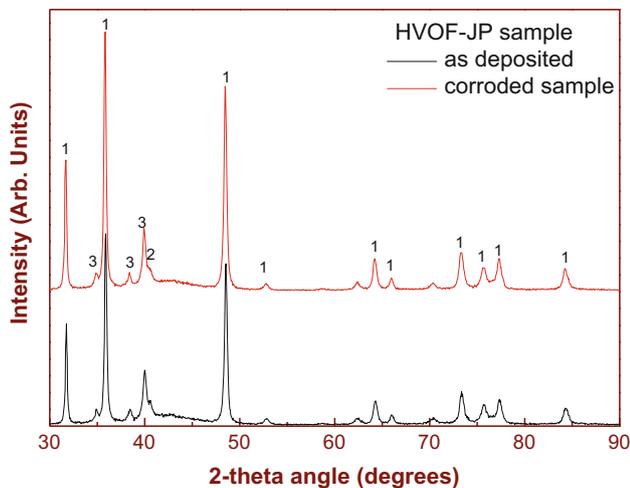
**Fig. 10** Plane-view SEM micrograph of the corroded HVOF-JP sample (a) and magnification of the denoted area (b)

In the plane-view SEM micrograph (Fig. 10a), the preferential attack of the binder matrix by the corrosive media is revealed. The attack on WC grains is minimal (Fig. 3b). It is probable that a galvanic cell is created between the two areas that result in the accelerated corrosion of the matrix as noted in previous sections. Moreover, in some areas (Fig. 10b) there was also some evidence of removal of the WC. EDS on these areas revealed the presence of high oxygen concentrations (average 20 at.%) together with Na and Cl (average 8 at.% for each one).

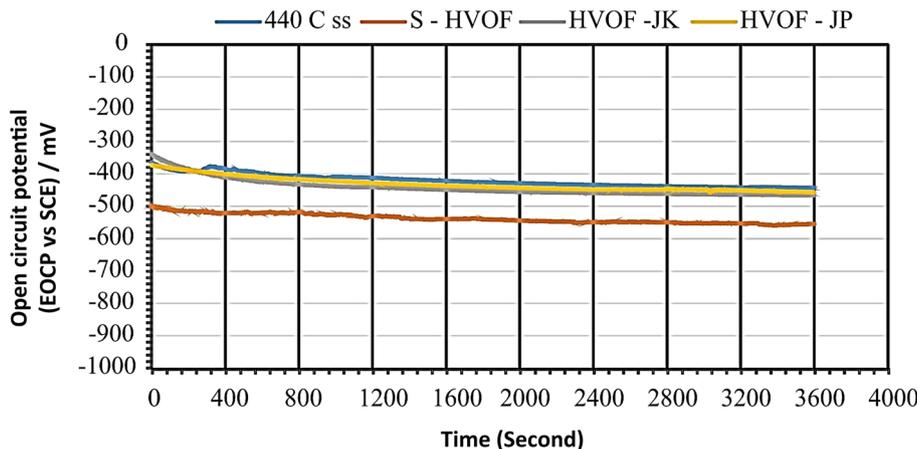
**Fig. 12** OCP measurements of S-HVOF-, HVOF-JK- and HVOF-JP-coated samples together with the bare substrate (440 C stainless steel substrate)

The open-circuit potential (OCP) of coated and uncoated samples (versus SCE; saturated calomel electrode) in 3.5 wt.% NaCl aqueous solution during a period of 60 min is shown in Fig. 12. OCP measurements stabilize after  $\sim 30$  min of exposure. It can be seen (Fig. 12) that compared with 440C stainless steel ( $E_{\text{OCP}} = -443 \pm 10$  mV) all coated samples had more electronegative values (for S-HVOF,  $E_{\text{OCP}} = -550.3 \pm 20$  mV; for HVOF-JK,  $E_{\text{OCP}} = -466 \pm 10$  mV and for HVOF-JP  $E_{\text{OCP}} = -457 \pm 10$  mV) with the most electronegative  $E_{\text{OCP}}$  reported for S-HVOF-coated samples. These measurements show that the coated samples (especially S-HVOF coating) are more active (or anodic) in comparison with the stainless steel substrate. This indicates that the substrate is nobler than the coatings, and thus, taking only thermodynamic considerations, the coating corrosion will most likely occur in preference to the substrate when the substrate and the coating are in electrolytic contact.

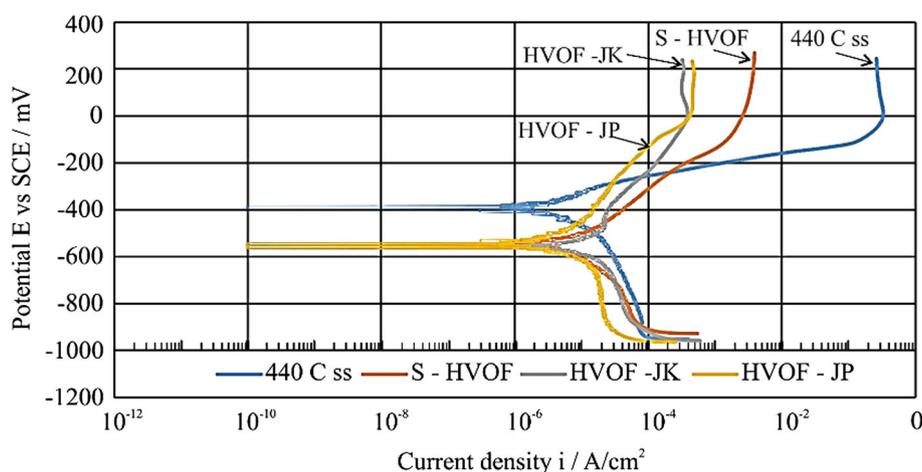
**Fig. 13** Potentiodynamic polarization measurements of S-HVOF-, HVOF-JK- and HVOF-JP-coated samples together with the bare substrate (440C ss)

The potentiodynamic polarization diagrams of coated and uncoated samples are presented in Fig. 13. In the cathodic part of the polarization curves, two regions can be observed that probably represents (1) the mass transfer dominated reduction of dissolved oxygen in the solution and (2) the charge transfer controlled evolution of hydrogen from the aqueous media at more negative potentials. The corrosion potentials ( $E_{\text{corr}}$ ), corrosion currents ( $i_{\text{corr}}$ ) and Tafel slopes (ba, bc) of S-HVOF-, HVOF-JK- and HVOF-JP-coated samples together with the bare stainless steel substrate 440C are summarized in Table 3. These parameters were estimated by taking into consideration several zones from 50 to 200 mV (away from  $E_{\text{corr}}$ ) to optimize the fitting of the Tafel slopes. The  $E_{\text{corr}}$  values (Table 3) of the coated samples are more electronegative compared with the relevant  $E_{\text{OCP}}$  values, meaning that the substrate is nobler than the coatings. Furthermore,  $i_{\text{corr}}$  for

rises and at a potential of  $\sim -100$  mV versus SCE the current begins to stabilize whereas at  $\sim 0$  mV versus SCE a stable corrosion current density value is reached, possibly due to the formation of a stable oxide layer. As for the coated samples, the entire anodic region is an active dissolution region, without the existence of a pitting potential, reaching a relatively steady corrosion current. Anodic reaction products cannot enter the solution faster, and mass transfer limited current density is reached (Fig. 13).

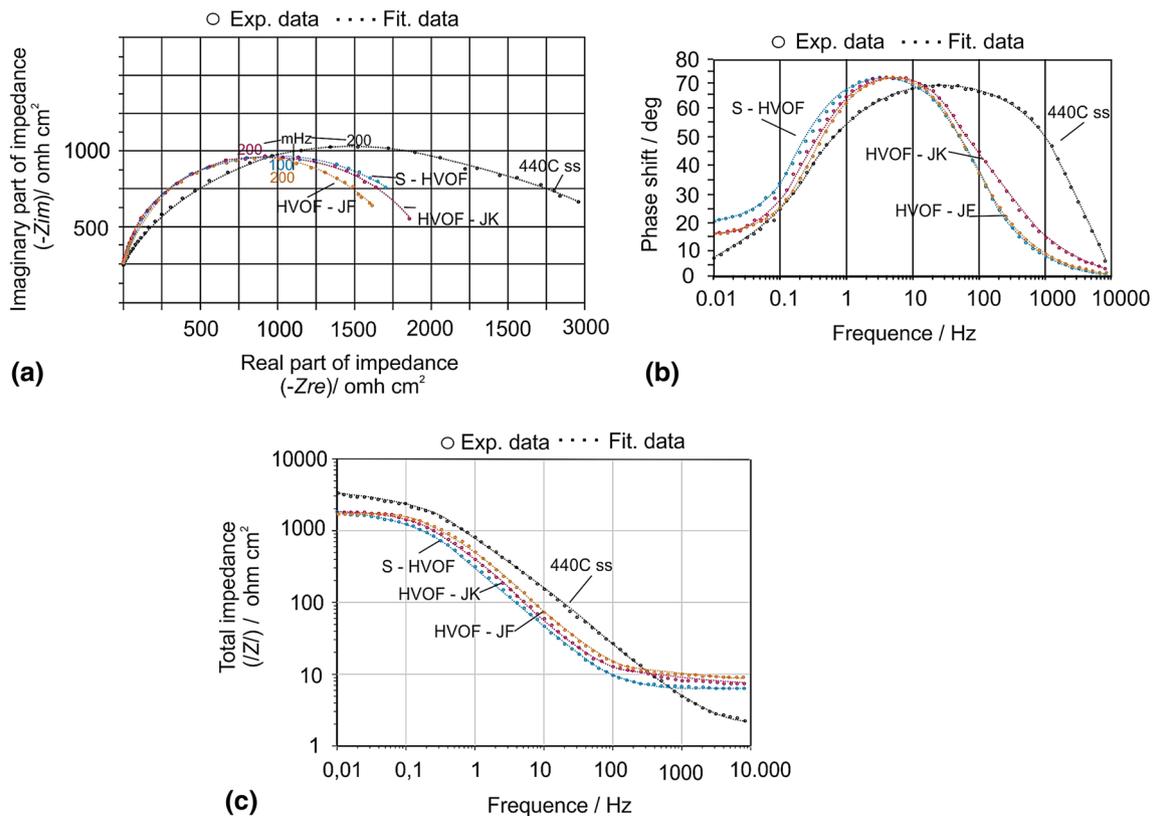
**Fig. 14** (a) Nyquist plots, (b) Bode plots and (c) total impedance–frequency plots for S-HVOF-, HVOF-JK- and HVOF-JP-coated samples together with the bare substrate (440C ss) obtained after

60 min of immersion in 3.5 wt.% NaCl aqueous solution at ~ 25 °C.  $Z_{im}$  and  $Z_{re}$  are imaginary part and real part of complex impedance, respectively, whereas  $|Z|$  is the impedance meter of complex number

The absence of a non-perfect semicircle at very high frequencies (Fig. 14a) can be attributed to the frequency dispersion and the absence of any continuous surface film on the specimens (“Corrosion Test Results”). Furthermore, the presence of maximum two time constants at Bode diagrams (Fig. 14b) may be related to the presence of WC grains which provide additional interfaces on the surface of the coated samples. The increase in the total impedance at low frequencies for all specimens reaching a dc limit is an indication of a complete lack of diffusion mechanism and the presence of localized corrosion (Ref 43).

Based on the resulted impedance curves (Fig. 14) and the previous results and discussion, two equivalent circuits (Fig. 15) were chosen in order to describe the early stages of corrosion of 440C stainless steel (Fig. 15a) and coated samples (Fig. 15b) in 3.5 wt.% NaCl aqueous solution. This equivalent circuit seems to offer the most coherent physical interpretation of the results having the minimum possible electrical elements.

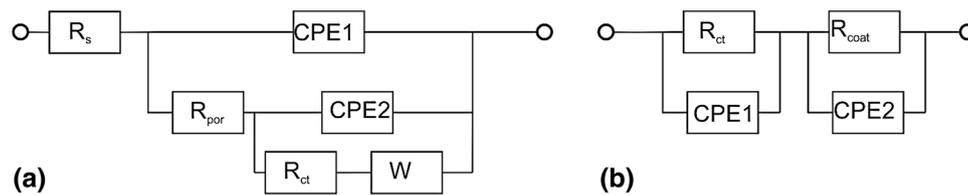
**Fig. 15** Equivalent electrical circuit representing the corrosion behavior of (a) the bare substrate (440C ss) and (b) S-HVOF-, HVOF-JK- and HVOF-JP-coated samples after 60 min of immersion in 3.5 wt.% NaCl aqueous solution at  $\sim 25\text{ }^{\circ}\text{C}$

The adopted equivalent circuits for the 440C stainless steel consist of the following (Fig. 15a):

3. a Warburg ( $W$ ) resistance  $Z_w$  related to the diffusion direction of oxidants to any formed electric double layer,
4. an impedance  $Z_{CPE1}$  of a constant phase element CPE1 (or CPE3) that characterizes the capacitance  $C_c$  of any oxide layer (or product's layer) on the 440C stainless steel,

5. an impedance  $Z_{CPE2}$  of a constant phase element CPE2, which characterizes the capacitance contribution  $C_{dl}$  of any formed electric double layer on the interface between specimens and the solution inside any corrosion area,

1. a charged transfer resistance  $R_{ct}$ , which characterizes the polarization of the specimens–solution interface due to the formation of an electric double layer on the interface between specimens and the solution inside any corrosion area. An increase in the value indicates that the increase in corrosion resistance of passive films occurs due to either film thickening or compositional modification in the corrosive environment,

2. an impedance  $Z_{CPE1}$  of a constant phase element CPE1, which characterizes the capacitance contribution  $C_{dl}$  of any formed electric double layer on the interface between specimens and the solution inside any corrosion area,
