Existing housing stock in the UK and the thermal insulation challenge: case of granite traditional constructions in the United Kingdom.

BENNADJI, A., SCOTT, J. and TAYLOR, B.

Existing housing stock in the UK and the Thermal insulation challenge

Case of granite traditional constructions in the United Kingdom

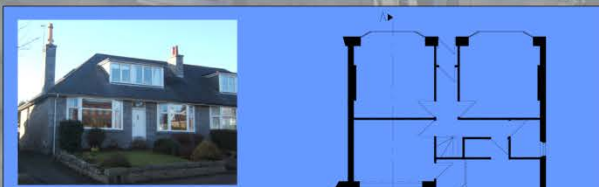
Above: View of house 2 Below: Locations of cold spots in fabric caused by alterations and changes in building regulations

Originally this granite dwelling had four family rooms downstairs, two upstairs home. This has undergone significant adaptation during the intervening period due to changing demographic, technology and fashion. Significant alterations have been conducted to include space additions to the roof and most recently to the rear of the building. Technologically, there has been a change to the heating and an increase in the electrical appliances within the building. With these changes over different periods, it is anticipated that improvements to the building/additions are not consistent throughout the building. For example, the building fabric in different locations will vary and without a thorough building survey, it is unlikely that any one u-value is known or accurate, for a variety of reasons. This will lead, in practice, to 'cold spots' in many existing buildings. Likely locations for these 'cold spots' are the joints between each additions. An easy solution would be to insulate the exterior of these buildings. For granite wall buildings in Aberdeen the city planning authorities rule out the use of external insulation – granite forms the cultural identity of the character of Aberdeen, therefore the easy option for Granite buildings (simply putting insulation on the exterior) is simply not an option, and this is the same for most of the older, historic buildings in Urban and Rural settings.

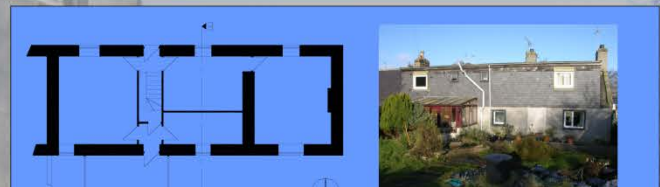
Above: View of house 2 Below: Proposed Solution (not adopted)

Originally a home with an attached workspace, this rural dwelling has undergone several changes throughout a long lifespan. Large, solid granite walls prevent significant alteration or upgrading of the building fabric on the lower storey, with a conservatory the only physical space added at this level. The roof space, in this instance, is where the house has been developed. There is very little insulation and no large windows in the ground floor, conversely the upper storey has large south facing glazing and an insulated envelope (built in the early 1980's). Initial post occupancy study highlights the significant increase in temperature in the upper storey, while the lower ground floor remains cooler (in the homeowners' opinion). In this instance, the change in the pattern of use of the building is problematic – daytime activity is in the lower storey, which is cold therefore the heating in the building remains 'on' even on moderately warm summer days. In the evenings, with the upper storey on the same heating loop and benefiting from passive gains, is where significant heat build up occurs. This could be used or perhaps stored, but in this instance it is not, with the preference to release the heat by opening a window. With the ventilation at night, the sequence begins again as no heat is stored overnight and the lower storey remains 'cold' to the home user (especially in the early morning).

On the other hand the rejected alternative solution, despite its acceptable technical standard, the soul of the internal spaces was not appreciated by the owner; therefore the solution should be technical and maintain the originalities of the existing housing stock. The limited availability of qualified and experienced labour will constitute another challenge, and guidance on how to deal with the large numbers of housing typologies that the UK contains should be issued to various agencies involved in informing the future labour force. This process will take more than two decades to be solved and a scientific study with a focus on a better control of energy consumption and CO₂ emission should be conducted. The proposed research will also garner understanding of the social and psychological impacts of the potential radical restructuring of British housing estates. Other type of buildings, such as large office buildings, benefit from integrated information systems that assist architects and designers to achieve better energy conservation, the housing area does not benefit from such integrated systems and a parallel development still needs to be achieved, the skills and technology based on academic research.
