**SCOTTISH MARKET CROSSES:
THE DEVELOPMENT OF A RISK ASSESSMENT MODEL**

LINDSEY JANE THOMSON

School of Construction, Property and Surveying

July 2000

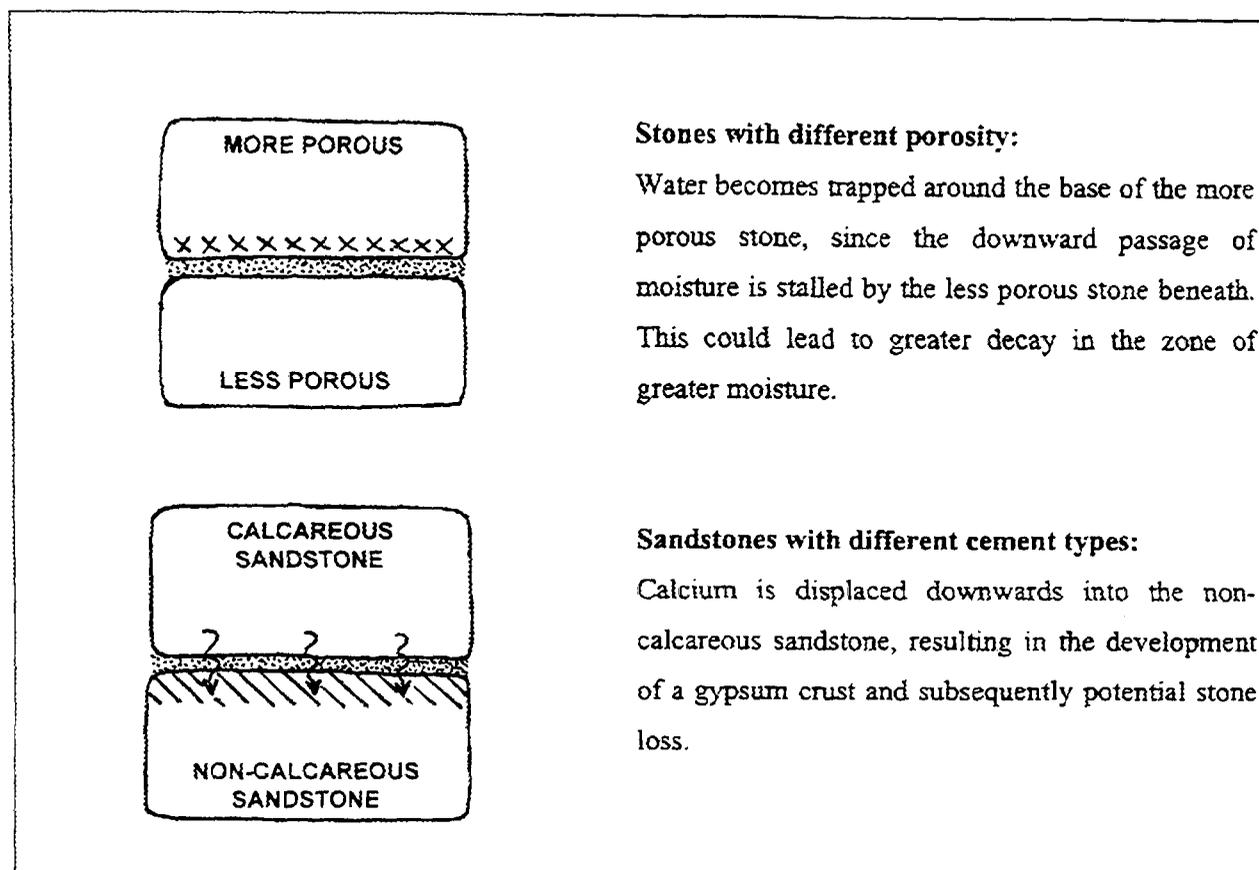
Figure 4.8 The effects of juxtaposing incompatible stone types.

crust upon the non-calcareous stone. This effect could occur on either the replacement stone or the older stone, depending on which one has which cement type (see diagrams in Figure 4.8 below).

In the sample there are 15 crosses which could be at risk from decay due to stone replacement. However, upon examination of these there is little evidence for decay that can be attributed to such differences in the stone properties. Decay evident on certain crosses (eg Dunbar) can be discounted from this analysis where old photographic evidence indicates that it already existed prior to the addition of the new stone parts. In some cases the apparent lack of any effect might be due to the very recent dates of some replacements (eg replacements were made at Turriff in 1997, Banff in 1994 and Cupar in 1987). As such, the time elapsed since the intervention may be insufficient to produce visible decay effects. However, in the case of stone replacements made at Beaulieu (1987) and Inverkeithing (1974), the time required for the development of the decay now visible on the *new* masonry seems relatively short. The lowest shaft section of Beaulieu cross was replaced just 11 years prior to the present field survey and is already showing a little granulation around the top on one side next to the joint. At Inverkeithing a new shaft section was inserted into the middle of the shaft in 1974. It now shows a patch of moderate scaling towards its top on one side. This salt damage could potentially be due to incompatibility of cement types, but this cannot be confirmed without testing. If the decay in the two latter cases at Beaulieu and Inverkeithing is indeed due to differences in adjacent stone properties, then it seems the effect of this can be relatively rapid. It is unclear whether decay observed on the older stone parts of Bowden cross and on Dundee cross is related to differing properties of adjacent stones. It is incidentally also noticeable from a few of the other

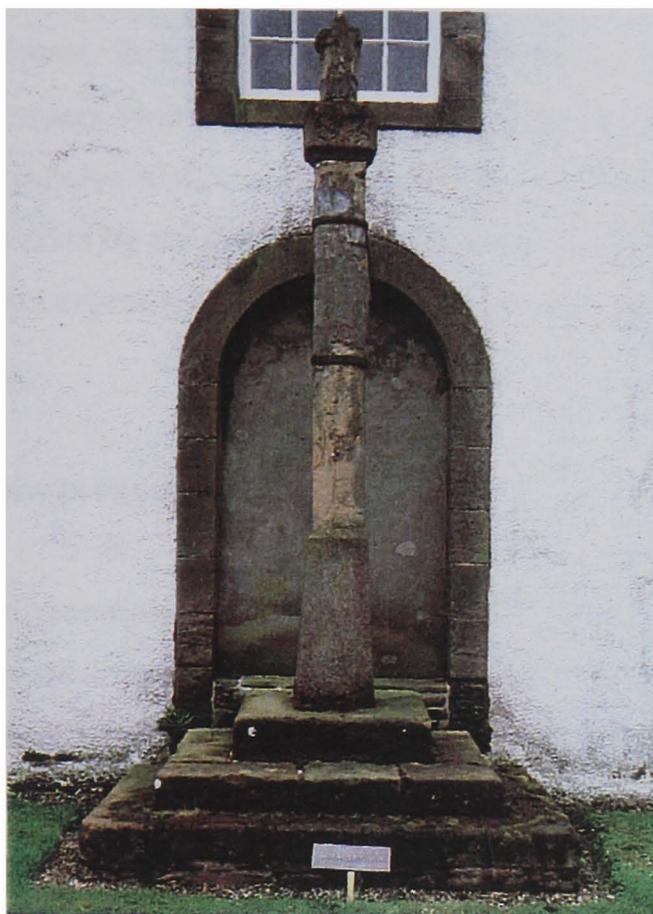
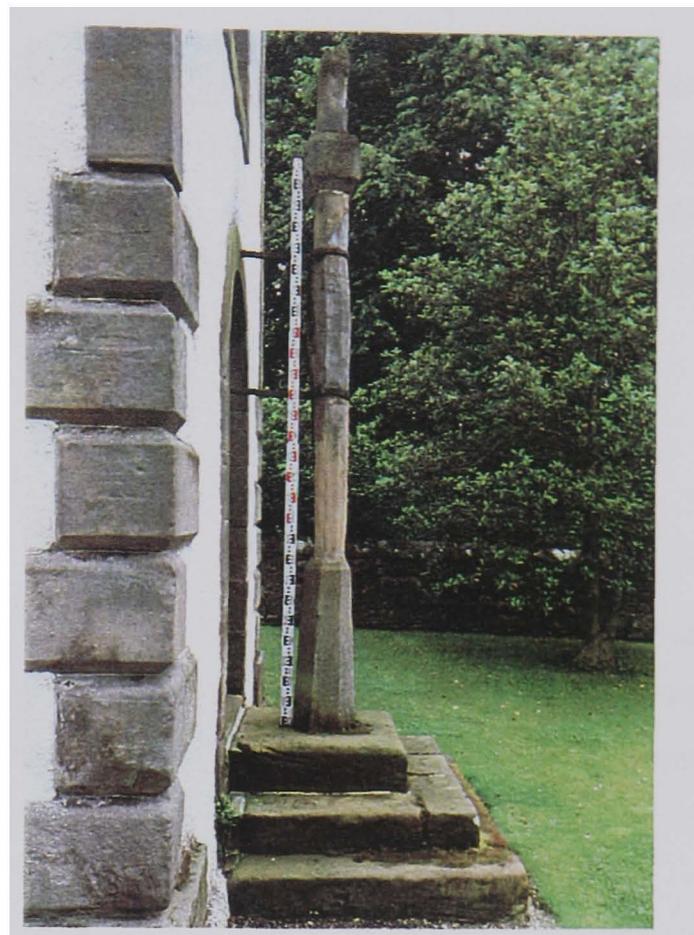
This fairly plain and poorly preserved cross consists of a rectangular-shaped base of three steps, surmounted by a stop-chamfered shaft. The capital sitting on top of the shaft is decorated with a lozenge pattern on the front face, and the stylised cross-shaped finial that crowns this is in the form of an upright block ending in a small trefoil.

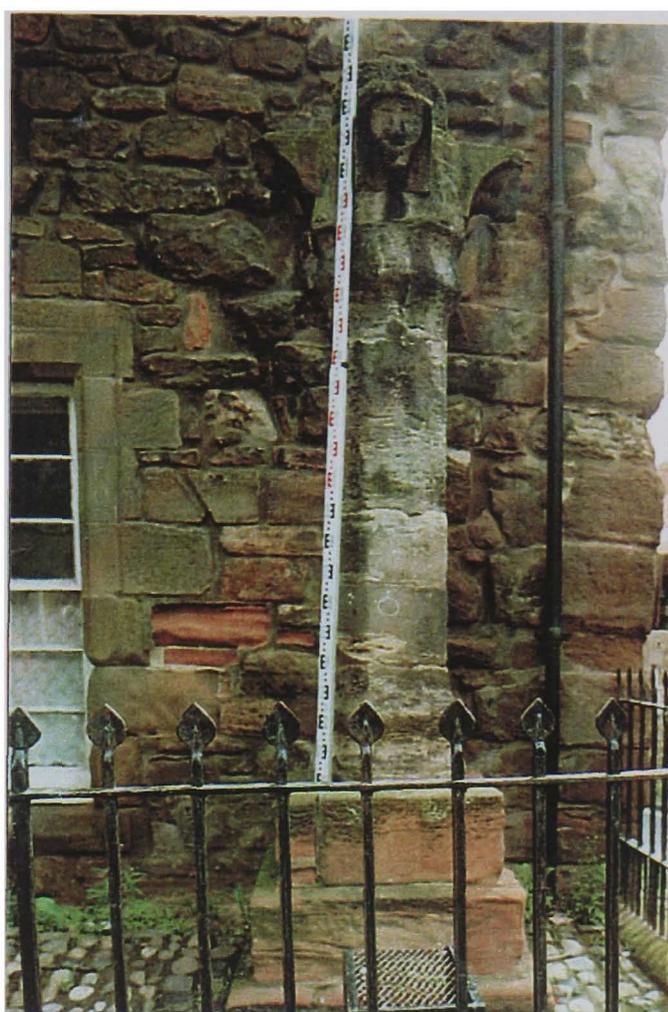
Dunbar market cross has been altered and now has a rather unusual design. The shaft comprises six octagonal blocks of stone with weathered moulding on the top and bottom sections. At the top of the shaft are three skewputts bearing grotesque human heads, protruding to the N, W and S, and above this the capital terminates in a dome-shape. The shaft is mounted upon a base of three square steps, the lowest of which is buried for much of its depth within the cobbles. Some small attachments include a piece of lead retained on the N side of the shaft within a small square recess indicative of a former attachment, and the remains of two rusty iron nails still embedded in the stone flush with the surface on the N side.
