<b>MOUTI, Z., WESTWOOD, K., LONG, D. and NJUGUNA, J. 2013. An experimental investigation into localised low-velocity impact loading on glass fibre-reinforced polyamide automotive product. <i>Composite Structures</i>, Vol. 104, pp. 43-53.</b>
---

# **An experimental investigation into localised low-velocity impact loading on glass fibre-reinforced polyamide automotive product**

Zakaria Mouti<sup>1</sup>, Keith Westwood<sup>2</sup>, Darren Long<sup>2</sup> and James Njuguna<sup>1\*</sup>

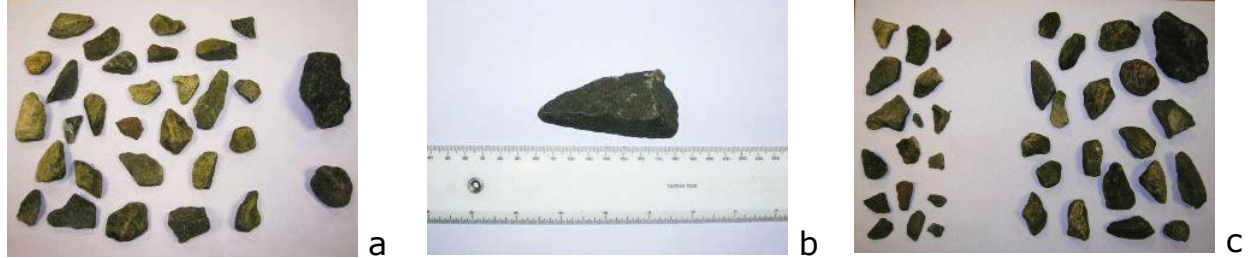
The characteristics of stones likely to cause damage into the engine oil pan presented in the Figure 1 were quantified allowing the measurement of road stones typical mass and size [9]. The granite stones shown in Figure 2-a weigh less than 17 g and all fit into the damaged area between two consecutive ribs except the two big stones on the right side; the rounded stone weighs 21 g and the larger one weighs 78 g. There are variable gaps between the ribs in the area of impact. An 87 g random stone with a pointy profile is able to fit into the gap where damage is evident, Figure 2-b. A possible solution would be to reduce the rib spacing so as to exclude more stones, Figure 2-c. However, the mistake would be to overload the oil pan structure with protective features. The compromise is in the balance in where more or improved ribs are disposed in the areas prone to impacts.

Figure 2 - Collection of random stones

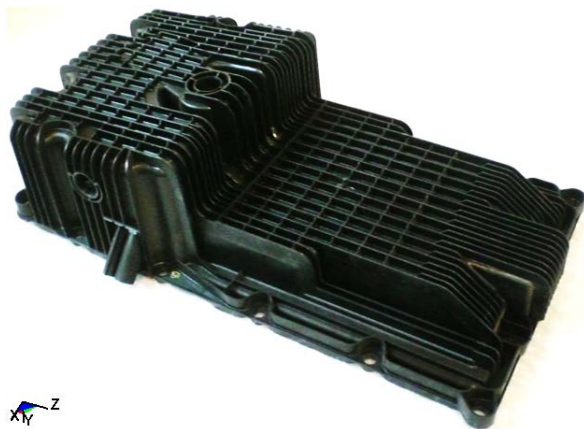
The design of the oil pan is made in such a way that its connection to the engine is consistent with the metal construction previously used. A distinguishable element of the design is the ribbing pattern which provided increased stiffness. Ribs are part of the oil pan and are not meant to snap, however, damage such as crushed or deflected ribs are acceptable at high impact energy. Figure 3 shows an early version of the oil pan made with PA66-GF35. This oil pan weights around 2.4 kg. Overall dimensions are  $580 \times 300 \times 75/160$  mm. Thickness of the base wall is 3 mm. Ribbing heights varies from 6-20 mm, ribbing thickness is 2 mm, rib spacing varies from 5-30 mm.

Figure 3 - Early version of the oil pan

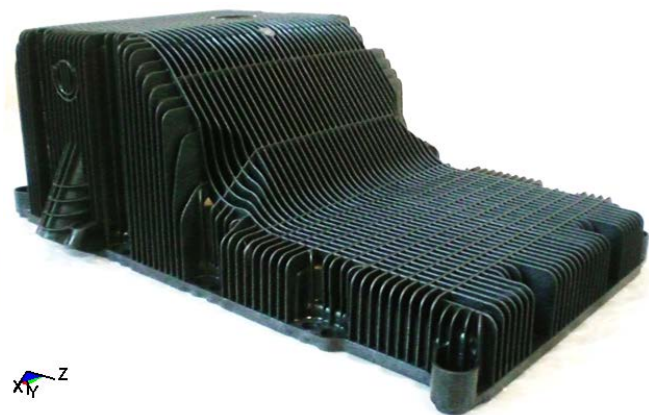
Figure 4 shows the last improved version of the oil pan made with PA66-i-GF35. This oil pan weights around 2.6 kg. Overall dimensions are  $580 \times 300 \times 60/200$  mm. Thickness of the base wall is 3 mm. Ribbing heights varies from 10-20 mm, ribbing thickness is 2 mm, rib spacing varies from 5-15 mm.

Figure 4 - Improved version of the oil pan

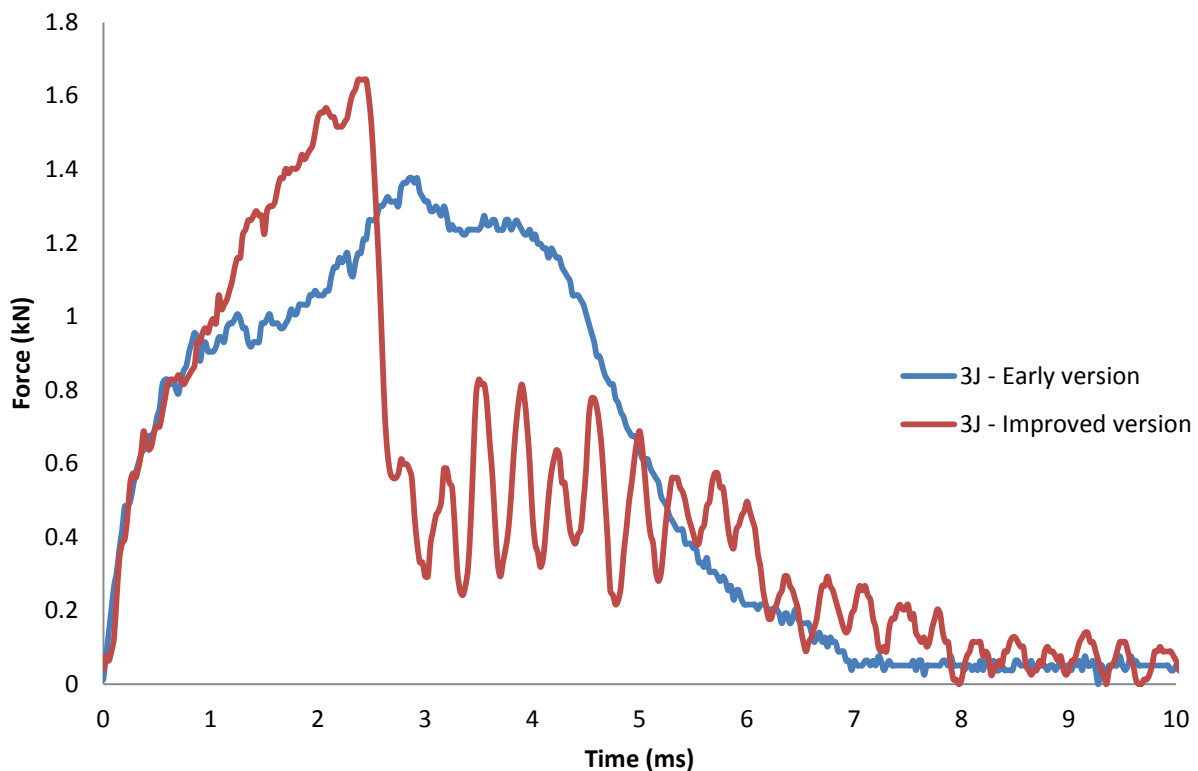
Figure 14 shows forces histories of each structure impacted at 3 J (drop tower) in the middle of a rib spacing in Area (B) on the pan section. In the early version, Z-axis ribs height is 10 mm and X-axis ribs height is 5 mm; spacing between Z-axis ribs is 15 mm and between X-axis is 25 mm. Therefore a 10 mm surface impact directly hits the wall. In the improved version, Z-axis and X-axis ribs heights are 10 mm and spacing between Z-axis ribs is 8 mm and between X-axis ribs is 15 mm. Consequently, a 10 mm surface impact inevitably hits the ribbing. The 3 J impact on the early version can be described as follows, between 0-3 ms, the wall deflects. At 3 ms, the maximum deflection is reached for the given impact. From then, the wall pushes back the impactor. The 3 J impact on the improved version has a different scenario. The impactor touches the two Z-axis ribs which resist and slightly deflects till 2.4 ms. From then, ribs deflect and the impactor slightly penetrates in between thus the fall in the force. At 2.6 ms, ribs start to stop deflecting and at 3 ms the walls of the ribs begin to push back the impactor. The oscillation in the force can be interpreted by successive returns between each rib wall. At 3 J, no failure is observed on each structure.

Figure 14 - Forces histories for each design at 3 J

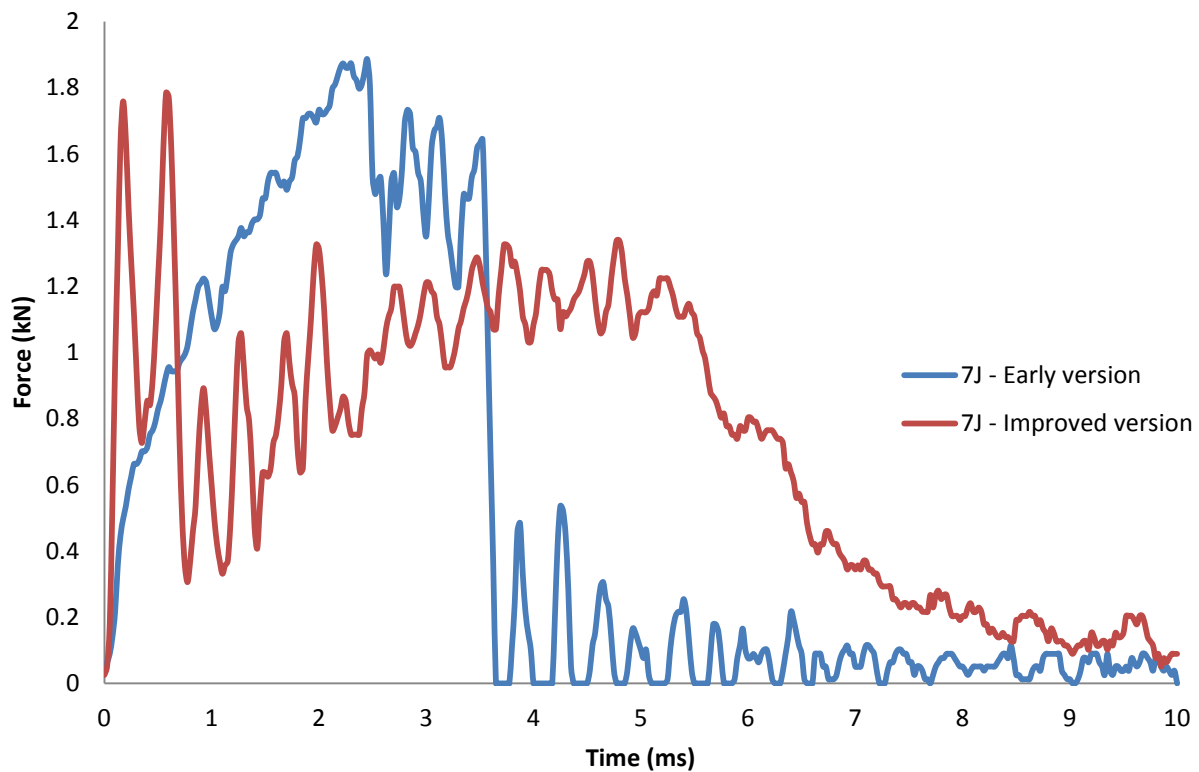
Figure 15 shows forces histories of each structure impacted at 7 J (drop tower) in the same area as before but on a blank spot of impact. In the 7 J impact on the early version, the wall deflects and begins to show signs of damage at 2.4 ms till it eventually fails at 3.5 ms. Crash appeared on both sides of the wall. In the 7 J impact on the improved version, the two ribs are successively touched and crushed till their walls stop to crush at 0.75 ms. From then, they resist, deflect and push back the impactor. No failure is visible on the wall but only damaged ribs. Figure 16 illustrates an example of a 3 mm crushed rib on the pick-up oil channel feature.

Figure 15 - Forces histories for each design at 7 J

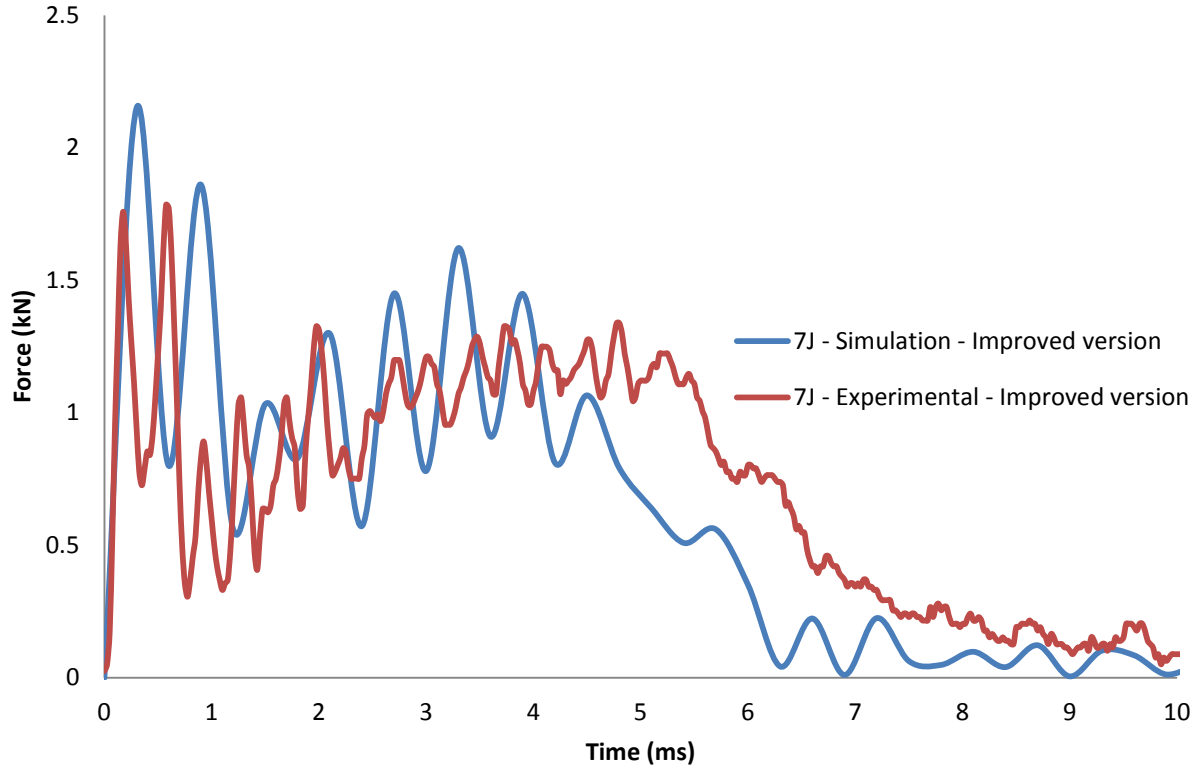
Figure 17 shows the correlation between 7 J experimental and simulated impacts on the same location of the improved version (PA66-i-GF35). The general look of each curve appears similar. However, forces in the model are overestimated at the beginning of the impact and underestimated towards the end. The model predicts around 20% more strength (2.15 kN instead of 1.76 kN) when the impactor tries to penetrate between the ribs and around 60% less towards the end (0.5 kN instead of 0.8 kN). However, the order of magnitude is correct and the model can be used to approximate the impact behaviour of the oil pan.

Figure 17 - Experimental and simulation forces histories on improved design at 7 J

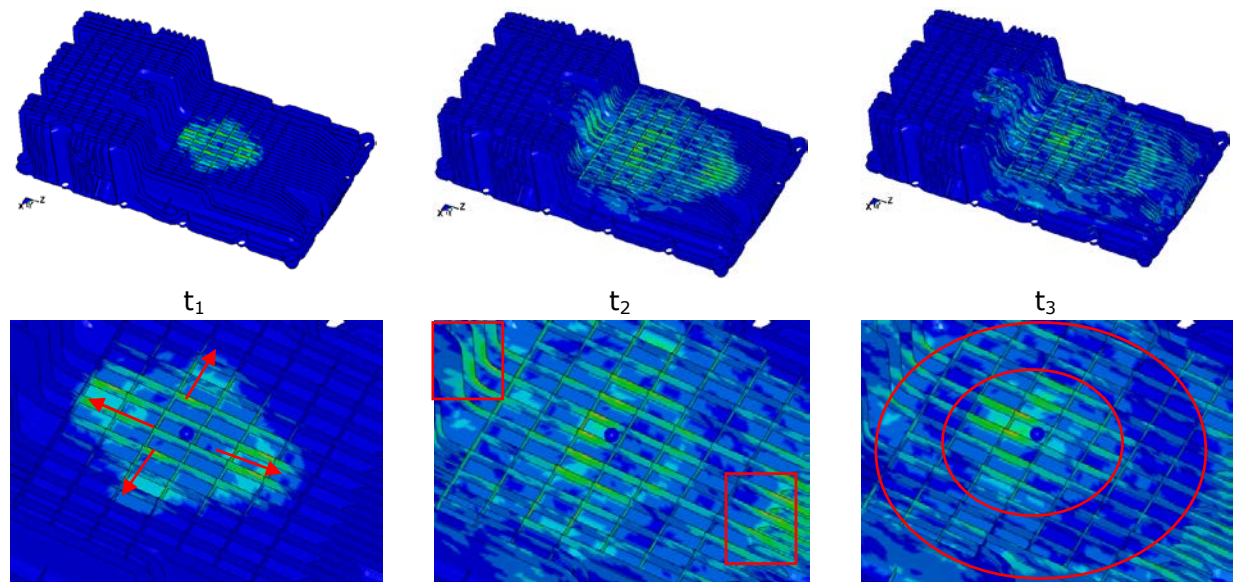
Figure 18 shows a 10 mm projectile impact sequence at 14 m/s with shock waves stress distribution propagating in circle away from the impact spot. At  $t_2$  when shock waves reach sharp edges, an accumulation of stress is created. The impact occurs in the base wall and the ribbing restrains the wall to deflect to a certain extent. The ribbing plays a major role in the stress distribution [19-20].

Figure 18 - Evolution of the stress undergone by the oil pan structure
