# Defect types.

# Chapter 3

## Defect Types

**Abstract** This chapter provides an overview of the common types of defects found in various structural materials and joints in aircraft. Materials manufacturing methods (including large-scale production) have been established in the aircraft industry. However, as will be seen in this chapter, manufacturing defects and defects during in-service conditions are very common across all material types. The structural material types include metals, composites, coatings, adhesively bonded and stir-welded joints. This chapter describes the defect types as a baseline for the description of their detection with the methods of Chap. 5 to 8. Based on the understanding of the defect types, there is great expectation for a technical breakthrough for the application of structural health monitoring (SHM) damage detection systems, where continuous monitoring and assessment with high throughput and yield will produce the desired structural integrity.

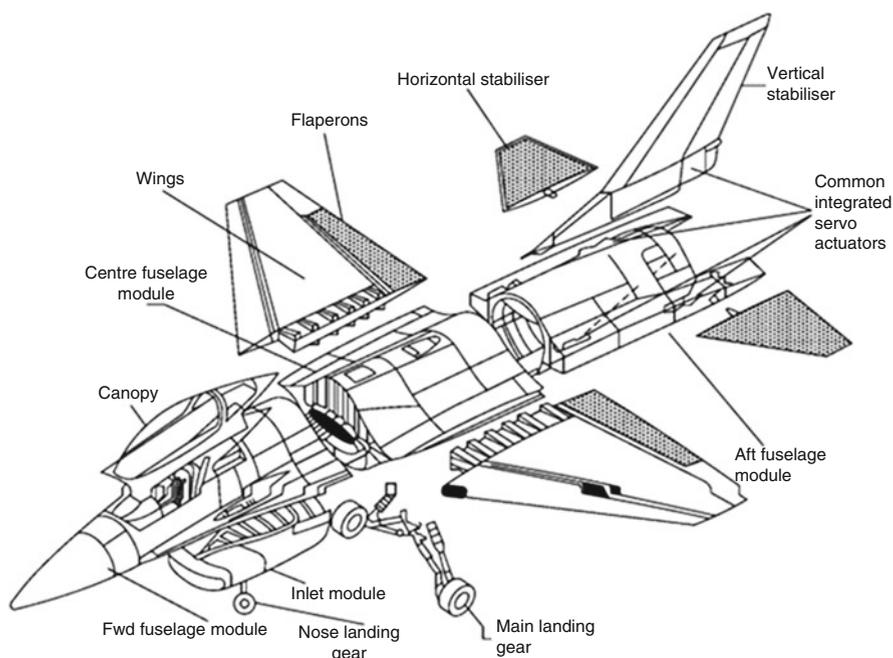
**Fig. 3.1** Main structural components of a modern military aircraft (Mouritz 2012a, 2012b, 2012c)

Load bearing aircraft structure is assembled and built using several major components such as fuselage, wings, engines and landing gear, as shown in Fig. 3.1. Among material types, metallic materials used in the aircraft structure manufacturing and assembly include aluminium, high-strength steel, titanium and superalloys (nickel, iron–nickel and cobalt-based alloys) with each possessing certain qualities that make them ideal for this use. Aluminium alloys have been the main airframe material. The attractiveness of aluminium alloys is that it is relatively low cost, lightweight, easily heat-treated to high strength levels and most easily fabricated with low costs. Titanium alloys can often be used to save weight by replacing heavier steel alloys in the airframe and superalloys in the low-temperature parts of gas turbines, and they are used instead of aluminium alloys when the temperature requirements exceed aluminium capabilities or when fatigue or corrosion has been a recurring problem. High-strength steels (HSS) are used for highly critical parts such as landing gear components. The main advantages of HSS are their high strengths and stiffness, but they are of high density and susceptible to brittle fracture. Superalloys are used extensively in jet turbine engines, when the temperature of exploitation excess 80% of the incipient melting temperatures while exhibiting high strength, good fatigue, creep resistance, good corrosion resistance and ability to work at high temperatures.

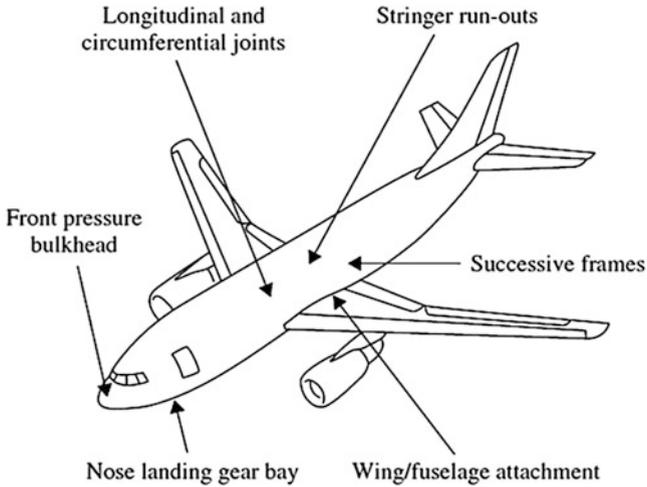
**Fig. 3.2** Common fatigue failure zones for Airbus A300 (Brand and Boller 1999)

Fatigue is the primary reason for failure in aerospace metals that occurs under repeated loads leading to premature failure of structural parts. If it is not detected in the early stages, it can cause catastrophic failures. It is usually characterized as the initiation and propagation of cracks to an unaccepted size. Fatigue is mostly controlled with stress history, material properties, chemical environment and manufacturing quality (Arrieta and Striz 2005). Table 3.2 shows a summary of the common fatigue causes observed in aircraft that have led to accidents, whereas Fig. 3.2 shows the structural areas prone to fatigue damage in early Airbus A300 design.

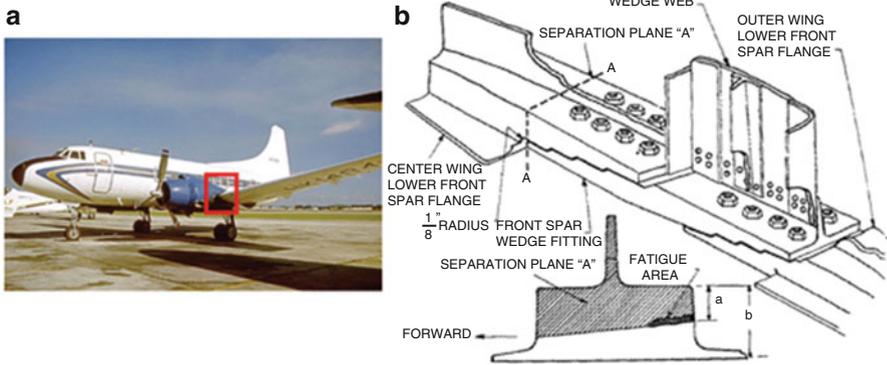
**Fig. 3.3** (a) A typical Martin 202 aircraft (produced by Glenn L. Martin Company during 1947–1948) with approximate fatigue location (in red box) (Ruth 1973), (b) schematic section of separation of lower flange showing fatigue are and also sudden increase of depth of flange ‘a’ to approximately twice the depth as indicated by ‘b’ (after Civil Aeronautics Board 1949)

the left-wing separation from the aircraft during thunderstorm related turbulence conditions. Investigations conducted by Civil Aeronautics Board revealed that a fatigue crack caused the detachment of outer wing (made of AA 7075-T6 alloy) from the rest of the wing. The aircraft design was not based on fail-safe approach at that time and this accident along with other Comet type aircraft failures led to the development of “Fail-Safe Design” approach (Tiffany et al. 2010; Ruth 1973). This approach is regarded as the extension of the safe-life concept in which the component or system is designed in a way that it will not fail within a specified period. After this period, the part is removed from the service. In Fail-Safe approach, however; in case of specific type of failure, the component or system should carry an honourable service load even after one of its components fail. In this approach, different from Safe-Life, the failure for specific part is possible, yet the system design prevents or at least mitigates the unsafe consequences of the system’s catastrophic failure. In other words, the part may fail yet it does not trigger the failure of other parts and, it remains as safe as it was before the failure (Mills et al. 2009; McBrearty 1956). Figure 3.3 shows the schematic for the wing root assembly failure for a Martin 202 aircraft.

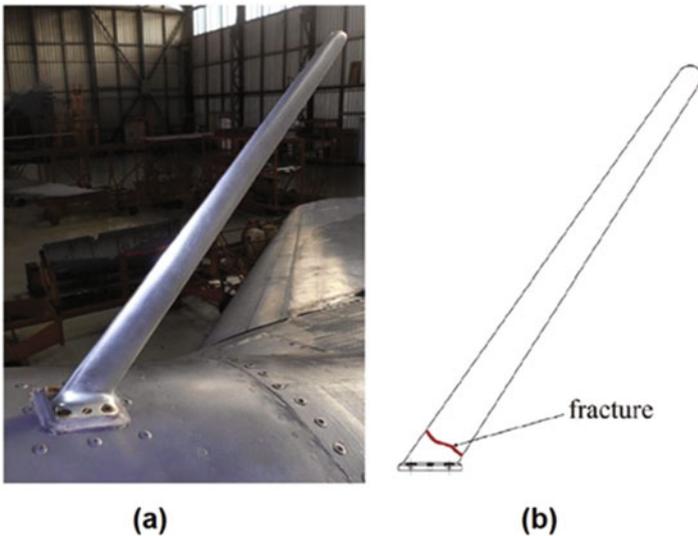
**Fig. 3.4** Fractured ADF antenna of a military aircraft (a) location of antenna, (b) breaking line (Rebhi et al. 2018)

More recently, Rebhi et al. examined the reason for the fracturing of the ADF antenna placed just behind the cockpit of a military aircraft (Rebhi et al. 2018). Figure 3.4a shows the ADF antenna location on the aircraft while Fig. 3.4b shows where it breaks. Note that the upper portion of the antenna was fractured because of the fatigue initiated by the corrosion pits. The crack origin was found to be at the outer surface on the antenna by tracing back the beach mark Fig. 3.5.

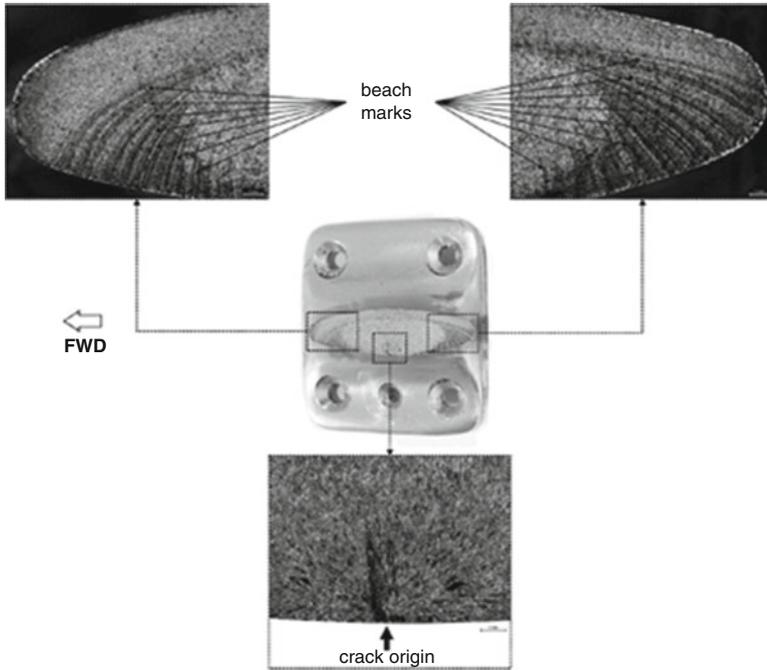
Fig. 3.5 Fractured surface of the ADF antenna (Rebhi et al. 2018)

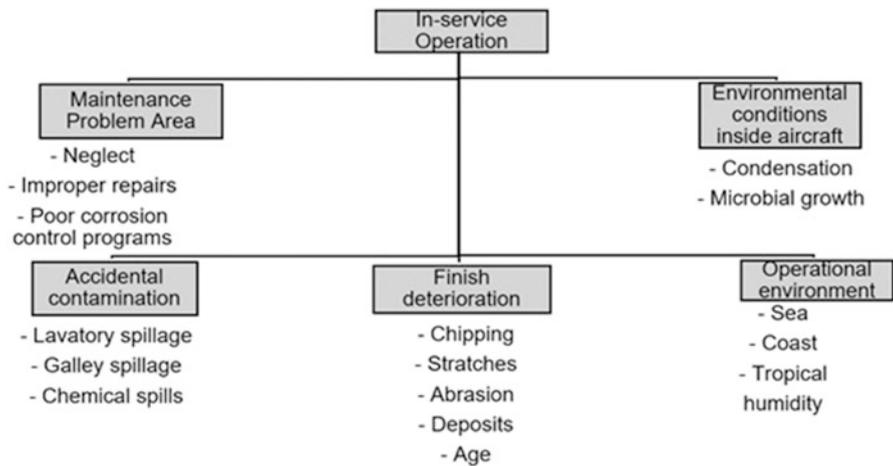
Fig. 3.6 Common sources of corrosion during in-service operation of aircraft (after Mouritz 2012a)

Corrosion-related expenses are estimated as big as 2.2 billion USD (Mouritz 2012a). It is commonly agreed that if corrosion issues are eliminated, maintenance of aircraft can be simplified. Many sources are available for corrosion during in-service phase of aircraft as illustrated in Fig. 3.6.

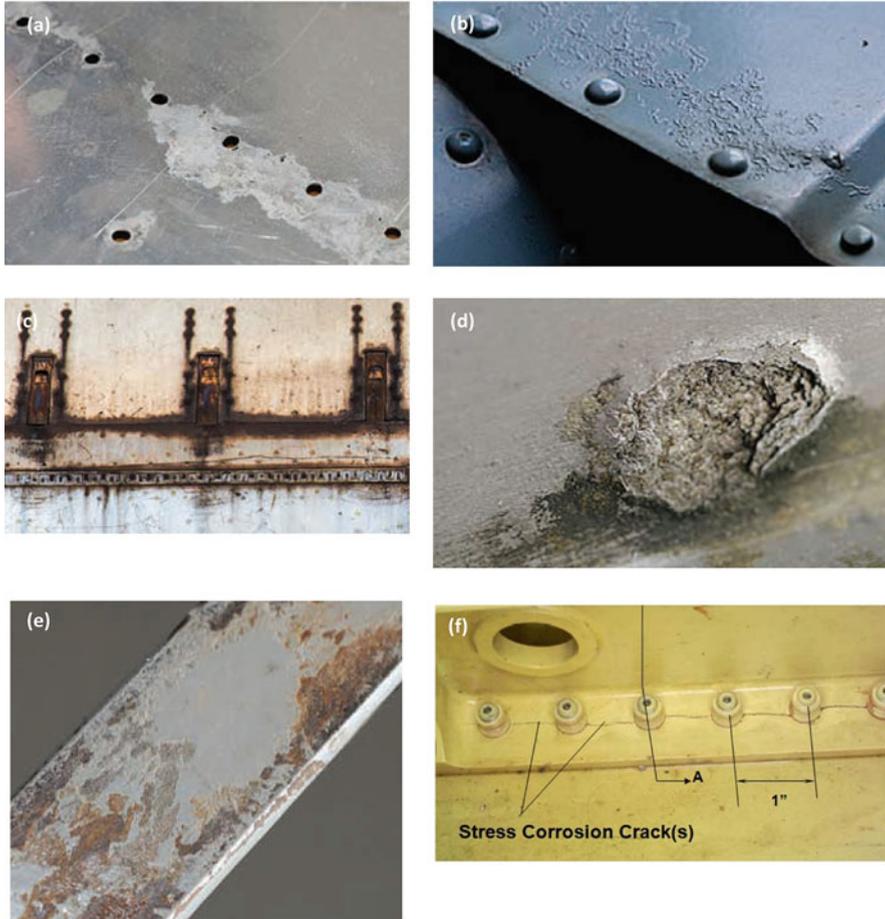
**Fig. 3.7** Different forms of corrosion: (a) general surface corrosion, (b) filliform corrosion, (c) galvanic corrosion, (d) exfoliation corrosion, (e) fretting corrosion (Aeronautics Guide, Forms of Corrosion 2019), and (f) stress corrosion cracking (Snyder, 2014)

- d. Exfoliation corrosion: Similar to stress corrosion it follows the grain boundaries and causes a leaf-like separation of the metal grain structure (Fig. 3.7d). It reduces the load-carrying capacity of aircraft parts, and the best way to combat with it is to use material with grain structure resistant to exfoliation.

- e. Filiform corrosion: It results from poorly prepared polyurethane paints and appears as worm-like lines under the paint that eventually lead to bubbling and flaking (Fig. 3.7b).

- f. Galvanic corrosion: This type of corrosion occurs by when two metals having different electric potentials are electrically connected via an electrolyte. It can be observed on aluminium–nickel–bronze bushing in an aluminium fitting in macro-scale, whereas one can notice it at the surface of an aluminium–copper intermetallic in micro-scale (Fig. 3.7c).
- g. Fretting corrosion: It is a corrosive attack when two mating surfaces have relative motion with each other, normally at rest. It is characterized by pitting of the surfaces and the generation of fine debris. As the restricted movements of the two surfaces prevents the debris from escaping easily, a highly localized abrasion occurs (Fig. 3.7e).

- h. General surface corrosion: It is the least destructive type of corrosion and also named as uniform surface attack (Fig. 3.7a). As the name implies, the metal is removed from surface uniformly and slowly in this case. Nevertheless, if it is not controlled for a long period, general corrosion may lead to structural failures (Aircraft Owners and Pilots Association [n.d.](#); Mouritz [2012a](#); Banis et al. [1999](#)).

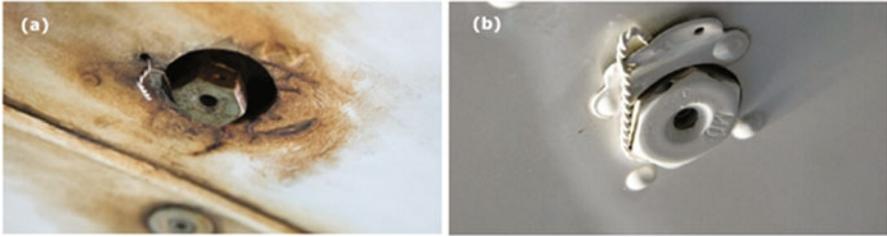
**Fig. 3.8** Corrosion marks on different metal parts (a) rust around steel bolt, (b) whitish/gray dulling on an aluminium surface (Aircraft Owners and Pilots Association [n.d.](#))

The visible sign of corrosion for aluminium and steel are quite different (Fig. 3.8). The steel surfaces are covered with reddish colored rust usually while aluminium corrosion is characterized as a whitish or gray 'dulling', which may lead to severe pitting and eventual destruction of the metal.

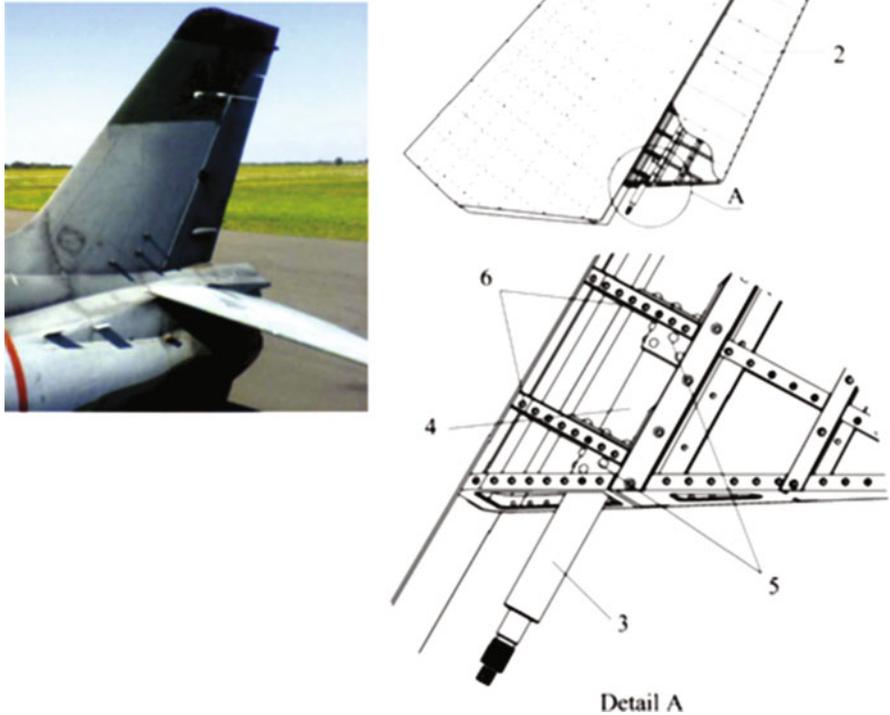
**Fig. 3.9** Empennage of an aircraft (on the left) and schematic illustration of the vertical stabilizer-rudder assembly (on the right): 1. Vertical stabilizer; 2. rudder; 3. rudder shaft; 4. torsional tube; 5. flange; 6. rib (Trifkovic et al. 2011)

Trifkovic et al. investigated a failed combat jet aircraft rudder shaft which is a component of the vertical stabilizer (Trifkovic et al. [2011](#)). The function of the vertical stabilizer is to prevent the yawing motion of the aircraft's nose. The components of the vertical stabilizer with rudder shaft are shown schematically in Fig. 3.9.

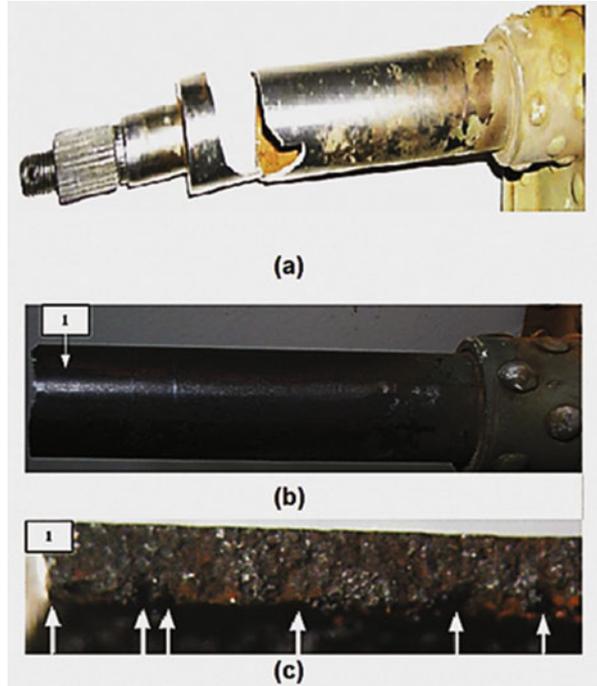
**Fig. 3.10** (a) Broken rudder shaft, (b) longitudinal crack formed on the outer surface and (c) sectioned view of the rudder shaft (Trifkovic et al. 2011)

The rudder shaft made of high strength St. 1.7784 steel failed because of pitting corrosion. Figure 3.10a shows the broken two pieces of the rudder shaft. To see the depth of the pits, the shaft sectioned from the longitudinal crack (shown with number 1), Fig. 3.10b. In Fig. 3.10c, corrosion pits formed in the inner wall are shown with arrows. It can be seen that these pits act as stress concentrators and result in early fracture of the shaft.

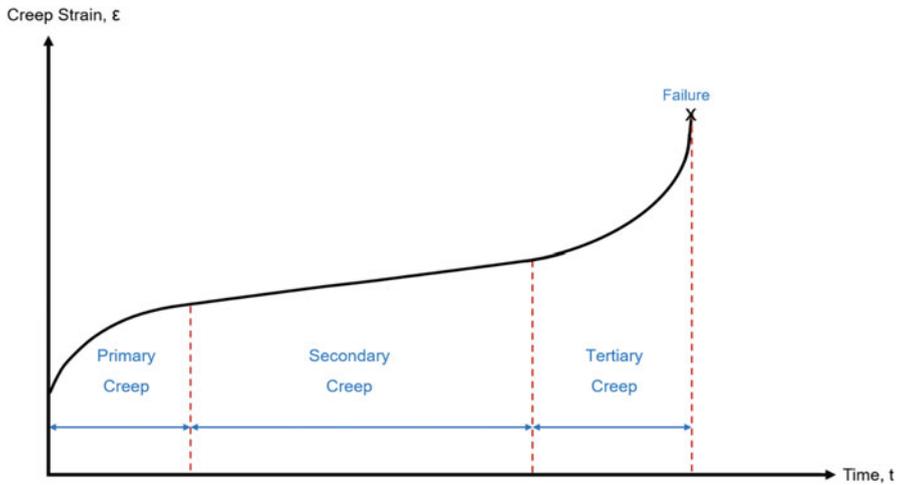
**Fig. 3.11** A typical creep curve and its progress

These stages have distinct behaviours with the function of the time and are illustrated in Fig. 3.11.

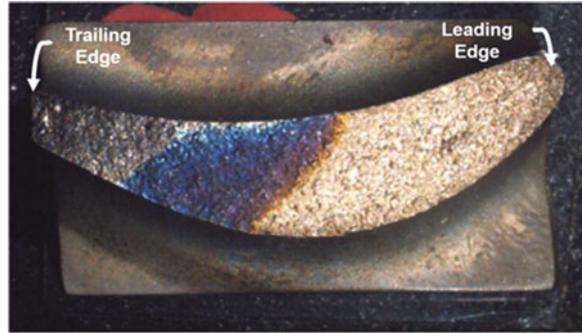
**Fig. 3.12** Fractured low-pressure turbine blade due to creep (Ejaz et al. 2011)

Creep is among the encountered failure types in aircraft engine components since those are exposed to extreme temperatures. If a rotating component in the aircraft engine is damaged, it will cause unbalance and lead to high vibration. This sudden increase in vibration can cause destruction in the engine in a very short time. Ejaz et al. conducted a study on the broken aircraft engine. They examined a low-pressure turbine blade made of Udimet 500 (a nickel–chromium–cobalt alloy) and found that primary cracking was initiated on the trailing edge of the blade due to creep; see Fig. 3.12 (Ejaz et al. 2011).

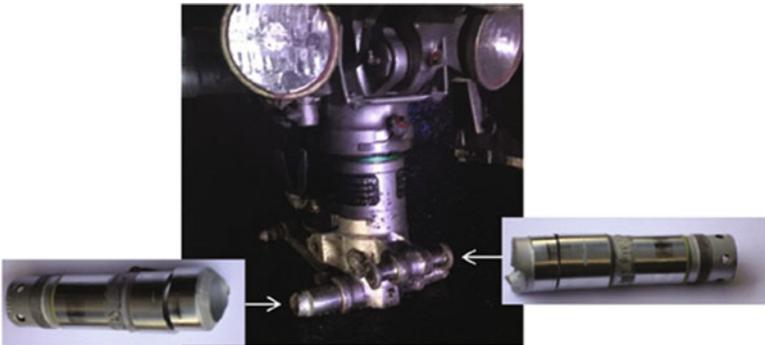
**Fig. 3.13** Fractured landing gear (Freitas et al. 2019)

Operational overload failure means that fast fracture of a material when stresses exceed the design stress of a material. Landing gears are the essential parts that undercarriage of an aircraft and are used for both takeoff and landing. It is well known that they are exposed to very high loads, especially at the time of landing. Freitas et al. (2019) showed a failed landing gear in Fig. 3.13. In this case, the aircraft experienced a hard landing due to the severe weather conditions, and the nose landing gear fractured into three pieces. Microscopic examination revealed ductile fracture characterized with dimples on the fractured surfaces (Fig. 3.14). These dimples are the main characteristics of the overloading failures and are due to the coalescence of microvoids during plastic deformation (Freitas et al. 2019).

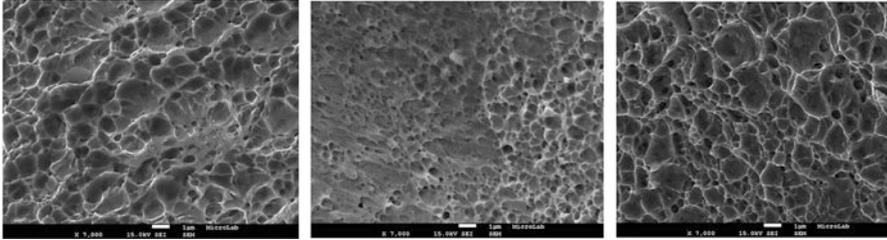
Fig. 3.14 SEM fractographs of the dimples on the fractured surfaces (×7000) (Freitas et al. 2019)

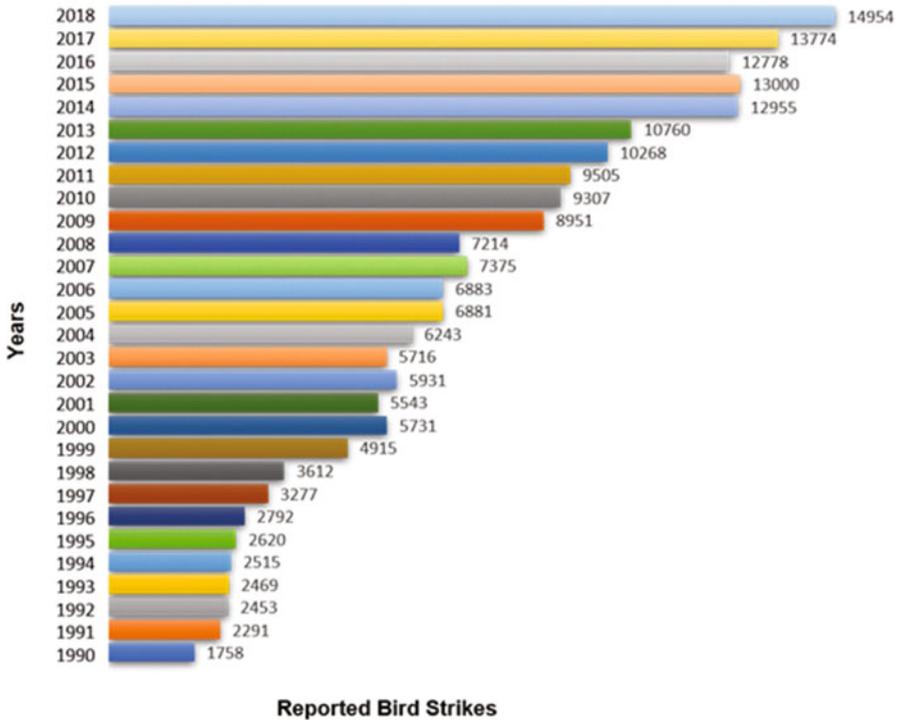
Fig. 3.15 Reported bird hits to civil aircraft from 1990 to 2018 in the USA (Dolbeer et al. 2019)

aircraft between 1990 and 2018 in the United States is given in Fig. 3.15. The number has been increasing over the years. In total, 202,472 bird strikes reported between 1990 and 2018, and almost 16% of these strikes damaged the aircraft (Dolbeer et al. 2019). The specific regions of planes that are susceptible to bird strikes are given in Fig. 3.16.

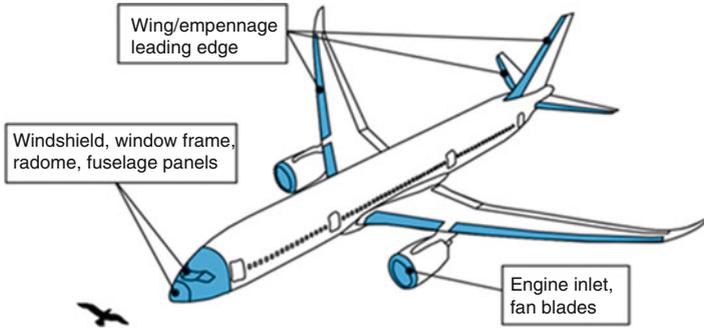
**Fig. 3.16** Risky regions for bird strikes (Heimbs 2012)

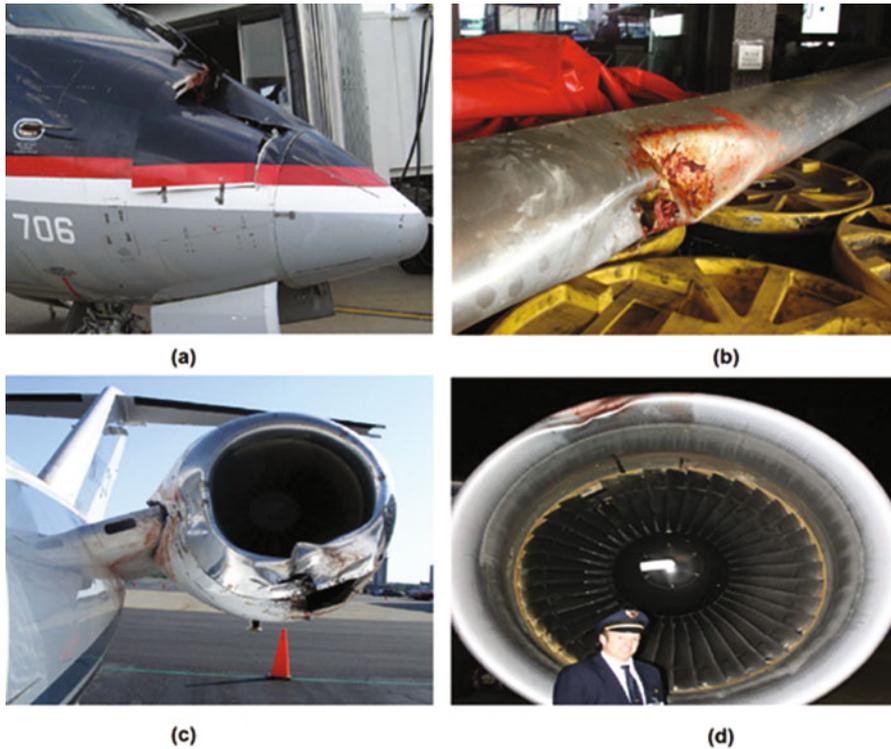
**Fig. 3.17** Examples of bird strike aircraft accidents: (a) CRJ Jet crashed by a black vulture, (b) the leading edge of the left wing of a B-737 hit a great blue heron, (c) A Cessna 525 en-route at 5000 feet above ground level was hit by a flock of white-winged scoters and (d) a Boeing 767 was struck by a flock of canvasback ducks at 800 feet (Dolbeer and Wright 2008)

Figure 3.17 shows some bird strike cases that happened in 2007 and caused significant damages to the aircraft. A black vulture crashed into the nose cone of

CRJ-700 on the final leg to the airport and caused severe damage as it can be seen in Fig. 3.17a. In another instance, a great blue heron struck to the left wing leading edge of the Boeing 737 on approach to the airport (Fig. 3.17b). A flock of white-winged scoters struck to both engines of Cessna 525 at 1500 m altitude (~5000 feet), and engine casing was damaged (Fig. 3.17c). In another instance, a flock of canvasback ducks hit to engines of Boeing 767 at 800 feet. The visual inspection revealed that fan and compressor blades in Engine #1 were seriously damaged (Fig. 3.17d) (Dolbeer and Wright 2008).

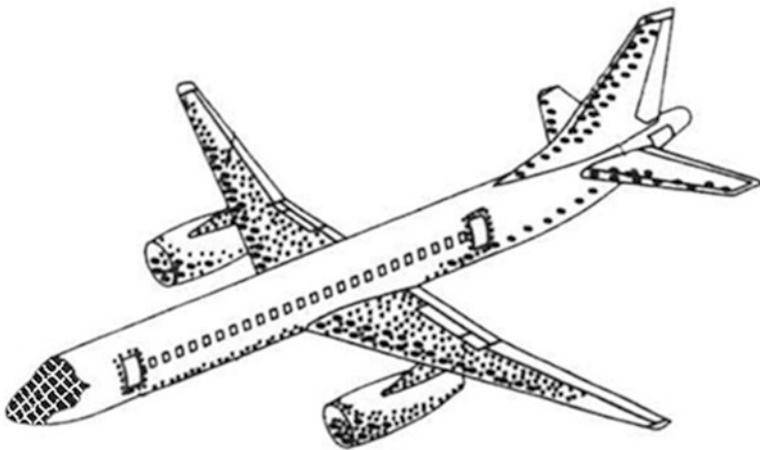
**Fig. 3.18** Critical regions for erosion on a commercial aircraft (Kutyinov and Ionov 1996)

Wear is simply defined as some degree of material loss from the surface. These are adhesive, abrasive, fatigue, impact, chemical (corrosive), electrical-arc-induced wear and fretting wear. Erosion is examined under the impact wear and occurs by impingement of sand, rain, volcanic ash and other particles to the aircraft during service. It gradually reduces the life cycle of the components. Particular regions of planes are more prone to erosion on air. Figure 3.18 illustrates these regions. The regions indicated by the smaller dots are exposed to lower speed object impacts and bigger dots are for the medium speed object impacts. The hatched region (nose of aircraft) corresponds to objects with higher speeds (Kutyinov and Ionov 1996).

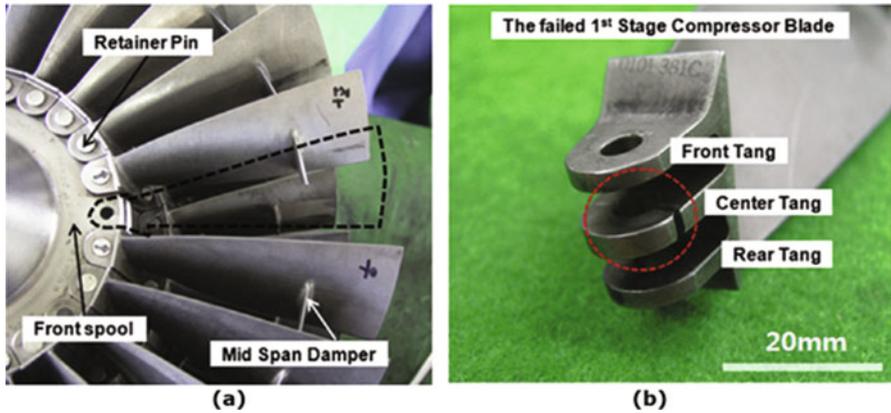
**Fig. 3.19** (a) Failed compressor blade and (b) detailed view of the fractured pinhole lug (Lee et al. 2011)

After a detailed inspection, it was observed that the center tang of a pinhole lag was fractured due to fretting wear induced fretting fatigue (Fig. 3.19b) (Lee et al. 2011).

In engineering applications, bolted parts, shrink and press fits, couplings and bearings are particularly vulnerable to fretting wear. In the aircraft, the most commonly encountered fretting wear occurs in engine components and riveted structural connections. Lee et al. analyzed the failed first-stage compressor blade shown in Fig. 3.19a. In this case, an emergency landing was made due to an engine problem.

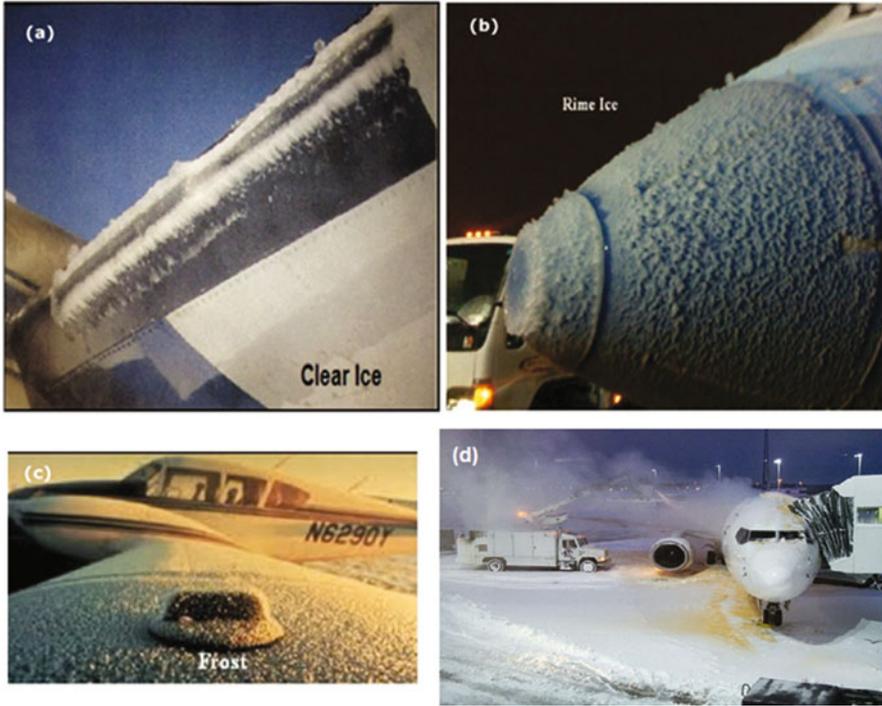
**Fig. 3.20** Examples of effect of extreme weather conditions on aircraft: (a) clear ice formation on the leading edge of an aircraft wing, (b) rime ice on radome of an aircraft, (c) frost formation on a wing (US National Oceanic and Atmospheric Administration *n.d.*) and (d) deicing of an aircraft (Hartman 2008)

Ice is collected primarily on antennas, propeller blades, horizontal stabilizers, rudder and landing gear struts, and it disrupts the function of wings, control surfaces and propellers, windscreens and canopies, radio antennas, pitot tubes, static vents and air intakes. Turbine engines are especially vulnerable as ice forming on the intake cowling constricts the air intake (US National Oceanic and Atmospheric Administration n.d.). Figure 3.20 shows various forms of icing conditions on aircraft parts and a typical deicing operation, which is usually performed by applying heated glycol diluted with water.

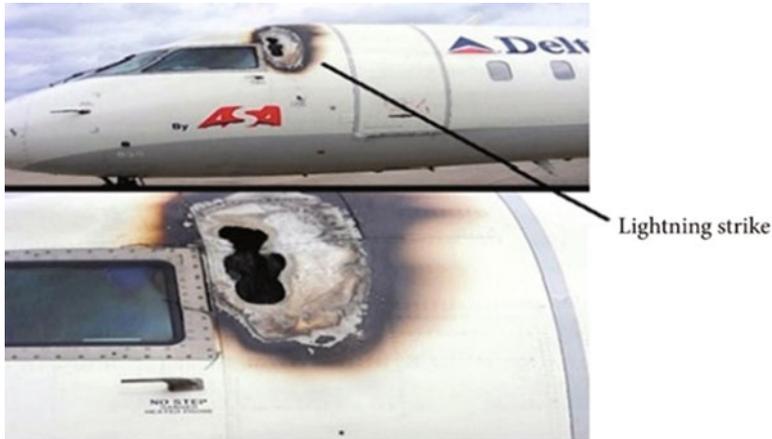
**Fig. 3.21** Lightning strikes damage to a regional jet (Alemour et al. 2019)

In 1967, Pan American Airlines Flight 214 was a Boeing 707 flying from San Juan in Puerto Rico to Philadelphia with a stop in Baltimore. The aircraft suffered a lightning strike upon taking off from Baltimore heading to Philadelphia, in which lightning-ignited vapours in the fuel tank led to an inflight explosion, totally destroying the aircraft and killing all aboard. Since then, lightning protection techniques have been improved tremendously. Nowadays, airplanes should be certified to verify the safety of their designs against lightning. As aircraft materials vary, their response to lightning differ. For example, Aluminium is a highly conductive material and, even in the worst-case scenario, the 200,000 A jolt can be quickly conducted away. However, for less-conductive materials such as carbon fibre composites or non-conductive fibreglass, lightning strike protection becomes more critical (Sweers et al. 2014; Black 2013; Rupke 2006). Figure 3.21 shows a lightning damage to a regional jet fuselage.

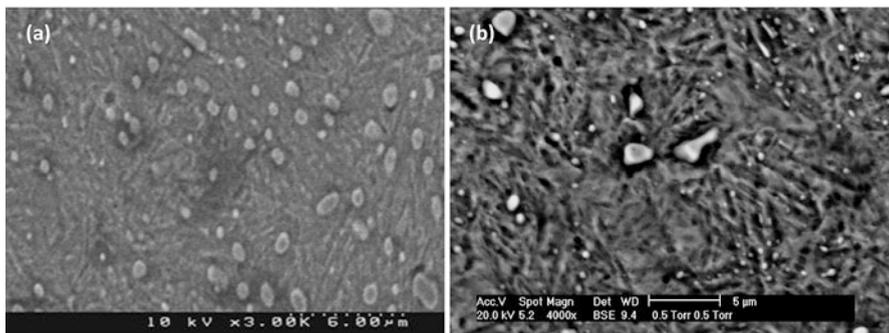
**Fig. 3.22** Martensitic steel surface (polished and etched surface) showing lathes and coarse carbides, with dark zones or microvoids between carbide particles and martensitic matrix (Faisal et al. 2011b)

of the high strength hardened steel showing spheroidal carbide particles dispersed in a martensite matrix phase, which itself probably contains some smaller temper carbides. Small spheroidal carbides observed in Fig. 3.22 or many high-carbon martensite structures are considered routine (Faisal et al. 2011a). However, grain-boundary carbides, massive carbides that occur on edges and corners are deemed detrimental to mechanical properties and should be avoided. While carbides are harder than the surrounding matrix (martensite/austenite), they do not always have an appreciable effect on micro-hardness (e.g. Vickers or Rockwell). Carbides are known to enhance wear resistance.

Undercarriage materials (e.g. landing gear) are expected to have high static and dynamic strength, fracture toughness, including fatigue strength. Arguably, the most used materials for load bearing part in aircraft is high-strength steel. The critical components of one of the largest landing gear assembly in commercial service (Airbus Industrie A330 and A340 passenger aircraft) are made from tempered martensite (Bhadeshia 2006). As an example, Fig. 3.22 contains the micro-structure

In the high-strength hardened steel, the carbides are much harder than the tempered martensitic surrounding matrix so that any plastic deformation gets concentrated in the surrounding matrix and is impeded by the carbides (Blaha et al. 2002), leading to an accommodation mechanism including plastic deformation and carbide cracking (Girodin et al. 2002). The details of this failure mechanism may not be visible at the microscopic magnifications normally used in conventional material testing and optical analysis, although some evidence of failure at the carbide–matrix interface can be visible for some of the larger particles using acoustic emission (AE) sensors during contact mechanics study (Faisal et al. 2011a) (e.g. Fig. 3.22).

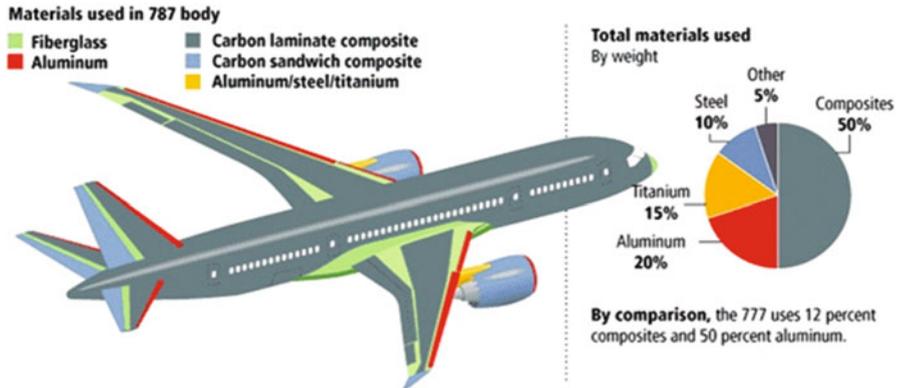
**Fig. 3.23** Composites and other structural materials used in aircraft construction. Example: Boeing 787 body (Rosato 2013)

behaviour in special current and future applications in the aerospace industry. Recently, fibre-reinforced polymer composites are developed and used in the aerospace, especially carbon- and glass-fibre-reinforced plastic (CFRP and GFRP respectively) that consist of carbon and glass fibres, both of which are stiff and strong (for their density), but brittle, in a polymer matrix, which is tough but neither particularly stiff nor strong. Metal and ceramic matrix composites remain important materials, e.g. fiber metal laminates, in particular glass fiber reinforced aluminium laminates (GLARE) of high fatigue performance or carbon-carbon (CC) composites as ceramic matrix composite for high temperature applications. An example of *use of composites in aircraft design* is presented in Fig 3.23.

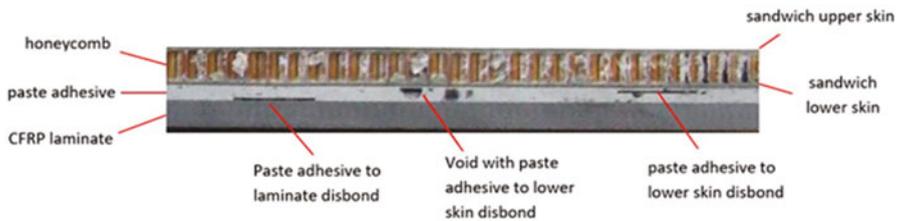
**Fig. 3.24** Section of honeycomb sandwich structure bonded to CFRP laminate (either spar or rib) by paste adhesive showing several disbond issues

Poor surface preparation is one of the leading causes of adhesively bonded joint failures. The creation of porosity and voids can also degrade the adhesive properties, as well as, create stress concentration during loading. During service, disbond can occur due to excessive stress applied at the bonding interface, impact damage, environmental degradation such as moisture ingress and aging of the adhesive layer (US Department of Transportation, FAA-AR-09-4 2009 (Tomblin, Seneviratne and Pillai, 2009)). Disbond can be found in any bonding surface, some of the examples include laminate/metal or laminate/laminate bonding surface, laminate skin to core (honeycomb or foam) bonding surface in sandwich structure and core to the core in multiple sandwich structure. Typical disbonds are shown in Figs. 3.24, 3.25, 3.26, and 3.27.

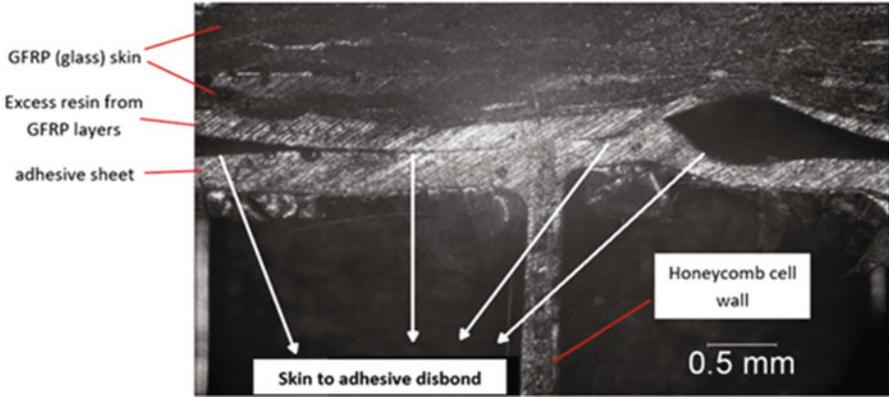
**Fig. 3.26** Honeycomb sandwich structure—disbond between the adhesive layer and the GFRP skin

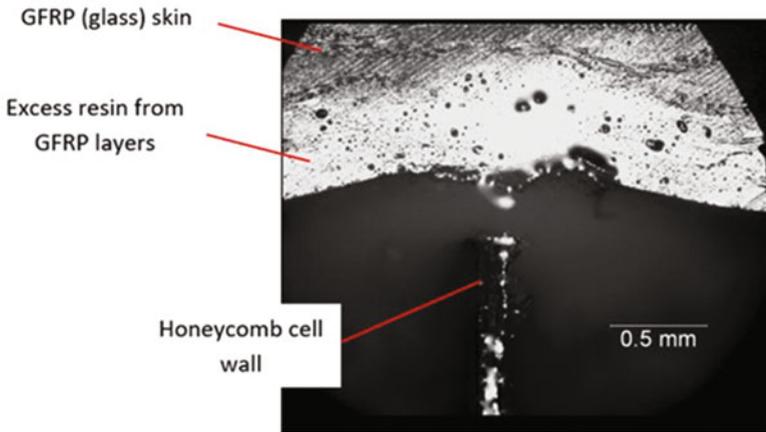
**Fig. 3.27** Honeycomb sandwich structure - disbond between the honeycomb cell wall and the GFRP skin, and porosity bubbles are also visible within the excess resin

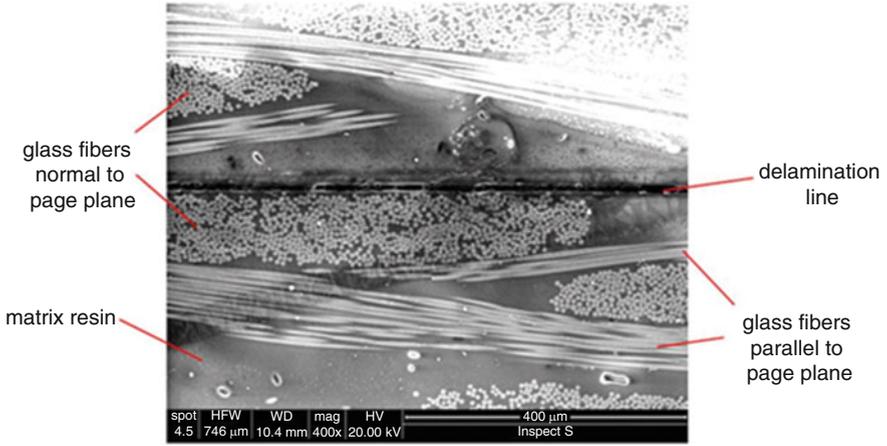
**Fig. 3.29** SEM view of delamination within a GFRP plain weave laminate; Average fibre diameter is 5–7μm

In-service delamination may be due to temperature cycling, local loads, impacts and fatigue. Failure due to delamination often initiates from free edges, surface defects and stress concentration points, which leads to the loss of overall stiffness/strength and under compressive loading leads to reduced buckling load limits (Vorontsov et al. 1990). Delaminations can also occur at free edges, in which a local three dimensional stress state phenomena plays an important role. Mainly explained by the mismatch of the elastic material properties between two adjacent dissimilar laminate layers, the free-edge effect is characterized by the concentrated occurrence of three-dimensional and singular stress fields at the free edges in the interfaces between two layers of composite laminates (Mittelstedt and Becker 2007). Several delamination cases are shown in Figs. 3.28, 3.29, and 3.30.

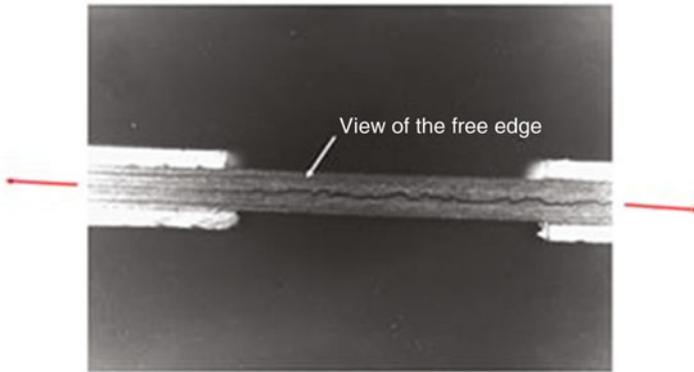
**Fig. 3.30** Free edge delamination of a  $[0_2, +45, 0_2, -45, 0, 90]_s$  laminate under tension loading

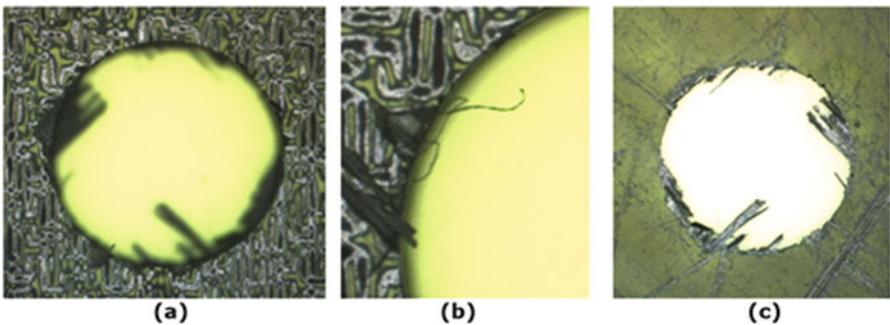
**Fig. 3.31** Drilling of composite GFRP: Input (a, b) and output (c) surface of the hole with clearly visible delamination and extracted fibres

Defects in the composites may also occur during other processes, e.g. during drilling (Figs. 3.31 and 3.32), where delamination and extracted fibres are visible (Tyczynski, Śliwa, Ostrowski 2015).

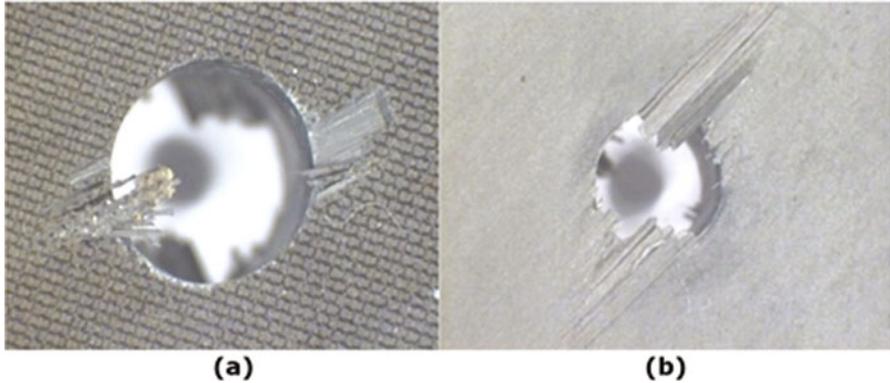
Fig. 3.32 Delamination in a carbon composite CFRP: (a) multidirectional (b) unidirectional

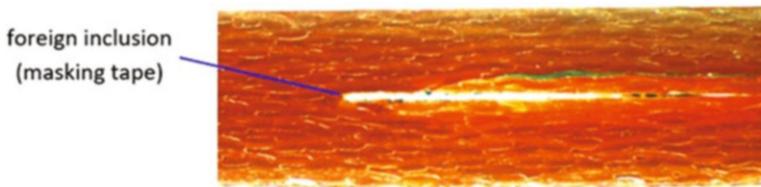
Fig. 3.33 Stereoscopic microscopic view of foreign inclusion (masking tape remaining) within GFRP laminate

(b) masking tape, (c) flash breaker tap and (d) peel ply that is an extra layer of synthetic material (glass, nylon or other) which is laid upon the outer surface of the composite during fabrication. This layer is intended to be peeled off in a subsequent bonding step before bonding. Several foreign inclusion examples are shown in Figs. 3.33 and 3.34.

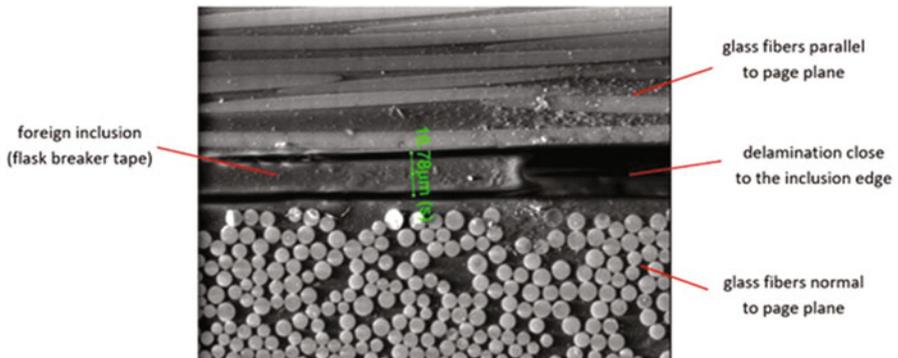
Fig. 3.34 SEM of foreign inclusion (flask breaker tape remaining) within a GFRP laminate; The upper ply has glass fibres oriented in the plane of the picture, whereas the lower glass ply has fibres normal to the picture plane. The average fibre diameter is 5–7µm

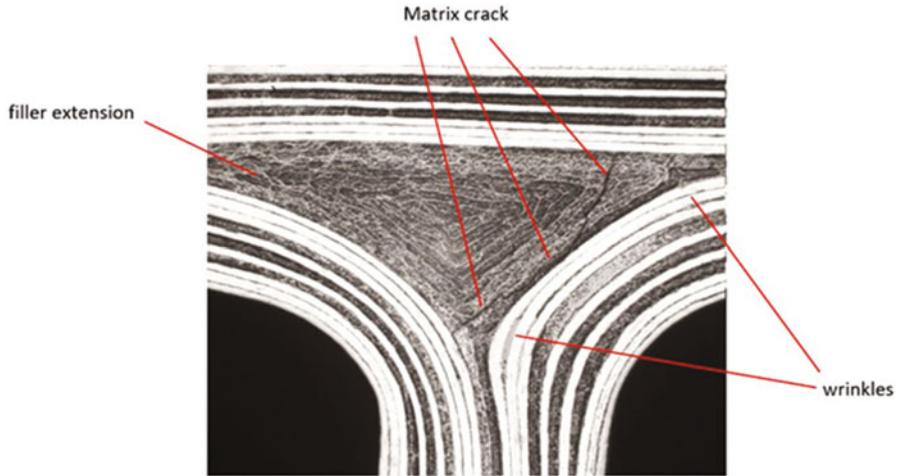
**Fig. 3.35** Interfiber matrix cracking in CFRP T-shape radius filler made of unidirectional graphite fibres embedded within resin; The part that experienced a misprocess during fabrication is geometrically distorted and shows besides the crack two wrinkles on the right side and filler extension on the left side

Matrix cracking is both a manufacturing and in-service defect (Fig. 3.35). It is characterized by cracks within the resin cementing the fibres of a laminate structure. It is often caused by mechanical stress lateral to the direction of the fibres, either during manufacturing or in-service. It is usually the first damage to occur when a composite laminate is subjected to mechanical stress such as quasi-static/cyclic tensile loading (Gayathri et al. 2010). Matrix cracking is characterized by damage in one or more layers without reaching the opposite surfaces. It turns into ‘fracture’ when the damage extends through the entire layers of the laminate.

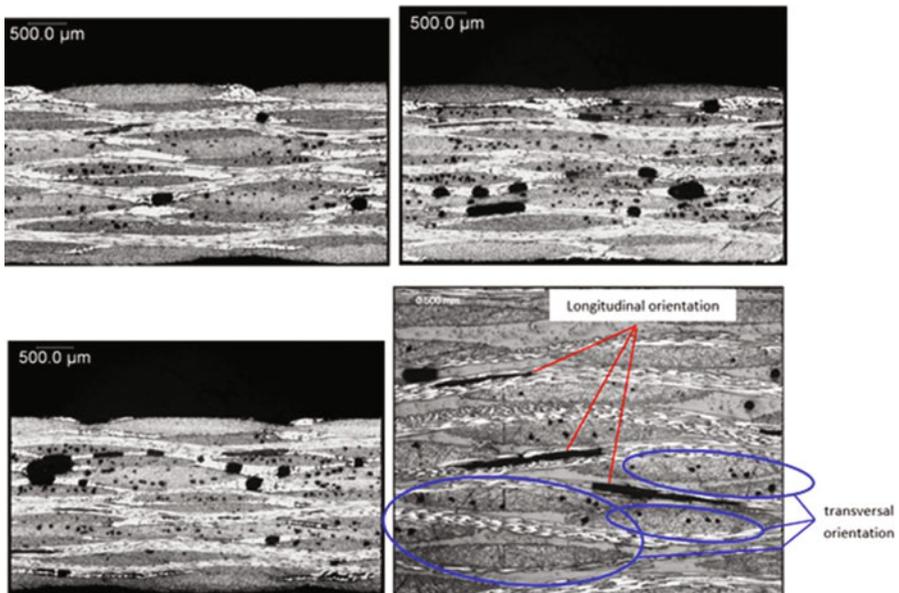
**Fig. 3.36** Sections of CFRP laminates with porosity. Porosity bubbles tend to align with fibre orientation and thus often appear either in transversal or longitudinal direction

Porosity in composites is a manufacturing defect caused by incomplete gas microbubbles outflow from the part during the process. A part of the microbubbles that should leave the part remains stuck to the layers and/or bonding interfaces and often combine to form discrete bubbles (Fig. 3.36). The discrete bubbles themselves can also combine and lead to macroscopic delamination or disbond. Porosity is generally defined per volume percentage. High porosity level (several percent) critically affects mechanical properties and thus aviation companies tend to severely limit porosity level to low values on critical parts (1.5% or 2% maximum). When the porosity level is high, the individual gas microbubbles often merge into voids. Actually, porosity and voids affect compressive, shear and bending strengths, which are dominated by the matrix properties. They also act as stress concentration points and possible damage initiation sites (Rubin and Jerina 1995).

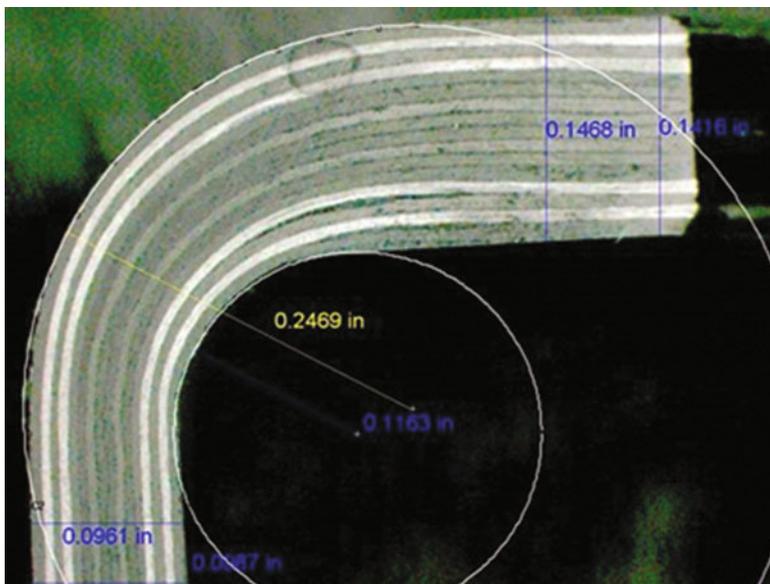
Fig. 3.37 Laminate non-uniform thickness in composite CFRP radius

Apart from the defects mentioned above, composite laminate may have other defects such as non-uniform laminate thickness and wrinkles or waviness. Non-uniform laminate thickness is a typical manufacturing defect generally related to non-uniform pressure or moulding tool misplacement during fabrication. An example of non-uniform laminate thickness in radius is shown in Fig. 3.37. Wrinkles (waviness) is also a typical manufacturing defect generally related to uncontrolled layer displacement during processing. Wrinkles can significantly affect the mechanical properties of composite laminates. A typical laminate wrinkle in a radius is shown in Fig. 3.38. Waviness can be formed during the cool-down phase of composite

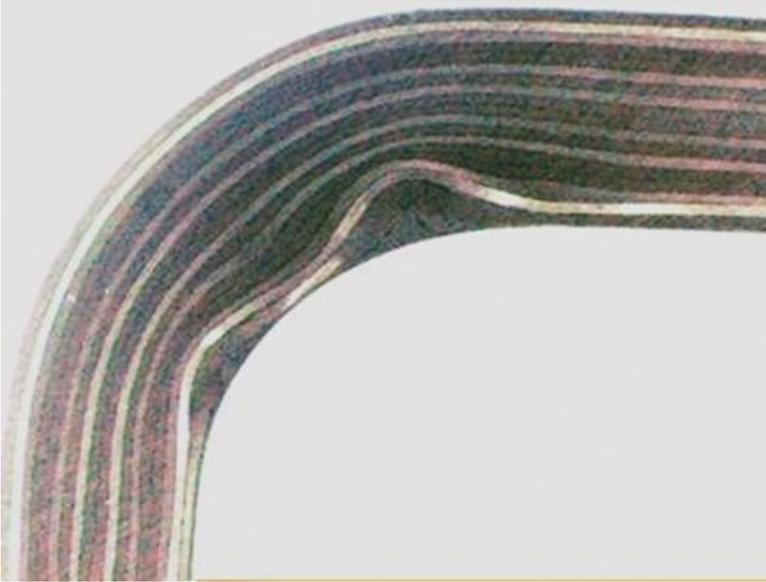
**Fig. 3.38** Laminate wrinkles in composite radius

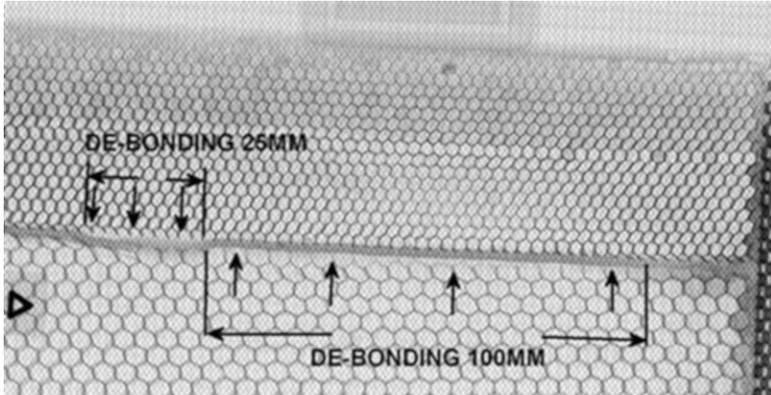
Fig. 3.39 X-ray radiography of honeycomb core to core disbond

Apart from honeycomb to laminate disbond mentioned above, honeycomb cores may also suffer additional defects (see Figs. 3.39, 3.40, 3.41, and 3.42) that may occur both at manufacturing or in-service steps as defined: (a) honeycomb to honeycomb disbond in multicore structures, (b) condensed core that is a lateral distortion of the size of the cells relative to their axis, (c) buckled core that is a general lateral shift of the cells relative to their axis, (d) crushed core that is a collapse of the core parallel to the cell axis and (e) torn core that is characterized by cell breaking in a perpendicular direction to the cell axis, and this defect is often related to excessive core crushing.
