# Defect types.

# Chapter 3

## Defect Types

**Abstract** This chapter provides an overview of the common types of defects found in various structural materials and joints in aircraft. Materials manufacturing methods (including large-scale production) have been established in the aircraft industry. However, as will be seen in this chapter, manufacturing defects and defects during in-service conditions are very common across all material types. The structural material types include metals, composites, coatings, adhesively bonded and stir-welded joints. This chapter describes the defect types as a baseline for the description of their detection with the methods of Chap. 5 to 8. Based on the understanding of the defect types, there is great expectation for a technical breakthrough for the application of structural health monitoring (SHM) damage detection systems, where continuous monitoring and assessment with high throughput and yield will produce the desired structural integrity.

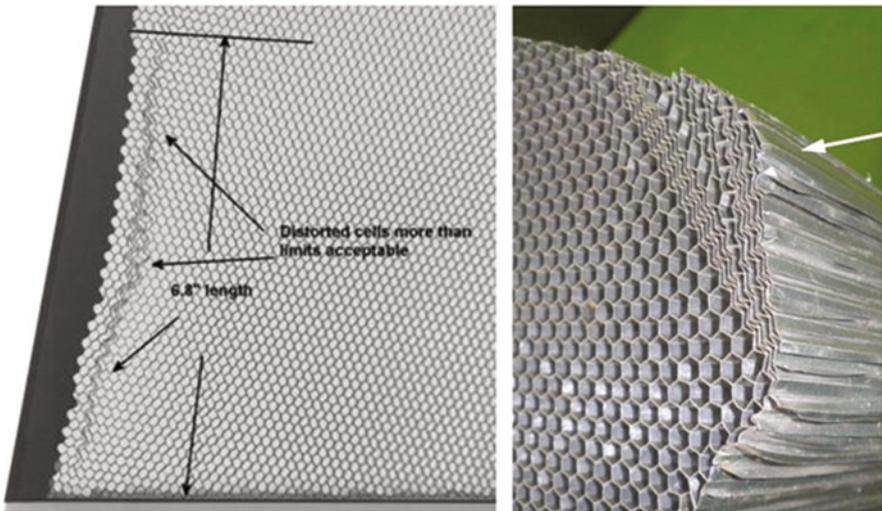
Fig. 3.40 X-ray radiography and visual examples of condensed honeycomb cores

Apart from honeycomb to laminate disbond mentioned above, honeycomb cores may also suffer additional defects (see Figs. 3.39, 3.40, 3.41, and 3.42) that may occur both at manufacturing or in-service steps as defined: (a) honeycomb to honeycomb disbond in multicore structures, (b) condensed core that is a lateral distortion of the size of the cells relative to their axis, (c) buckled core that is a general lateral shift of the cells relative to their axis, (d) crushed core that is a collapse of the core parallel to the cell axis and (e) torn core that is characterized by cell breaking in a perpendicular direction to the cell axis, and this defect is often related to excessive core crushing.

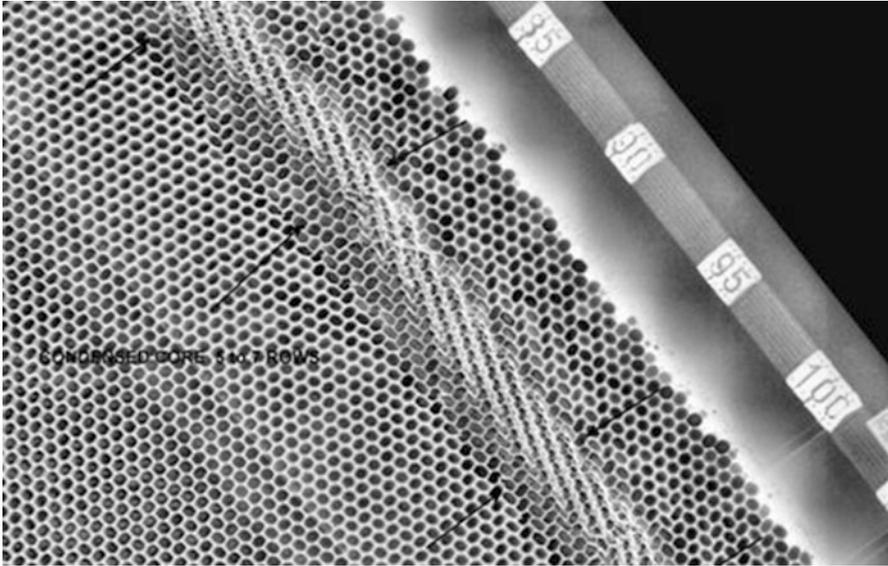
**Fig. 3.41** X-ray radiography and buckled honeycomb core

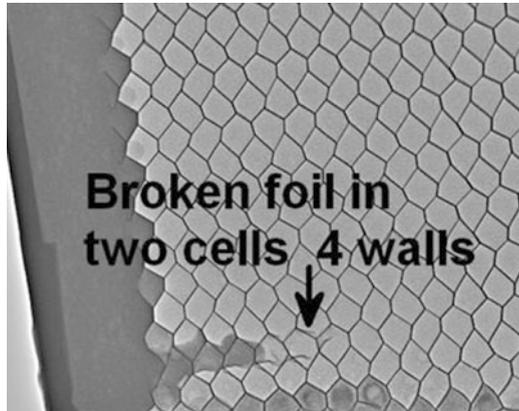
**Fig. 3.42** X-ray radiography and torn honeycomb core

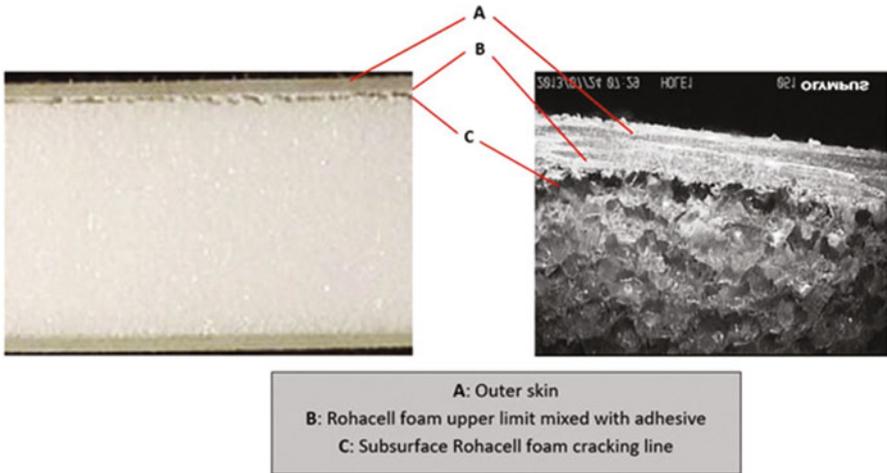
**Fig. 3.43** Rohacell foam core subsurface cracking; This is a typical foam core disbond. Disbond appears below the actual Rohacell foam to skin interface as subsurface cracking rather than at the rohacell foam outer limit that is mixed with an adhesive

Apart from foam to adhesive disbond defects mentioned above, foam cores may also experience other types of defects that may occur (see Fig. 3.43) both at manufacturing and in-service steps as defined: (a) core cracking that is generally related to excessive stress applied to the core and (b) core subsurface cracking that can be considered as a typical foam disbond defect. Since at bonding surface involving foam cores, an adhesive is always showing some slight penetration within the foam (less than 1 mm in thickness), the disbond appears within the foam just below the adhesive penetration line rather than at the foam limit line.

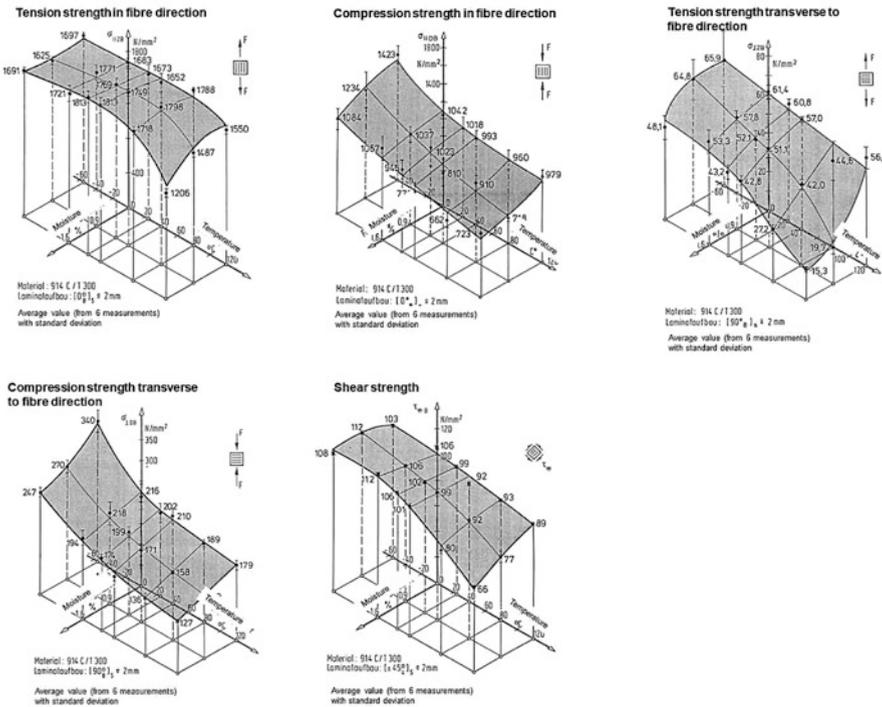
**Fig. 3.44** Influence of moisture and temperature on the material properties (T300, phi = 0.6, 914C) (Gädke 1988)

The material properties of fibre composites are also influenced by moisture and temperature. The effect is notably large at higher temperatures and moisture. Figure 3.44 shows the effect on the material properties obtained on small specimens (T300, fiber volume fraction = 0.6, 914C). The matrix 914C is one of the first generation used in aerospace. However, the general behaviour for different resin systems is similar.

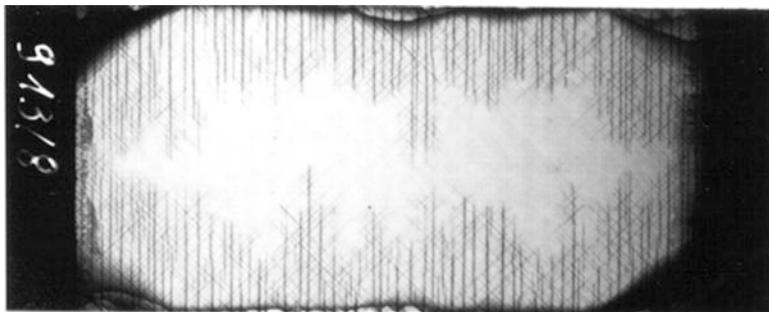
**Fig. 3.45** Characteristic crack muster of a  $[(0,+45,-45,90)_2]_S$  laminate under  $R = -1$  fatigue loading which still has 85% of residual strength

Figure 3.45 illustrates the characteristic crack pattern of a  $[(0, +45, -45, 90)_2]_S$  laminate under  $R = -1$  fatigue loading. Although the panel looks quite damaged the residual strength is still 85%. Figure 3.46 shows the influence of small impact damage on damage tolerance. For the static case, the influence of strength is reduced significantly to about 30-40%. However, under fatigue loading, these values are almost constant and only very slightly reduced to 25% strength, which is very damage tolerant. This behaviour is different from metallics where the influence of cracks is smaller for the static case and much larger for the fatigue loading. Figure 3.47 shows the fatigue behaviour of a  $[0_2, +45, 0_2, -45, 0, 90]_S$  laminate with an artificial delamination of  $\phi 10$  mm in the middle of the plate. The stress amplitude is  $\pm 400$  MPa and the stress ratio  $R = -1$ . The number of cycles until collapse is reached at  $14.2 \times 10^4$ . It can be seen that the artificial delamination is almost no growing until collapse. However, there are more delaminations at the edges due to the free edge effects. Figure 3.48 shows the results of a stiffened CFRP panel cyclically loaded by axial compression. The panel was partly artificial pre-damaged by separation of the second stringer by a Teflon layer. In each cycle,

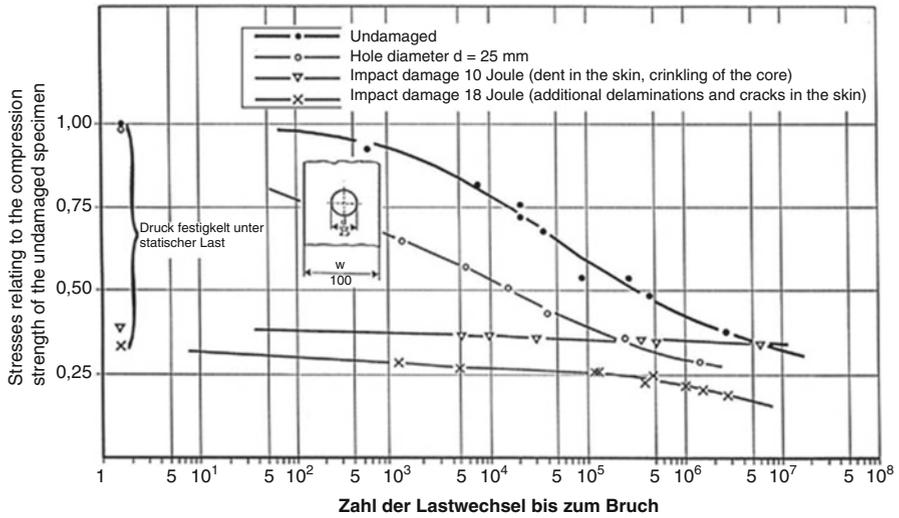
**Fig. 3.46** Fatigue behaviour of a sandwich structure,  $R = -1$ ,  $f = 5$  Hz, Skin: GFRP fabrics [ $\pm 45, 0/90$ ], Core: Nomex honeycomb 8 mm, Width  $w = 100$  mm, Length [350(180) mm]

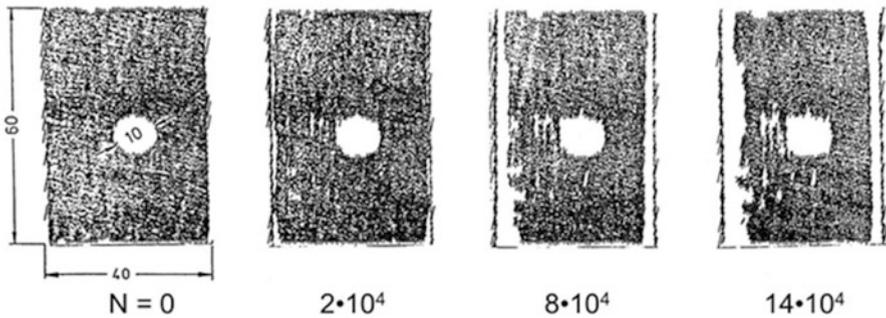
**Fig. 3.47** Delamination growth under fatigue loading of a  $[0_2, +45, 0_2, -45, 0, 90]_S$  laminate with an artificial delamination  $\phi 10$  mm in the middle, stress amplitude  $\pm 400$  MPa,  $R = -1$ , the number of cycles until collapse  $N = 14,2 \cdot 10^4$

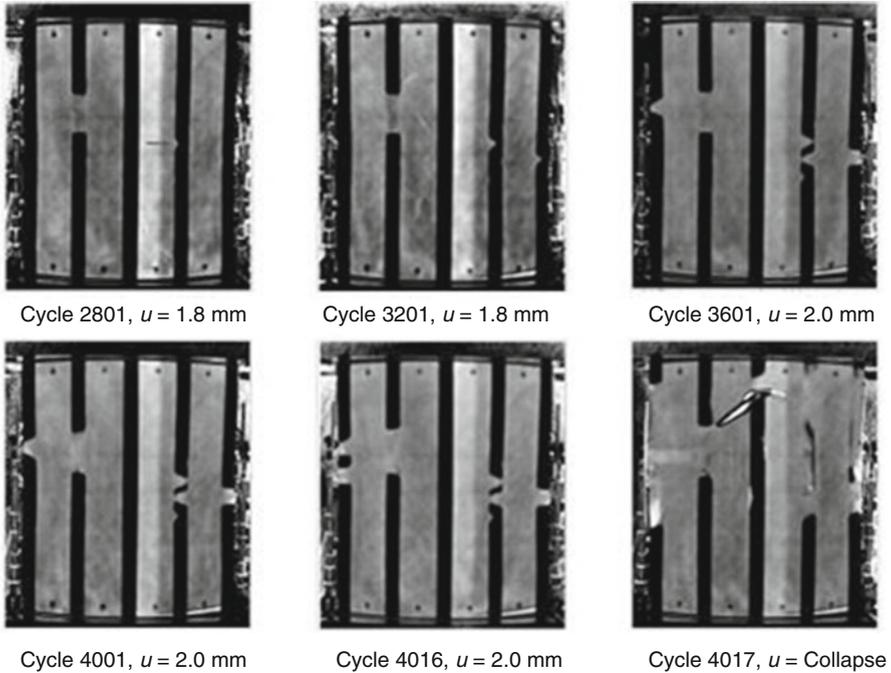
**Fig. 3.48** Thermo-graphy images of a stiffened CFRP panel cyclically loaded by axial compression

the panel was loaded almost by collapse load. One cycle took 7 s. The figure shows thermography images at different cycles until collapse. In the first figure, the artificial separation of the second stringer is visible. In the next steps, other stringers start to separate from the skin. But the artificial separation does not grow until collapse (Degenhardt et al. 2008).

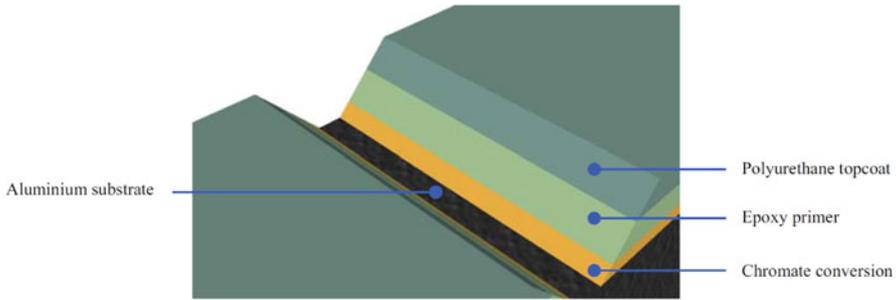
**Fig. 3.49** Aircraft structural coating that consists of polyurethane topcoat, epoxy primer, chromatic conversion on the aluminium substrate (Tiong and Clark 2010)

One of the main aspects of applying surface coatings to the substrate is to improve the overall performance of the coated components. This can be achieved through the proper application of coatings technology, their characterization, testing and evaluation. As an example (Fig. 3.49), for corrosion-resistant applications, most aircraft surfaces are painted with a shielding layer consisting of chromatic conversion on the substrate, an epoxy primer and a polyurethane topcoat (typical total thickness of about 50–125 $\mu\text{m}$ ). The role of epoxy primers is to inhibit corrosion of underlying substrates, whereas the topcoat (polyurethane) is a layer that is resistant to a range of chemicals and weather, largely flexible layer and provides the desired surface appearance. A layer of sealant coat is useful at faying surfaces (surfaces that are in contact at a joint) to help provide the flexibility of the layer and prevent cracking (Tiong and Clark 2010).

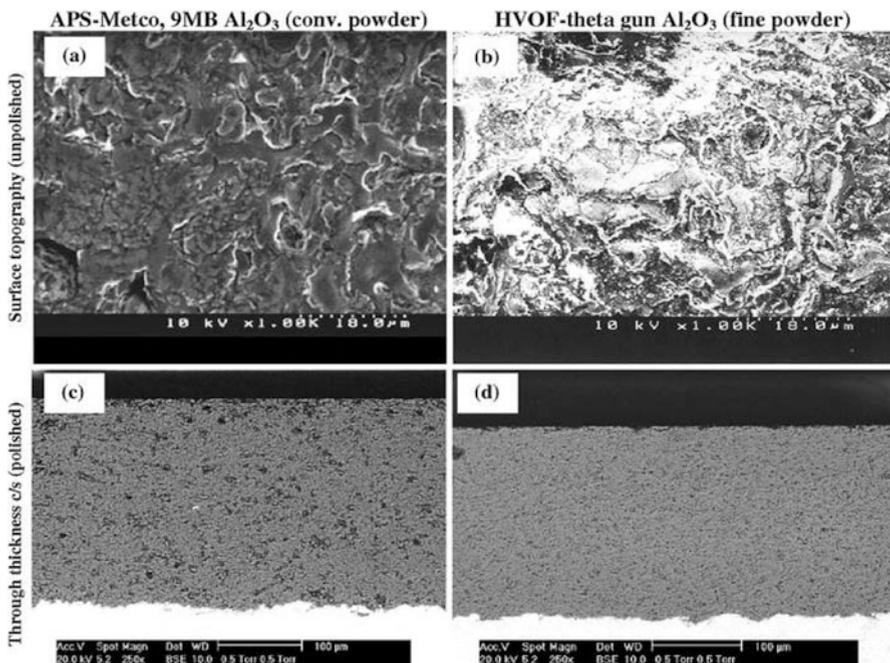
**Fig. 3.50** Thermally sprayed alumina coatings on steel substrates: (a) and (b) showing surface topographies with definite splat morphologies, (c) and (d) through-thickness coating cross-sections (polished surface) (Ahmed et al. 2012)

Taking an example of alumina ( $\text{Al}_2\text{O}_3$ ) coatings sprayed onto steel substrates using thermally sprayed techniques, have been used in aircraft parts because of their wear resistance properties (Thirumalaikumarasamy et al. 2014). Figures 3.50 and 3.51 shows some of the manufacturing features and defect in thermally sprayed coatings (air plasma spray-APS and high-velocity oxy-fuel-HVOF). The sprayed surfaces (Fig. 3.50a, b) show that the  $\text{Al}_2\text{O}_3$  particles have spread and non-melted or semi-molten particles not distinguishable. Polished cross-sections of the sample (Fig. 3.50c, d) show a qualitatively higher porosity for the APS alumina

(conventional powder) than HVOF alumina (fine powder). Average coating porosity was measured as 2.8% and 8.8% for the HVOF and APS coatings, respectively (Ahmed et al. 2012). The microscopic investigation revealed pores, voids, un-molten particle, non-bonded inter-splat areas and vertical cracks in splats, including columnar grain structure in lamellae (Fig. 3.51).

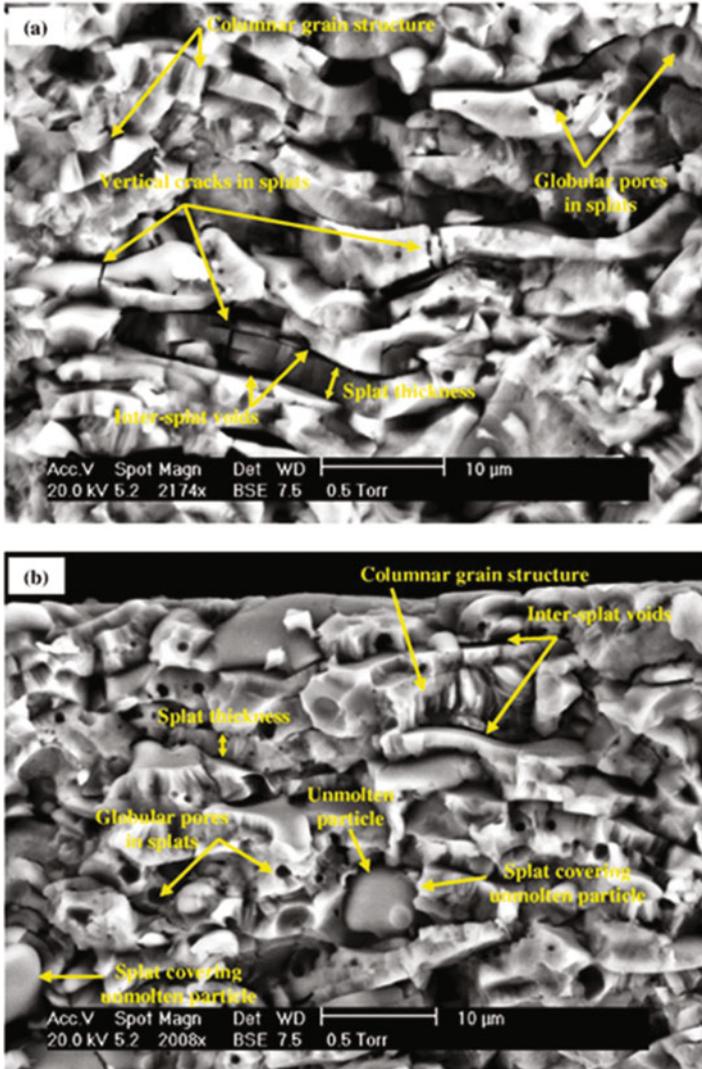
**Fig. 3.51** SEM images of  $\text{Al}_2\text{O}_3$  coatings (cryogenically fractured coating flakes) showing splat morphologies with columnar grain structure, pores, voids, vertical cracks in splats and unmolten particles: (a) APS  $\text{Al}_2\text{O}_3$  and (b) HVOF  $\text{Al}_2\text{O}_3$  (Ahmed et al. 2012)

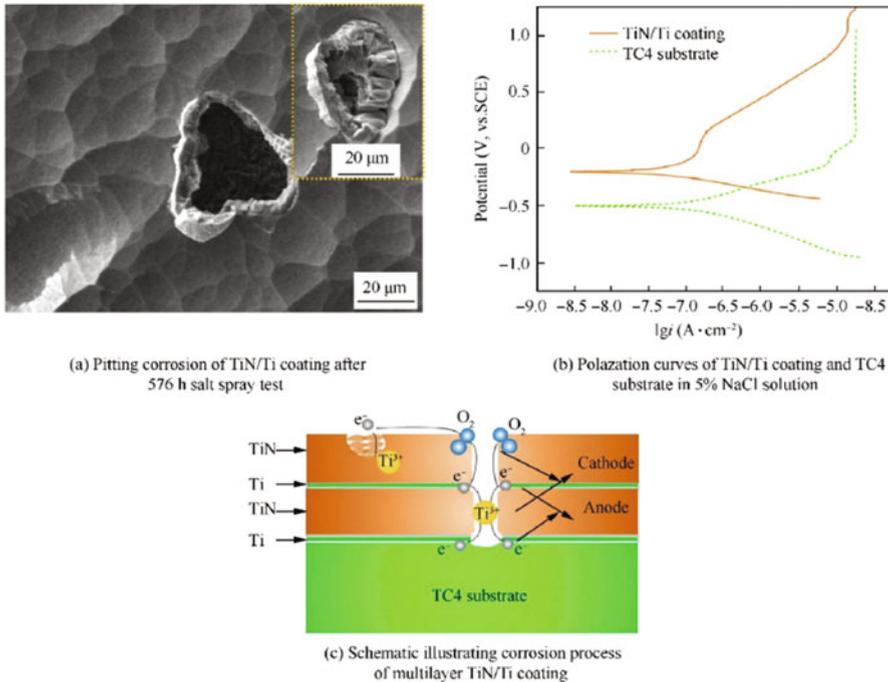
**Fig. 3.52** Morphology and mechanism of pitting corrosion of TiN/Ti coating (Sun et al. 2020)

Several coatings have been applied to aircraft engine parts (e.g. compressor blades) to develop multifunctional erosion and corrosion mitigations in harsh in-service conditions (Sun et al. 2020). In this work, the multi-arc ion plating technique was applied for TiN/Ti coating fabrication on the TC4 (Ti-5.60Al-3.07V, wt%) substrate. Note that such nitride coating depends not only on high mechanical strength but also on the complex mix of environmental conditions such as erosion and corrosion. Figure 3.52 shows the morphology and mechanism of pitting corrosion of TiN/Ti coating onto TC4 after 576 h salt spray corrosion). From

the Tafel polarization plots in Fig. 3.52b, it was observed that the corrosion potential difference promoted the corrosion cells between TiN and Ti, which were the cathode and anode for electrochemical corrosion (Sun et al. 2020), respectively, with corrosion process schematic shown in Fig. 3.52c. It was concluded that the structural design of multilayer dense coatings can be an improved way to prevent the medium of corrosion solutions.

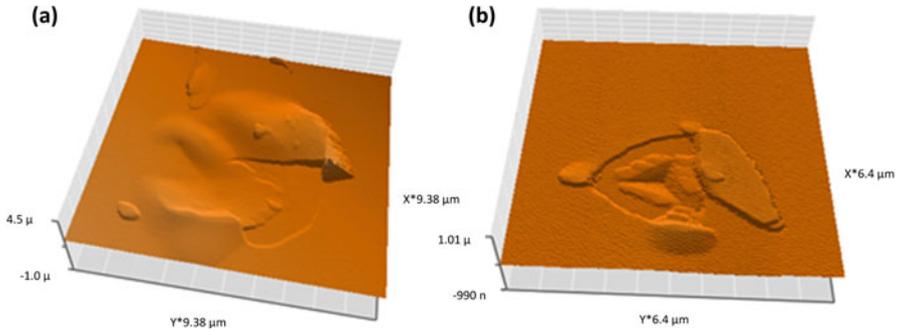
**Fig. 3.53** Failure in brittle coating (100 nm thick DLC on silicon substrate) during 20-cycles nanoindentation: (a) under conical indenter at 200 mN and (b) Berkovich indenter at 10 mN

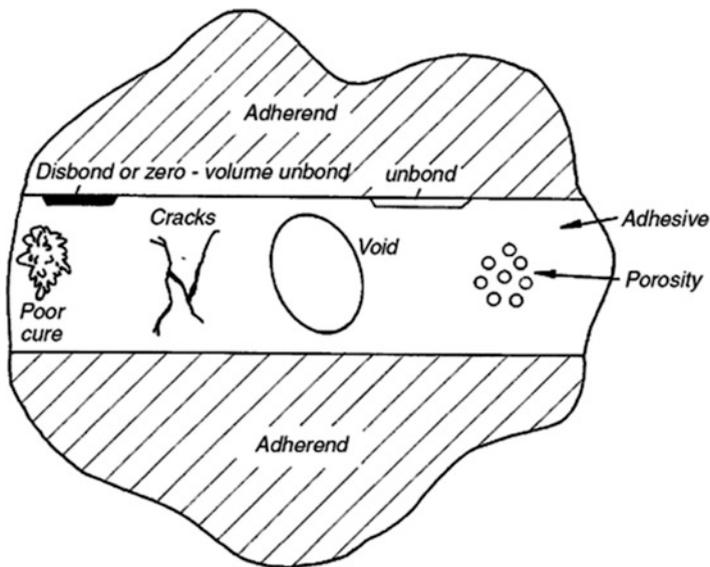
**Fig. 3.54** Defects in an adhesive bond (da Silva et al. 2018)

The aim of defect identification and characterization in adhesive bonds is to understand the mechanisms that lead to the creation of the defect, the effect of the defect on the performance of the adhesive joint and ultimately the damage tolerance of the joint. As with fastener-based joints, where the repair can be performed and the joint performance reinstated to 100% post-repair through a simple replacement of the fastener, a 100% regain of the adhesive joint strength is impossible unless a complete reapplication of the adhesive is performed. Hence, the defect type (e.g. Fig. 3.54) and severity must be identified accurately to assess the residual strength of the adhesive bond.

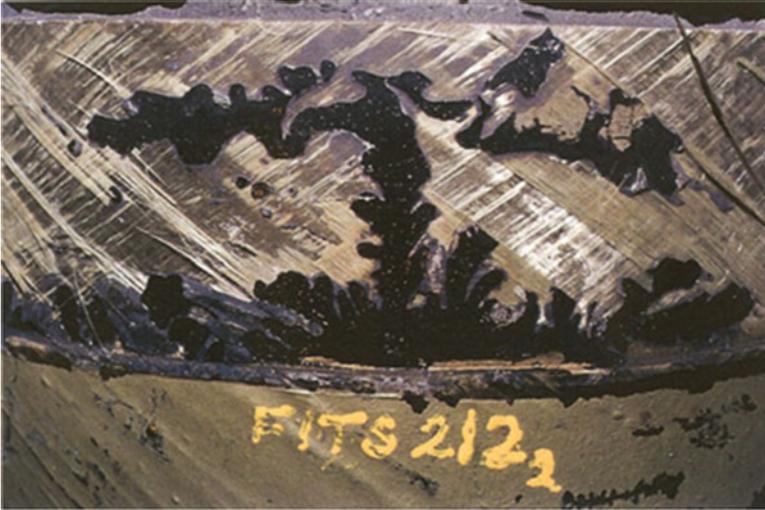
**Fig. 3.55** Void in the adhesive caused by premature handling of the joint before the adhesive cured (da Silva et al. 2018)

Manufacturing defects in adhesive bonds are classified into three main types: (a) complete voids, disbonds, porosity. This type of defect occurs because of air trapped within the adhesive during the fabrication stage (e.g. Fig. 3.55), the presence of volatiles, defects in the application of the adhesive or insufficient quantity of adhesive. The mixing of the adhesive and hardener during fabrication can sometimes introduce air trapped within the mixture (b) poor adhesion, the improper bond between the adherends and the adhesives. This kind of defects occurs due to improper surface preparation and impurities being present on the surfaces of the adherends before fabrication and (c) kissing defects caused by the local disbonding of the adhesives and adherends. These are also called zero volume disbonds due to the very small dimensions along with the thickness. The wider category of surface disbonds into which kissing bonds fall into that created by the application of adhesive only on one of the adherends in the fabrication stage. Kissing bonds are the worst case of this.

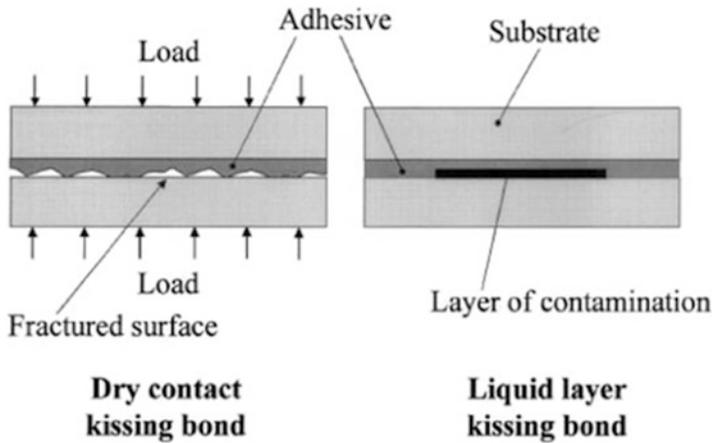
**Fig. 3.56** Schematics of dry contact and liquid layer kissing bonds (Brotherhood et al. 2002)

surfaces. Due to the intimate contact of the surfaces in a kissing bond (e.g. Fig. 3.56), where some or all of the surface asperities on both the surfaces are in contact, despite the complete lack of adhesive strength, they are very difficult to detect with many of the conventional non-destructive evaluation techniques. With this combination of undetectability and severity, the presence and detection of kissing bonds present a significant practical problem in the application of adhesive bonds in primary load-carrying structures.

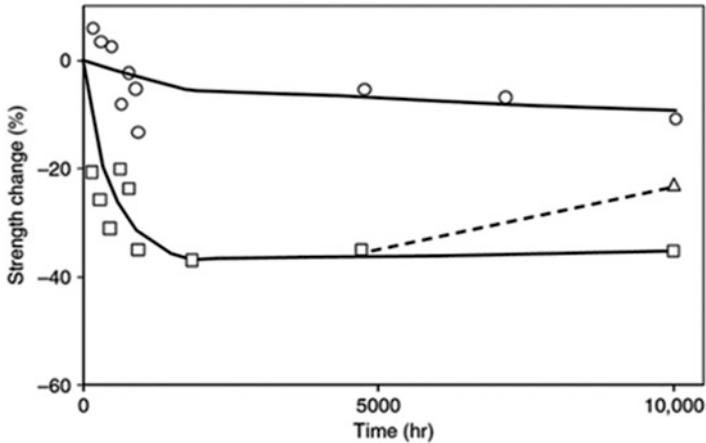
**Fig. 3.57** Nitrile-phenolic adhesive-bonded aluminium alloy joints exposed to wet air at 50°C and circle legend—50%RH, square legend—100%RH, triangle legend—joint exposed to 100%RH for 5000 h and stored at 50% RH for 5000 h (Comyn et al. 1987)

The general effect of hot and humid environments on the adhesive bond strength is summarised in Fig. 3.57. It shows the aluminium alloy lap joint strength degradation with respect to time of exposure to humidity. As shown, lower levels of humidity have significantly less effect on the bond strength compared to higher levels. This leads to the argument that there exists a critical concentration of moisture in the adhesive below, in which there will be no joint strength degradation. The dotted line in the plot indicated the strength recovery in a joint exposed to high humidity levels after exposure to lower humidity levels. This was attributed to the

failure in the primer close to the oxide layer rather than directly at the interface. The effect of moisture diffusion into the adhesive cannot be reversed and the joint strength degradation is irreversible. Moisture ingress in adhesive bonds can either be through direct absorption and diffusion through the adherends and the adhesive. In some cases, where the adherend diffusion is not possible, the cracks and voids present within the bond line promote the moisture uptake. Moisture usually leads to plasticization of the adhesive and/or changes in the glass transition ( $T_G$ ) temperature in some cases. The rate at which the moisture diffuses into the bond line depends on the diffusion coefficient which in turn depends on the environmental temperature. Hence, hot and wet environments pose the most aggressive form of accelerated ageing to adhesive bonds.

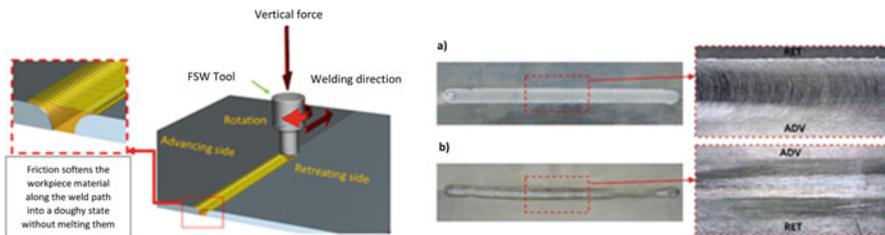
**Fig. 3.58** Scheme of the FSW process—a lap joint and example joint without any defect (advancing side-a, retreating side-b) (Myśliwiec et al. 2019)

Friction stir welding (FSW) is a solid-state joining process. It involves rotating a cylindrical tool with a short protrusion or ‘pin’, which is plunged between two metal plates (Fig. 3.58).

High pressure and shear strain plastically deform and consolidate the workpieces using material extrusion from the front to the back of the tool. The plates are clamped with a sturdy fixture to the backing plate with an anvil piece of hardened steel

underneath the path of the FSW tool, counteracting the vertical and horizontal forces arising during welding. The combination of frictional and deformation heating around the immersed rotating pin and at the interface between the shoulder of the tool and the plates leads to the consolidation of the two metal plates as the tool traverses along the joint line. FSW process was invented in the Welding Institute (TWI) in the UK in 1991 and has been researched extensively since then and applied in various fields such as the automotive, marine and aerospace industries, where aluminium alloys are heavily used (Thomas et al. 1991; Huang et al. 2018).

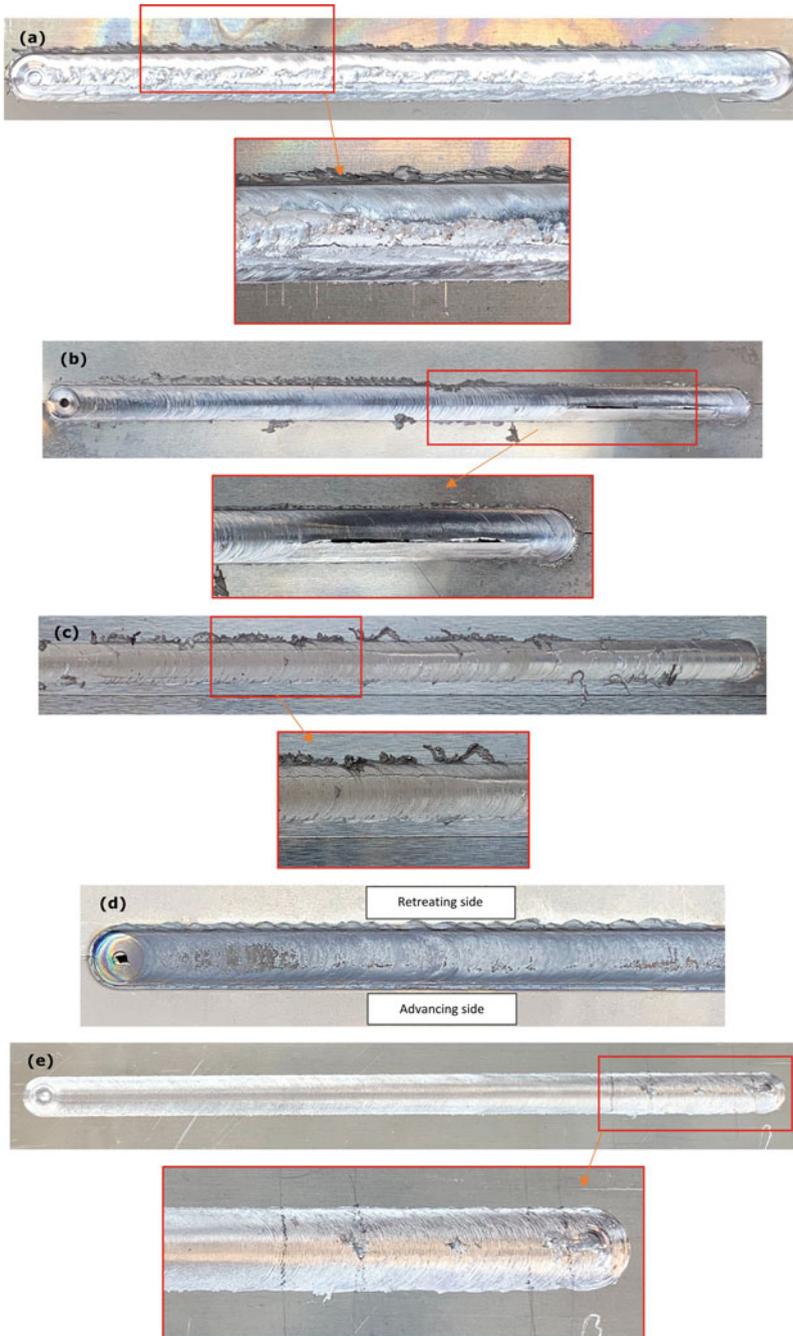
**Fig. 3.59** Friction stir weld (FSW) joints with defects; (a) butt joints of AA2024-T3 of 2 mm in thickness defect types: exceeds flash, cracking of the joints, the unnormal stirring of the material, (b) butt joints of AA7075-T6 of 0.5 mm in thickness, defect types: exceeds flash, wormhole, (c) lap joints of AA2024-T3 1 mm in thickness, defect types: exceeds flash, cracking of the joints, (d) butt joints of titanium grade 5 of 0.5 mm in thickness, defect types: excessive oxidation of the joints and (e) butt joints of AA2024-T3 of 0.5 mm in thickness, defect type: cavities

The FSW weld does not demonstrate many of the defect encountered in normal fusion welding and distortion is significantly less. But to consider the influence of all conditions and the process parameters on the final result of joining, it could be shown that the main possible defects (e.g. Fig. 3.59) occur when there is an inappropriate choice of parameters for a given case, especially for welding very thin sheets, and when plastic flow and stir materials in the welding zone are difficult to realize. The welds are created by the combined action of frictional heating and plastic deformation of the joined materials due to the rotating tool. To avoid defects, all important parameters, mainly the speeds and feeds influencing the heat input during welding, must be carefully chosen.
