Materials (ISSN 1996-1944)

Low Velocity Impact Behavior of Glass Filled Fiber-Reinforced Thermoplastic Engine Components

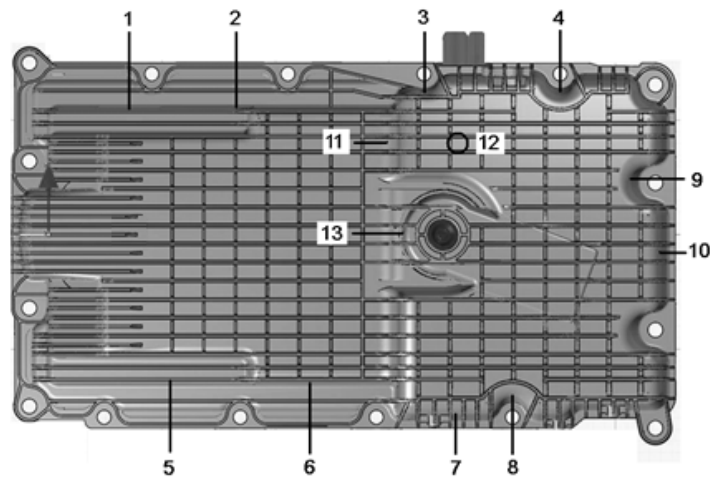
Figure 5. Map of the impact locations.

The 22 gram projectile was fired at the oil pan for a single impact perpendicular to the surface (Figure 5 and Figure 6). The impacts were reproduced at least four times using a new oil pan at each time.

Figure 5 shows some of the impacts realized on the oil pan. Depending on their location, the impact intensity used is variable. Figure 6 provides details of the impact energies applied for each impact location and the outcomes for each shot indicated in terms of percentage of failure in part integrity.

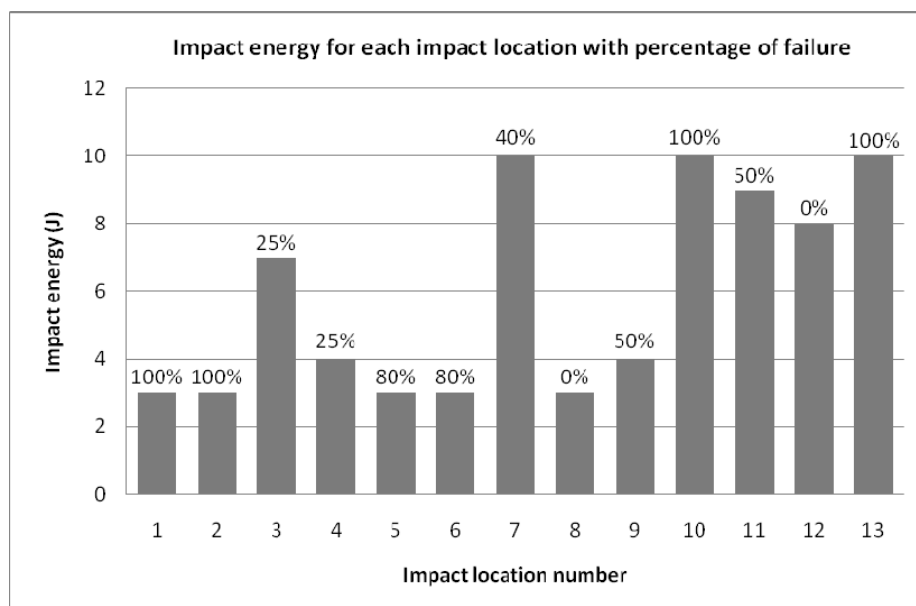
Figure 6. Percentage of failure for each impact location at different impact energies.

Figure 6 shows an overview of the impact limits that the oil pan can withstand and points out where the areas of weakness exist. The disparity in terms of impact resistance is clear. This is due to the complexity of the oil pan in its structure (with surfaces more or less stiffened in the inside of the oil pan) and its material arrangement (*i.e.*, fiber direction arrangement). The understanding of material failure is not easy. This judgment is blurred by the complexity of the material. Nevertheless, a resistance limit more or less constant was determined for each location shown in the map (Figure 5). Explicitly, the unlikely sides to receive an impact have to undergo 3-4 Joules, the edges of the pan and some medium level risk sides have to withstand 7-8 Joules. The most exposed areas should be able to withstand 10-12 Joules. The sides likely to fail in Figure 6 have to be improved, redesigned or stiffened. As expected, the ribbing is the relevant geometric parameter. It plays a big part in the impact resistance of the component. In addition, it is evident that the ribbing dimensions should be contained following the following values. The rib height should be between 4 to 10mm and for a height between 2-3 mm. For ribs less than these dimensions, it seems that the ribs are less efficient while above this height, the ribs are too fragile and brittle. Figure 7 shows various damage types that can result after an impact.
